APPENDIX H Fish Passage Assessment

New Zealand Transport Agency Waka Kotahi

BRYNDERWYN HILLS RECOVERY WORKS: FISH PASSAGE ASSESSMENT

13 AUGUST 2024

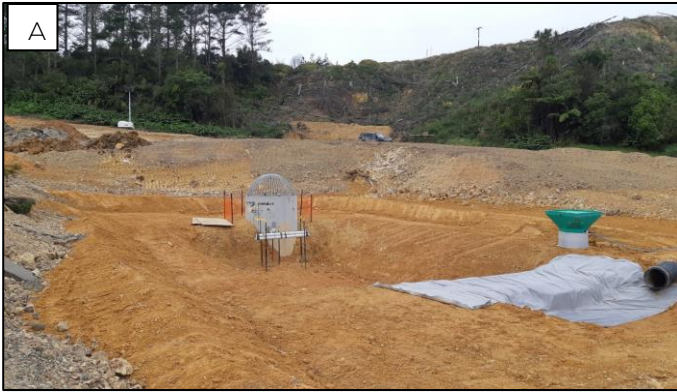
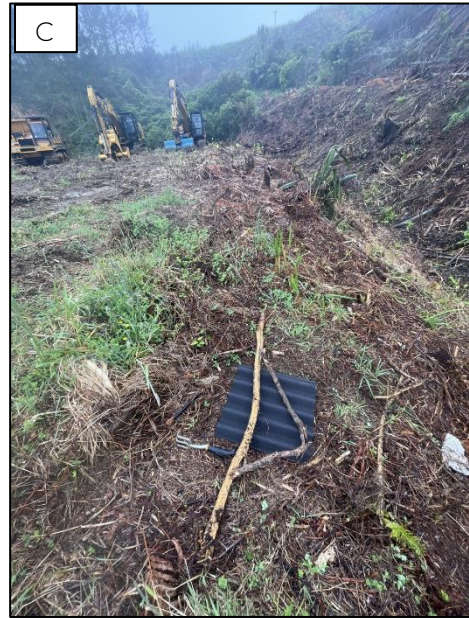
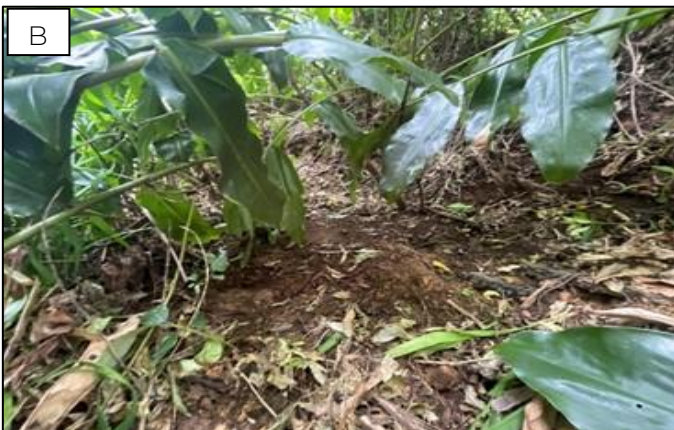
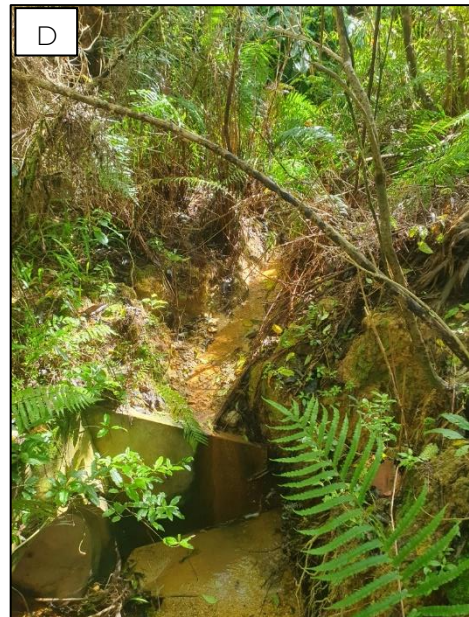
The intermittent stream was surrounded by a mix of native and exotic vegetation which was largely removed in December 2023 and completely removed in April 2024 (Plate 3-1). The site is within the headwaters of a small tributary that was found to have two branches.

Plate 3-1: (A) Fill Site A in April 2024, (B & C) Sections of stream at Fill Site A in December 2023, (D) Sections of stream at Fill Site A in October 2023.

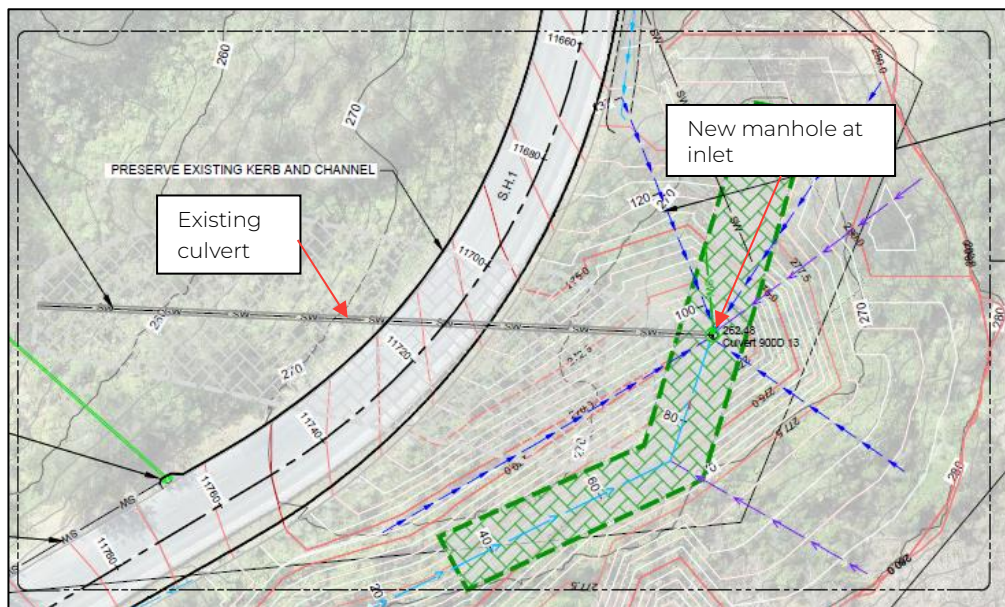
The affected area was approximately 8,700 square metres (m²) and included a total of approximately 100m of stream length. The existing headwall inlet was removed and replaced with a new manhole at the same location. The manhole lid level was increased by addition of new risers as filling progressed to match the finished ground level. The existing 900mm culvert beneath SH1 at Site A will remain (Figure 3-2). A flow path is proposed to be established to the new manhole; however, it is likely additional fill will be added to this site during potential future works.

Figure 3-2: Site A existing culvert shown in grey and new manhole extension in green.

Due to the loss of upstream habitat for freshwater fauna at Site A and total loss of access to fish, there is now no value in providing the passage for fish through the culvert beneath the road. Furthermore, the stream was intermittent, had limited upstream habitat and the quality of fish passage through the culvert and manhole remains broadly similar to existing baseline conditions. Therefore, the magnitude of effect on freshwater fauna has been assessed as being Negligible. Based on this the overall level of effect of culvert upgrades on fish passage at Site A has scored Very Low. An exemption is proposed to Site A as fish passage is not required based on the WK-OIC.

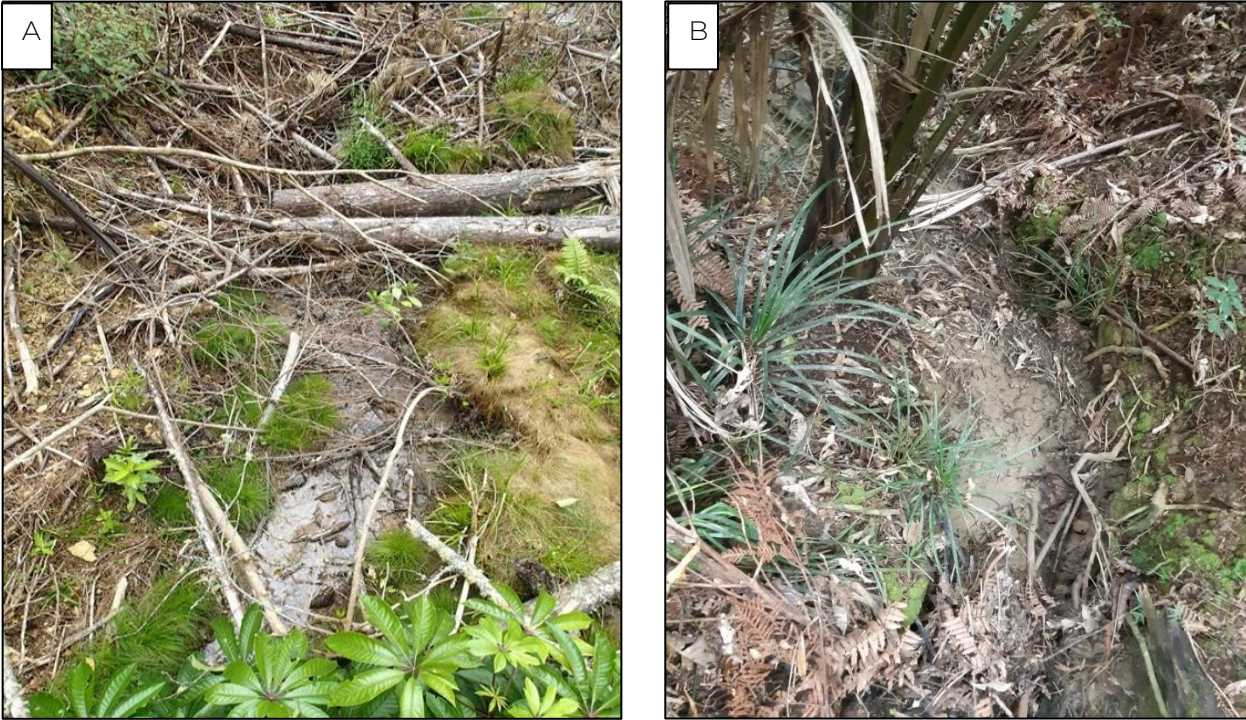
Site B1 is predominantly situated in harvested pine plantation, with a small strip of natural vegetation along the road. The stream and wetland habitats had very low flow in December 2023 and have been impacted by forestry activities (Plate 3-2).

Plate 3-2: A) Stream at Site B1 (fill site) upstream of the road in December 2023, B) Stream at Site B1 downstream of the road in April 2024

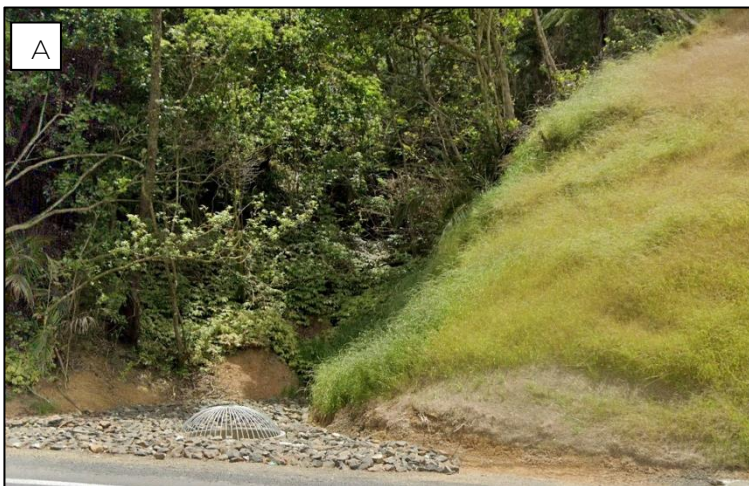
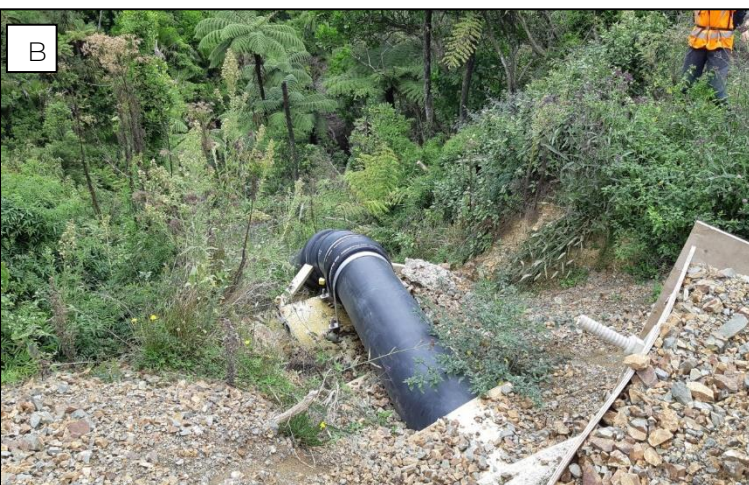
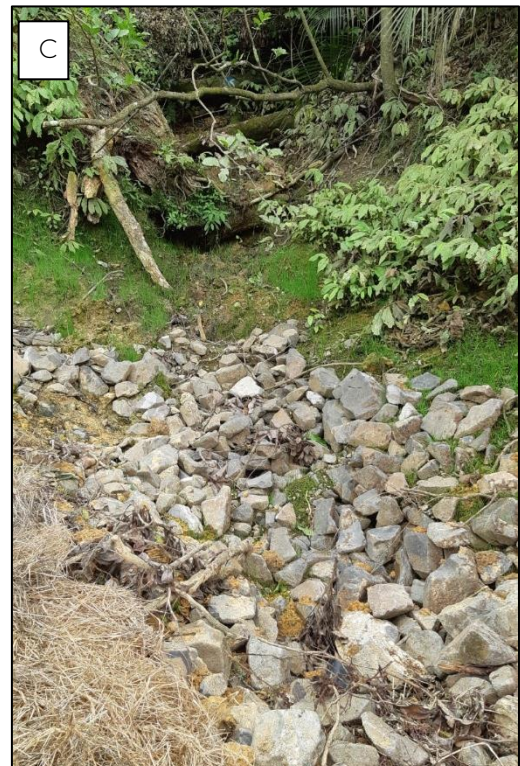
The intermittent stream at Site D1 is within indigenous forest. This stream was impacted by slips during severe weather and there is now only approximately 9 m of channel remaining upstream of SH1, which is conveyed through a manhole at the road (Plate 3-3). Downstream of the road there is a suspended smooth bore high density polyethelene flume pipe.

Plate 3-3: A) Stream and scruffy dome at Site D1 upstream of the road in December 2023, B) Stream upstream on the road after completed works in April 2024, C) Flume downstream of the road.

The intermittent nature of the stream has likely prevented or restricted upstream fish passage. There is also now very limited habitat available since the slip. Salvage results suggest that no fish were present upstream of the road, however, a population of Hochstetter's frog was found.

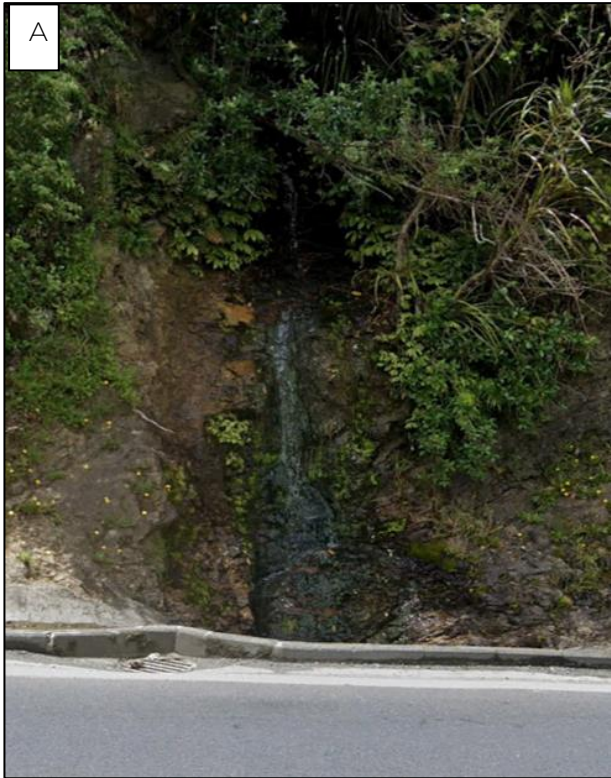
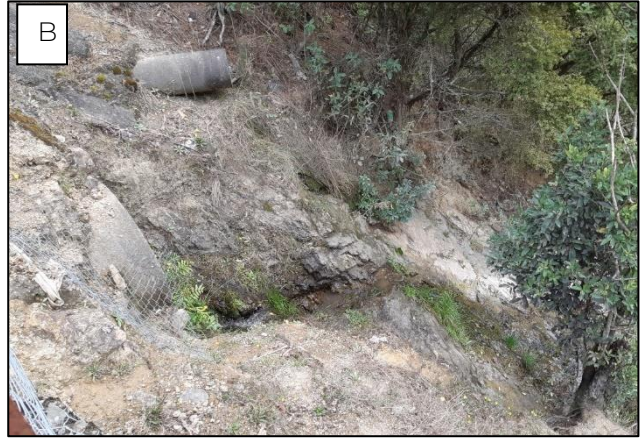
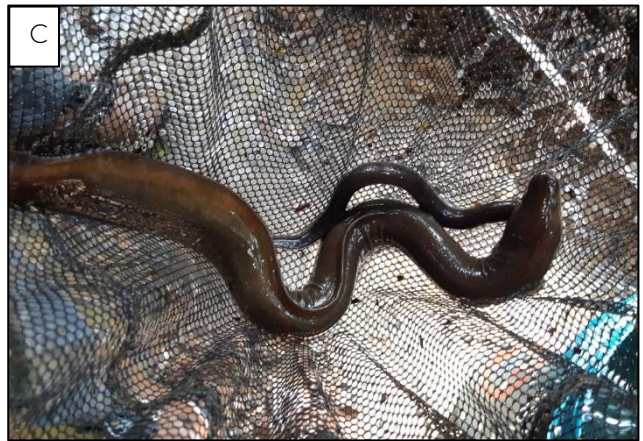
The stream at Site D2 is a steep permanent stream located within indigenous forest. The stream has high quality habitat with various pools and runs upstream of the road before in flows down a waterfall at the road edge (upstream end; Plate 3-4).

Plate 3-4: A) Stream waterfall upstream of the road at Site D2 in December 2023, B) Stream waterfall downstream of the road at Site D2 in April 2024, C) Longfin eel salvaged from upstream of SH1 waterfall in April 2024.

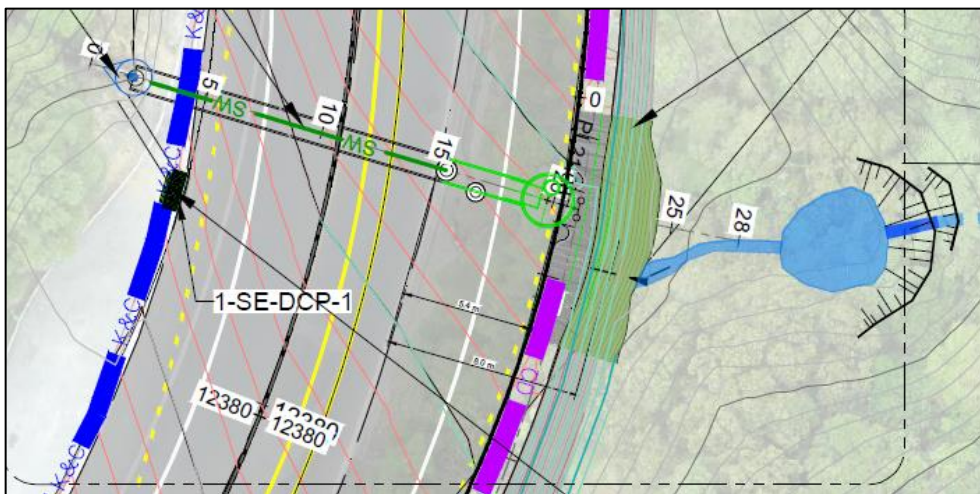
The existing 12 m long, 900 mm wide culvert is proposed to be extended by 5 m at its upstream length. This has historically restricted fish passage with an existing approximately 1m drop. This includes installation of a manhole and drop structure which is creating a total barrier to the upstream passage of fish without retrofits.

Figure 3-5: Site D2 existing culvert shown in black and new extension and manhole in green.

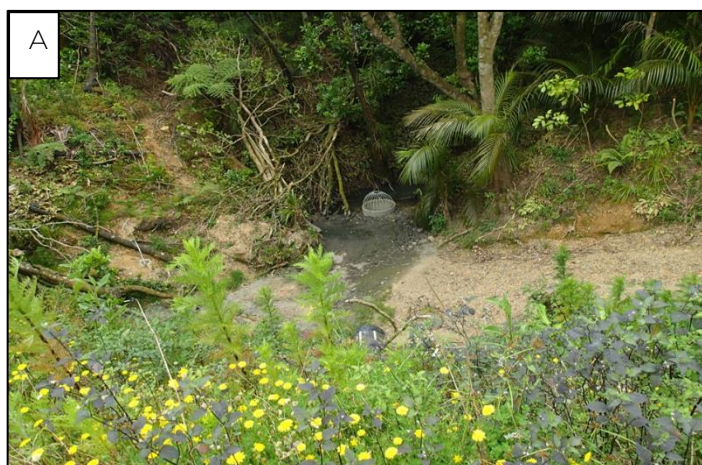
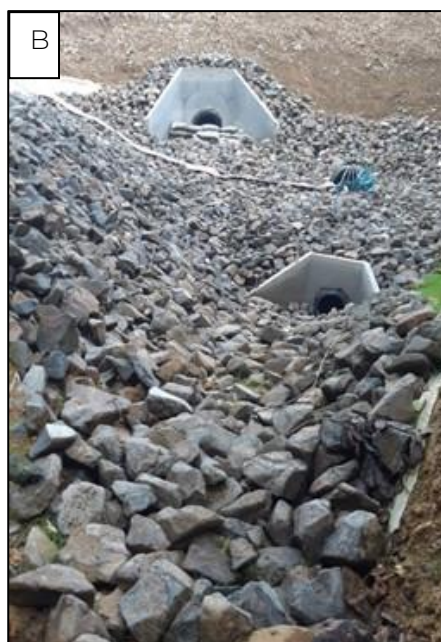
The stream at Site F1 is a permanent stream within indigenous forest that has minimal flow and upstream habitat for fish. Flow is conveyed across SH1 through a manhole and culvert (Plate 3-5).

Plate 3-5: A) Stream at Site F1, upstream from SH1 in December 2023, B) Stream at Site F1 after construction in April 2024.

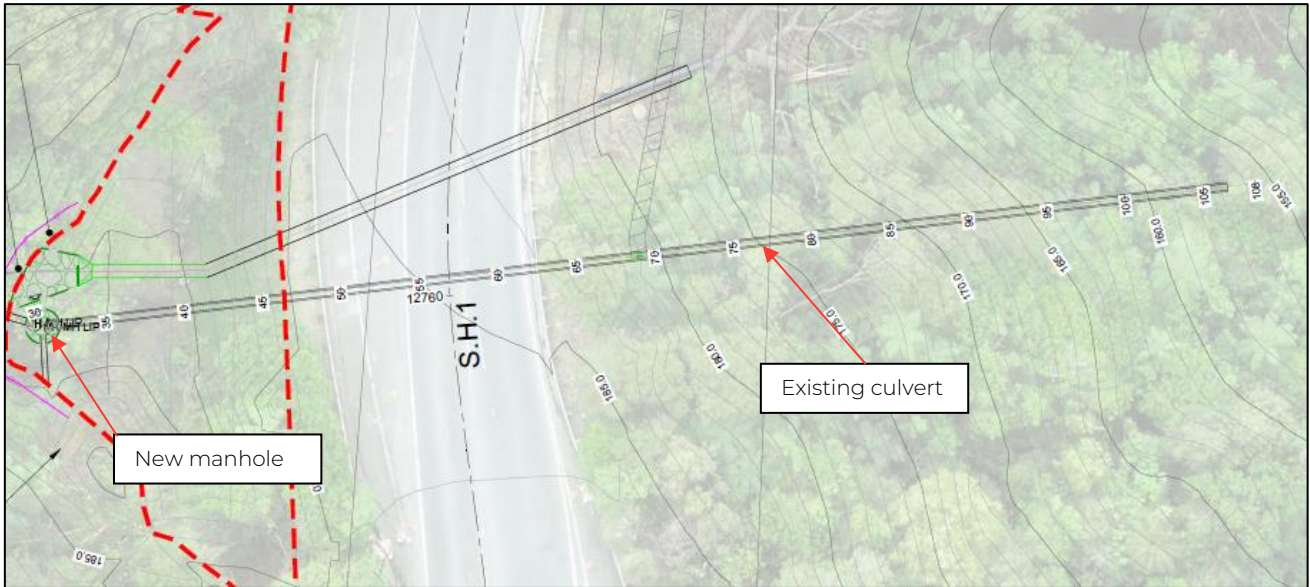
The existing 75.5 m long, 375 mm wide culvert was repaired, and a new manhole and scruffy dome was installed at the culvert's inlet. The manhole is perched above the height of the stream bed by approximately 35 cm and has a 1.7 m head drop.

Figure 3-6: Site F1 existing culvert shown in black and new extension and manhole in green.

Based on CCTV, the existing culvert was found to have a buried junction manhole, which is not benched and is inaccessible (*pers comm*, Mat Chiaroni, WSP stormwater Engineer). This in addition to the minimal flow observed within the stream have likely prevented fish passage historically.

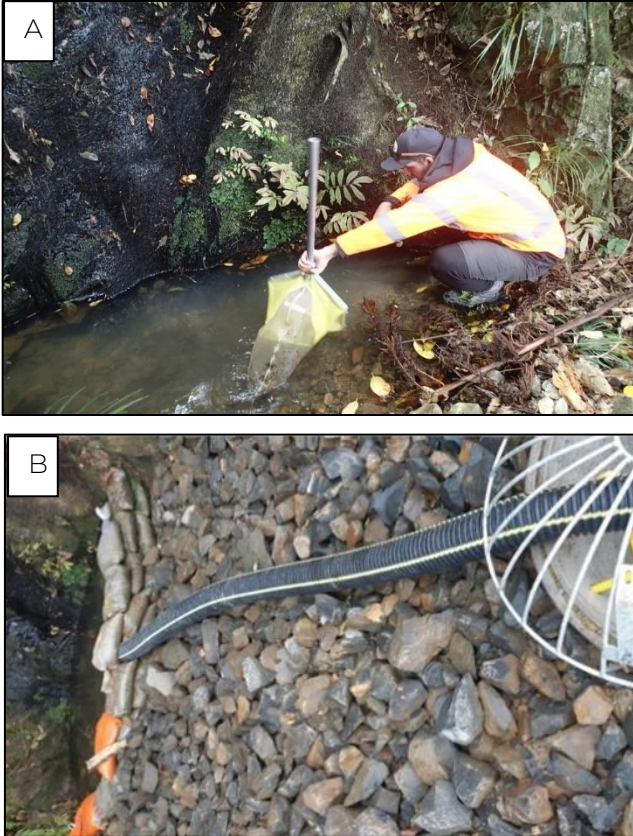
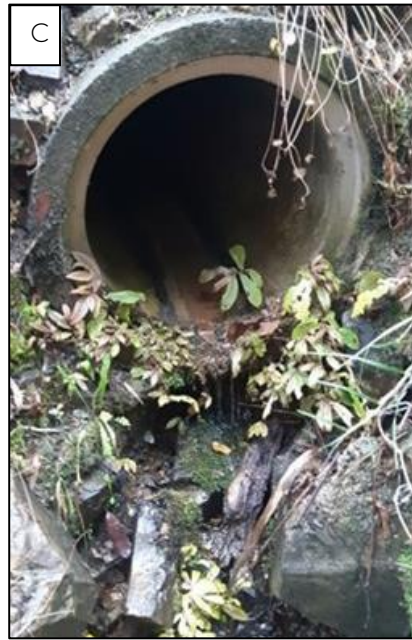
At Site G2 there is a permanent stream within native bush. Directly upstream of the road there is various fish habitat and a waterfall and pool on the edge of the road. Flow is conveyed beneath SH1 through a manhole and culvert (Plate 3-6).

Plate 3-6: A) Stream at Site G2 upstream of SH1 in December 2023, B) Stream at Site G2 during construction upstream of SH1 in April 2023, C) Outlet of culvert downstream of SH1 in April 2024

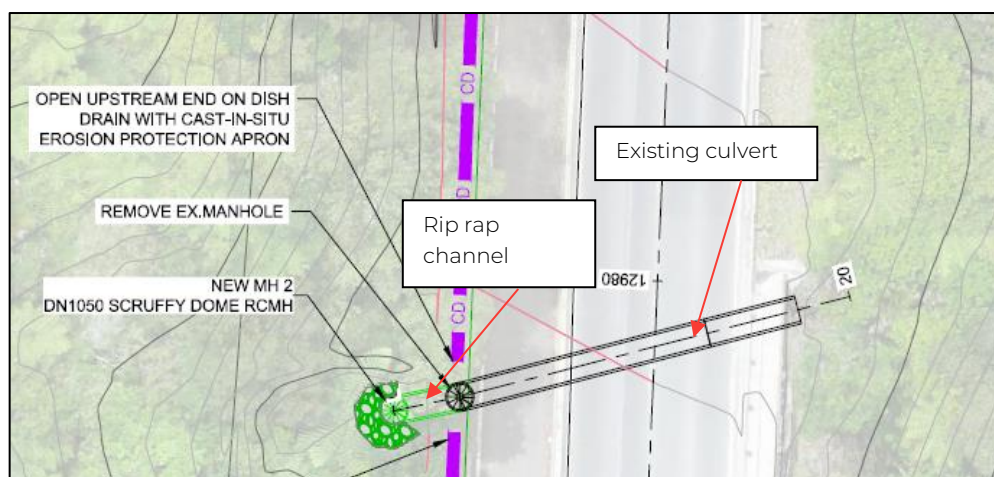
A new manhole with scruffy dome was installed at the inlet amongst rip rap protection in the bed of the stream (Plate 3-7). The manhole has a head drop of 1 m. Approximately 3.6 m of rip rap was installed from the inlet of the scruffy dome to the pool at the bottom of the waterfall.

Figure 3-7: Site G2 existing culvert shown in black and rip rap channel and manhole in green.

Recommendations have been provided to retrofit the design to provide fish passage at this site (see Appendix A), and if implemented are considered to provide fish passage resulting in Negligible magnitude of effect. Therefore, with retrofits the overall level of effect on fish passage scores Very Low.

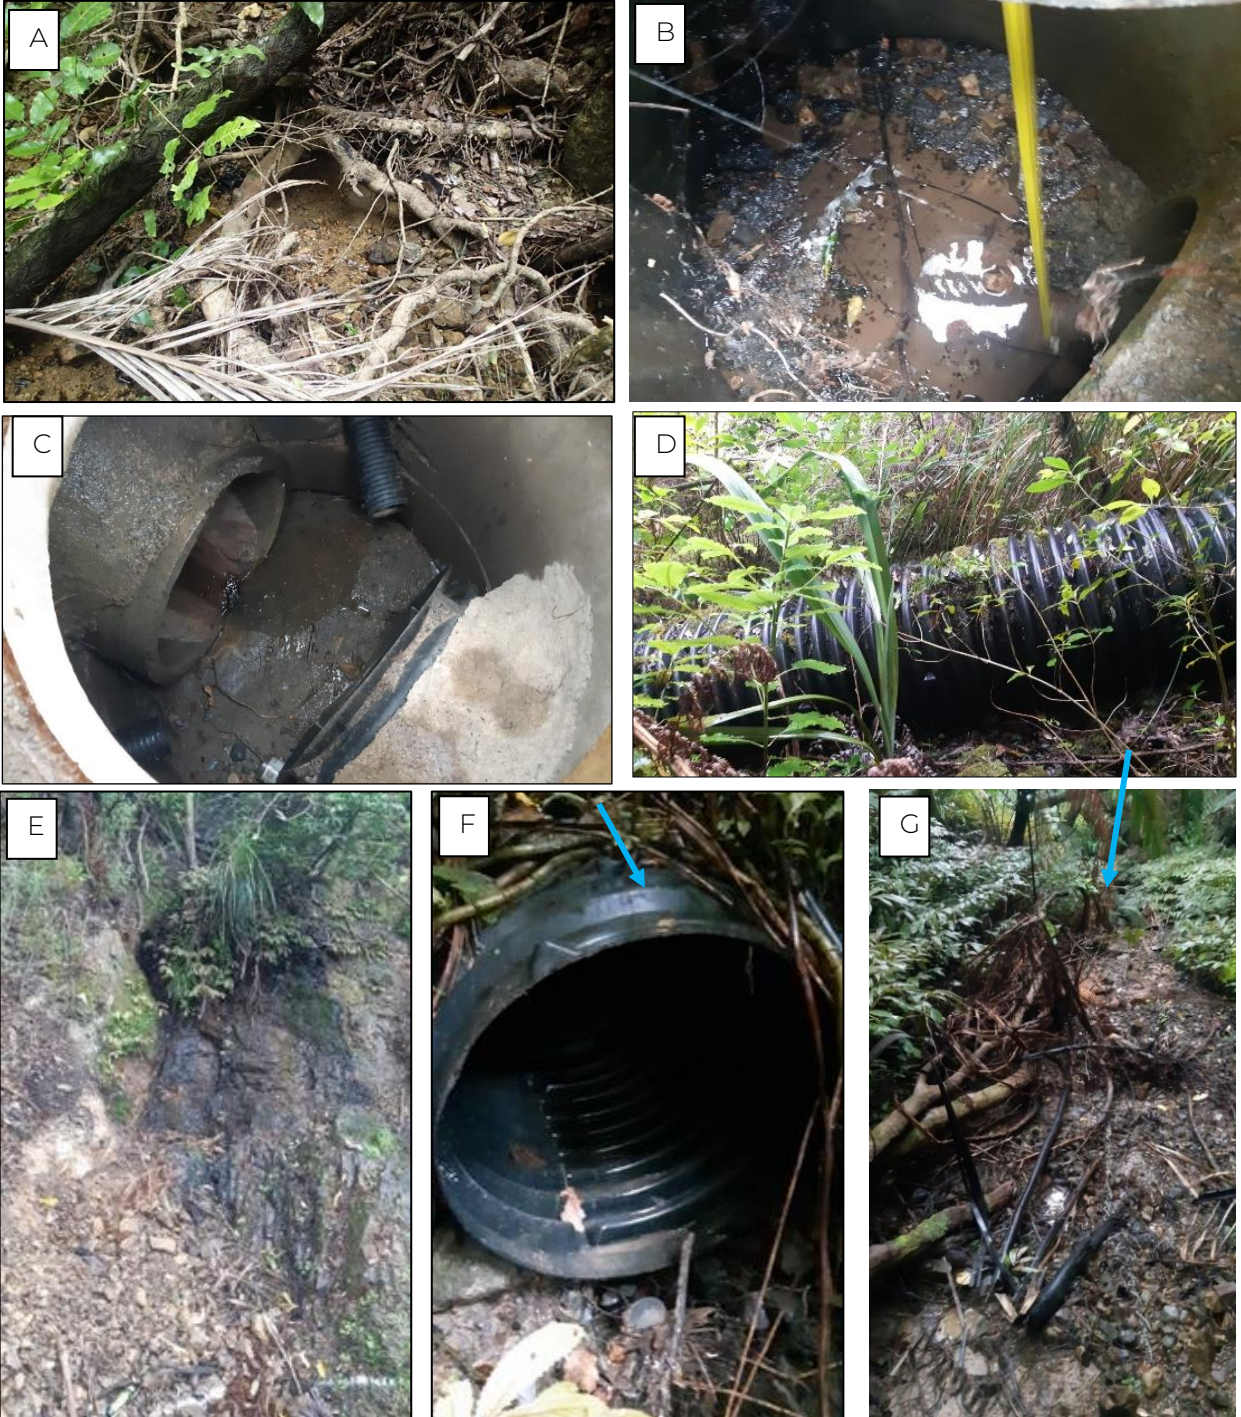
At Site G3 there is a permanent stream within native bush (Plate 3-7). Flow is conveyed beneath SH1 through a manhole and culvert, then down a large flume to the gully.

Plate 3-7: A) Stream at Site G3, upstream of SH1 in December 2023, B) Manhole upstream of the road with drop into inlet, C) manhole downstream of the road with flow disappearing before it flows down the flume, D) Flume down to stream, E) Stream at Site G3 upstream of SH1 in April 2024, F) perched outlet at end of flume, G) flows going subsurface at outlet of flume.

The existing structure and flume are preventing upstream fish passage which is resulting in a total barrier for upstream fish passage to approximately 50% of the sub catchment. However, upstream of the road there was a waterfall and little flow during site visit. There is some habitat upstream for eels particularly during winter months, although no fish had been observed based on a number of issues restricting passage with the current structure and other existing downstream artificial barriers. The existing design does not modify or make fish passage worse at this location. Therefore, the magnitude of effect has been assessed as Negligible and the overall effect on fish passage is score Very Low.

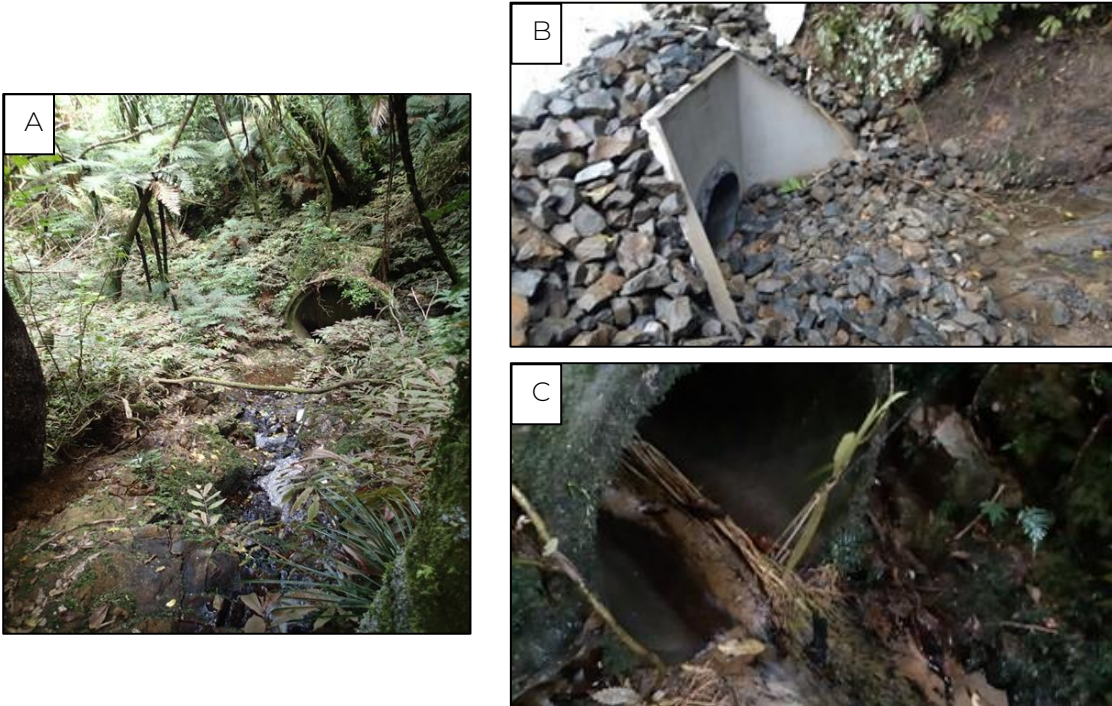
Permanent stream at Site H flows within native bush. Flow was previously conveyed beneath SH1 through a culvert.

Plate 3-8: A) Stream at Site H, downstream of SH1 in December 2023, B) Constructed culvert inlet upstream of SH1 in April 2024, C) Existing culvert outlet at Site H, downstream of SH1 in April 2024.

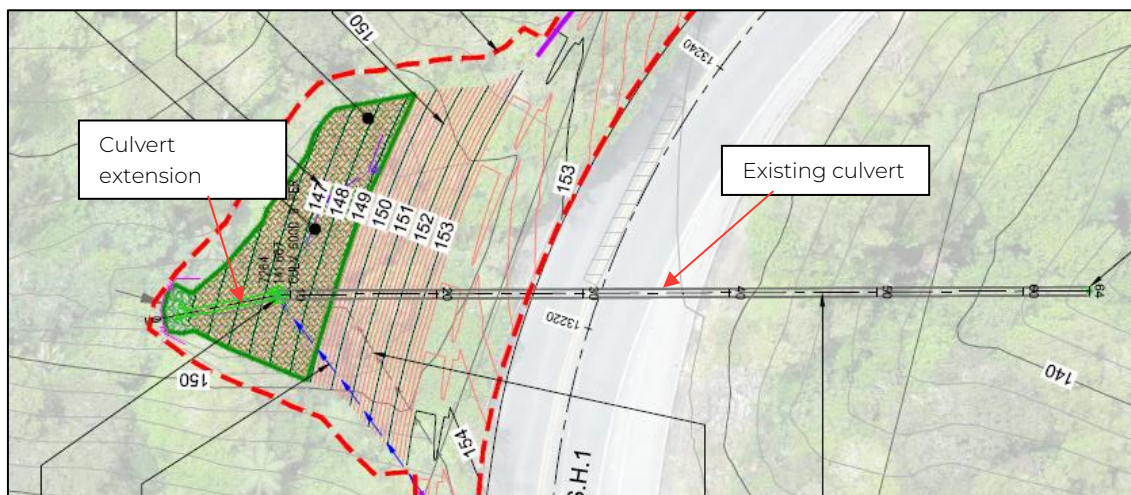
The existing 61 m long, 600 mm wide culvert has been extended 7 m, including addition of a new manhole with scruffy dome at the junction between the existing and new pies. The new pipe is perched above the height of the old one in the manhole, by approximately 30 cm. At the inlet of the new pipe a wingwall and rock armour apron will be installed.

Figure 3-9: Site H existing culvert shown in black and culvert and manhole in green. New drainage blanket and fill shown in green and red, respectively.

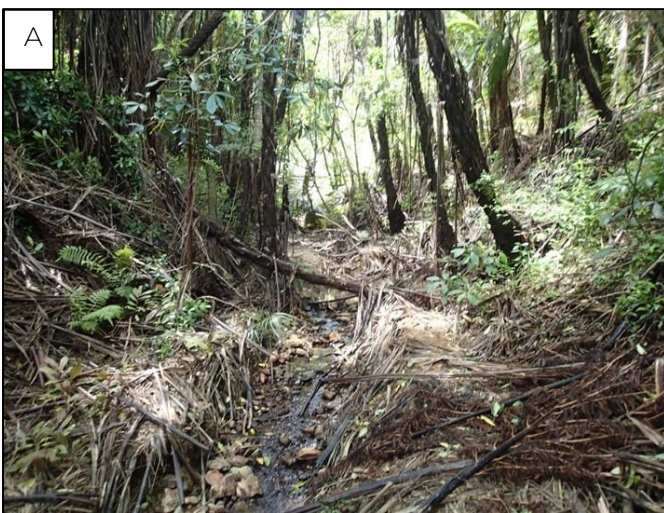
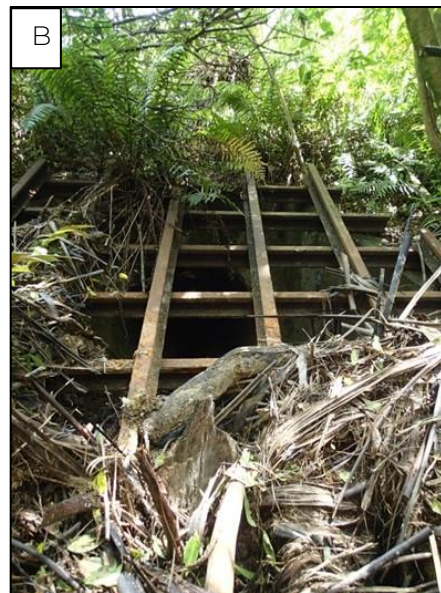
Plate 3-9: A) Stream at Site I, upstream of SH1 in December 2023, B) Culvert inlet with large debris screen.

Shortfin eels have managed to access habitat upstream of the existing culvert, as indicated by the eDNA samples. Freshwater crayfish were also found to be present upstream of the culvert. However, the current culvert which has a perch at the outlet in restricting fish passage.

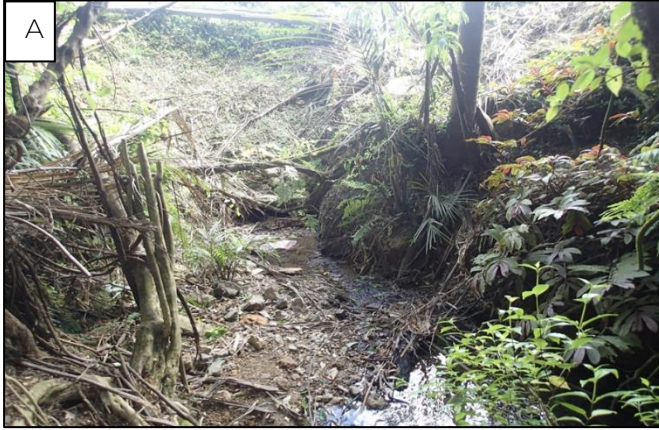
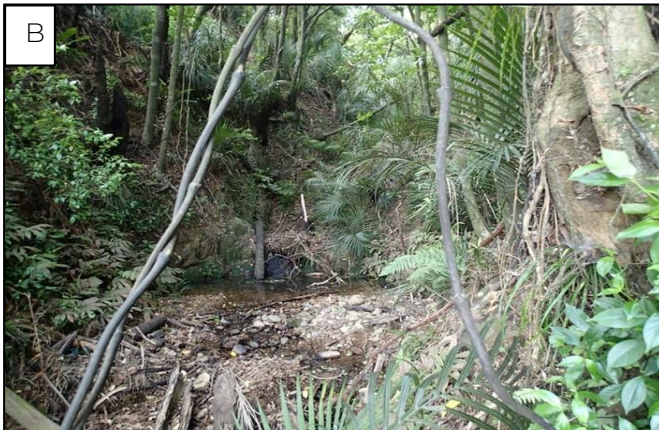
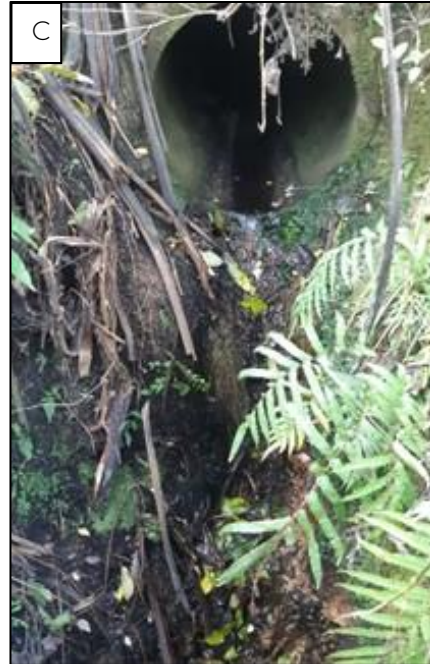
Permanent stream in native bush at Site J (Plate 3-10). The stream is conveyed beneath SH1 through culvert.

Plate 3-10: A/B) Stream at Site J, upstream of SH1 in December 2023, B) Outlet of culvert at Site J, downstream of SH1 in April 2024

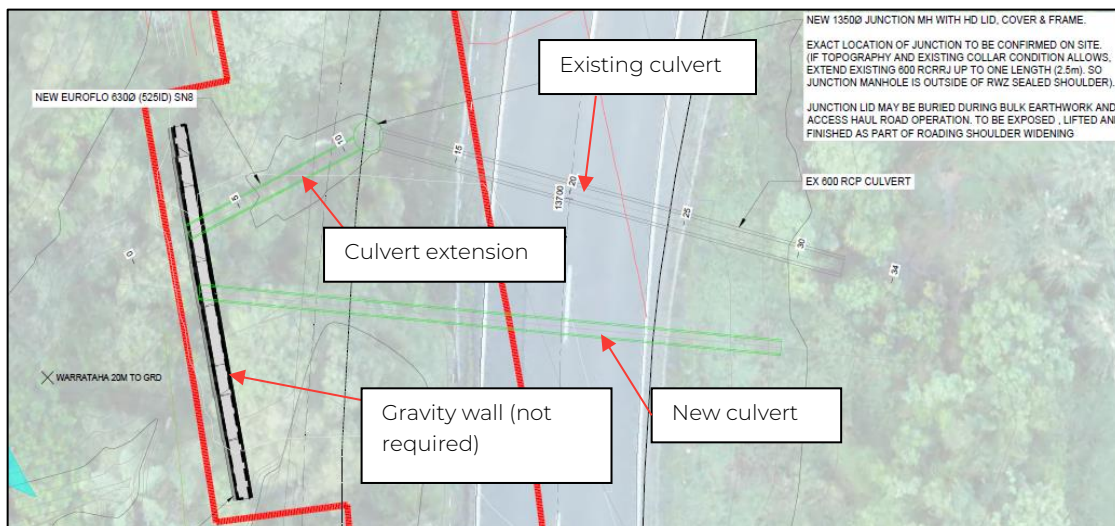
The existing 21 m long, 600 mm wide culvert was extended by 9 m at stream bed level. The new inlet was proposed to be embedded into a new gravity wall, but this was not required and is a fill embankment (Figure 3-10). A new manhole was also installed at the junction between the new and old pipe. The new 25 m long 600 mm culvert is an emergency overflow is rather than to permanently convey the stream.

Figure 3-10: Site J existing culvert shown in grey and new culverts and manhole in green.

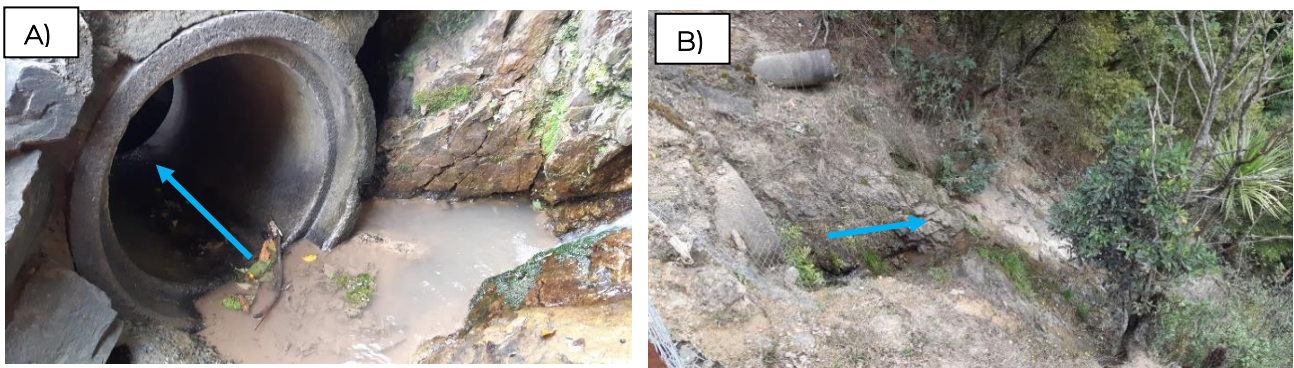
Figure A2. Site D2: A) Waterfall: current inlet to be replaced, B) outlet.

Retrofits are proposed at Site D2 to meet the requirements of the WK-OIC. Upstream of the road the pipe has been extended the manhole has been replaced (Figure A2). The scruffy dome will be backfilled with concrete from the base to the lip of culvert overhang. This should include a slight angle to the centre of the concrete ramp to concentrate flows but should be less than 15 degrees. Baffles should be installed along the backfilled concrete slope, and potentially some spat rope from the upstream pool through the culvert inlet into the manhole may be required. The newly constructed and reformed waterfall is proposed to be similar to the current situation. It may take several years to establish moss that is previously helped facilitate fish passage which will need to be monitored to ensure fish passage is successful at this site.

Downstream of the road it was not possible to fully view the downstream outlet based on health and safety constraints with the steep banks. However, there may be the opportunity to install a small piece of spat rope lined with PVC if there is a small perch at the outlet (Figure 1B). Spat rope is proposed to be installed throughout the length of the culvert.

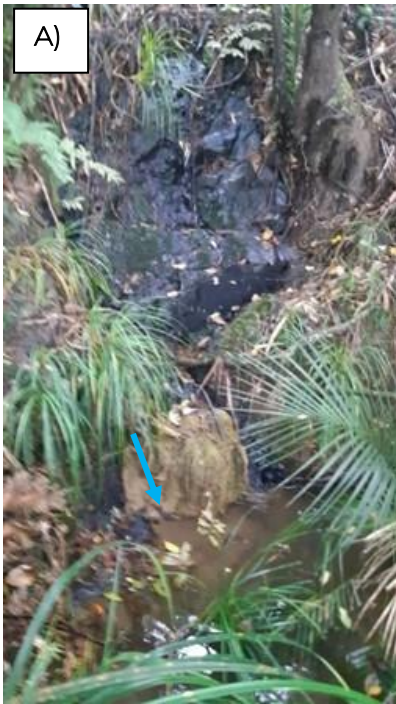
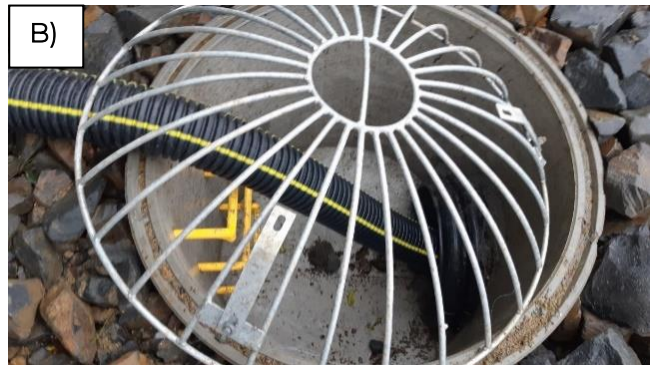
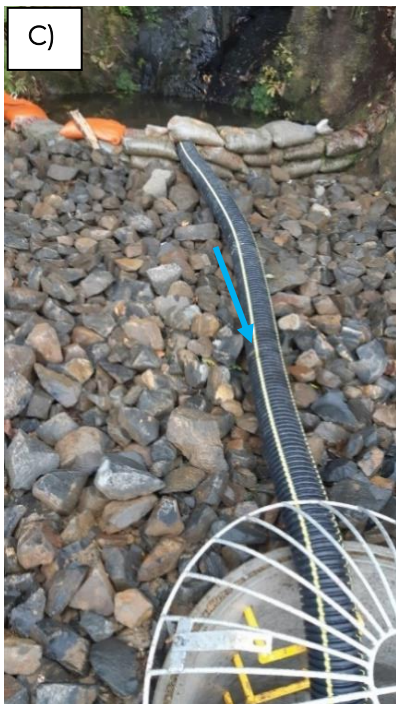
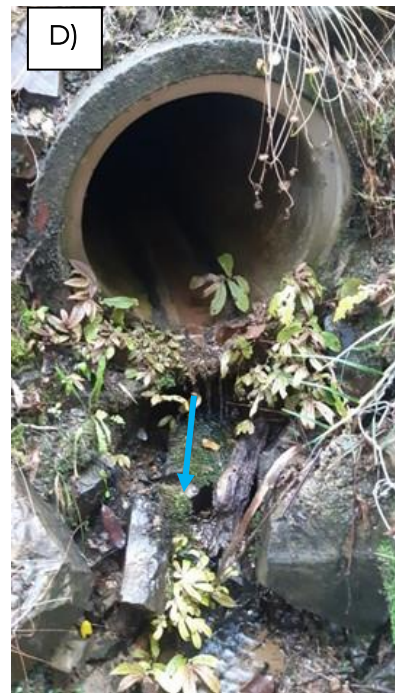
Figure A3. Site G2 (CH12980): A) waterfall and stream upstream of the road, B/C) current installed inlet with large rip rap with subsurface flow to scruffy dome, D) current outlet showing perch.

Consideration was given to installing a culvert between the pool and the scruffy dome (the pipe would have been installed part way down the scruffy dome and baffles would have been installed). However, based on cost constraints a channel was created through the rock rip rap and a notch was created into the top of the manhole. The manhole is proposed to be retrofitted with spat rope through the plastic pipe installed in a spiral to the base of the culvert (Figure A3).

Downstream of the road spat rope lined with PVC at the outlet to pool is recommended to better facilitate passage into the culvert (Figure A3). Spat rope is proposed to be installed throughout the length of the culvert.

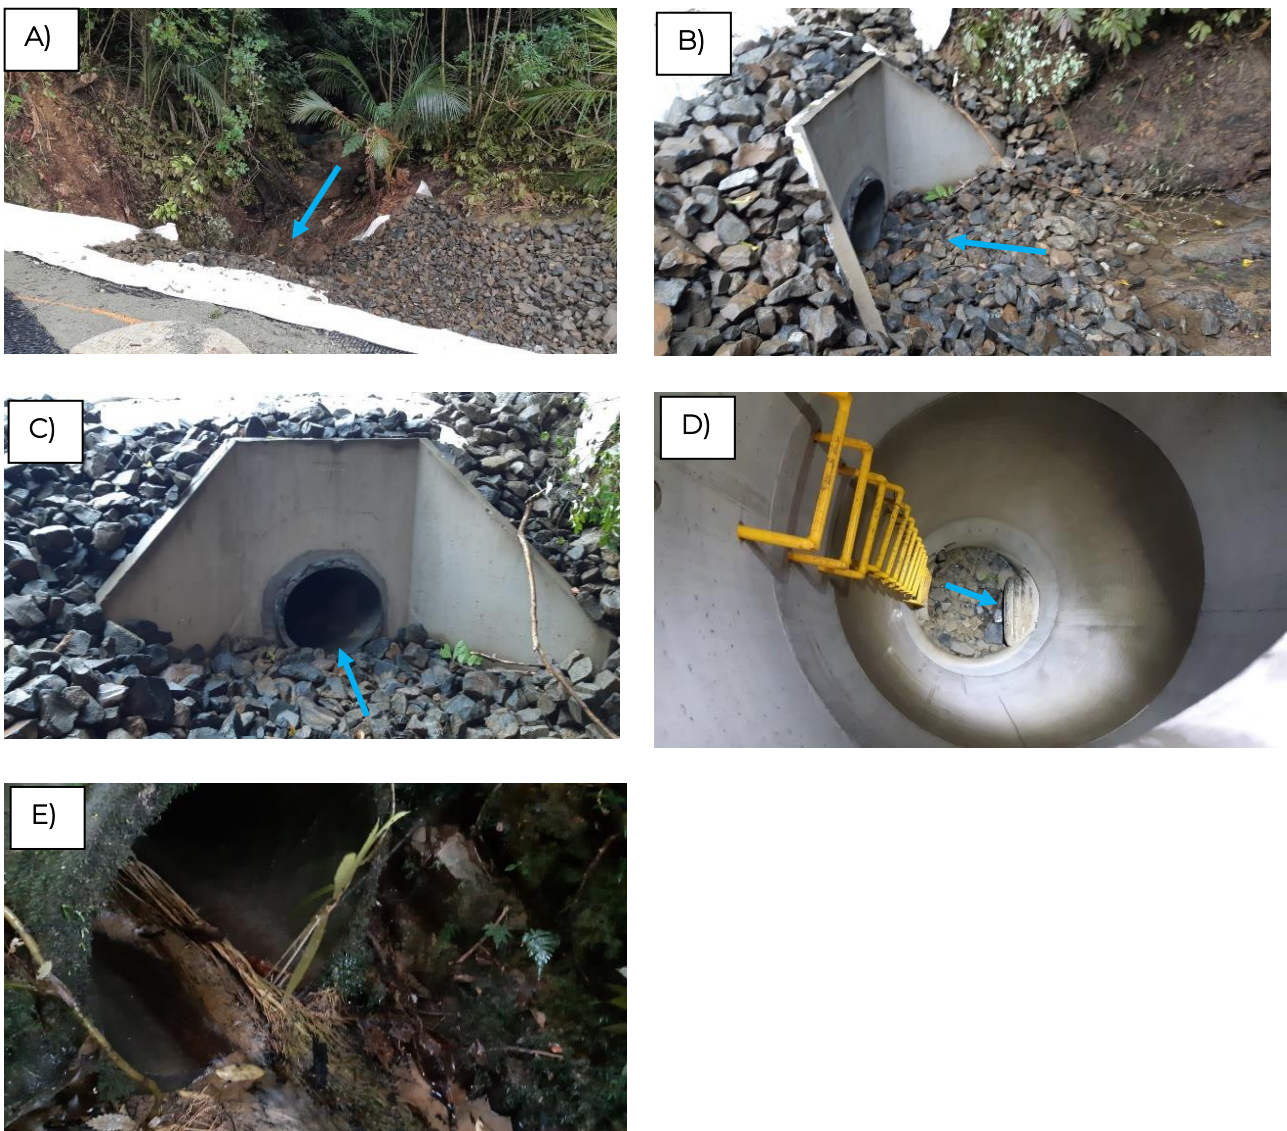
The manhole inlet pipe upstream of the road is perched. Some rock has been put in place here for Hochstetter's frog, but the inlet is still perched (Figure A4). There is the option to void fill with fines but there are issues with this washing through the pipe and the small rocks damaging the structure over time. It is proposed that some of the small rocks are removed and replaced with larger rocks. Then the outlet includes a small amount of spat rope lined with PVC. Spat rope is also proposed to be installed through the length of the culvert.

Figure A4. Site H: A/B/C) culvert extension and rip rap installed at inlet, D) manhole inlet currently still perched, E) outlet downstream of road.

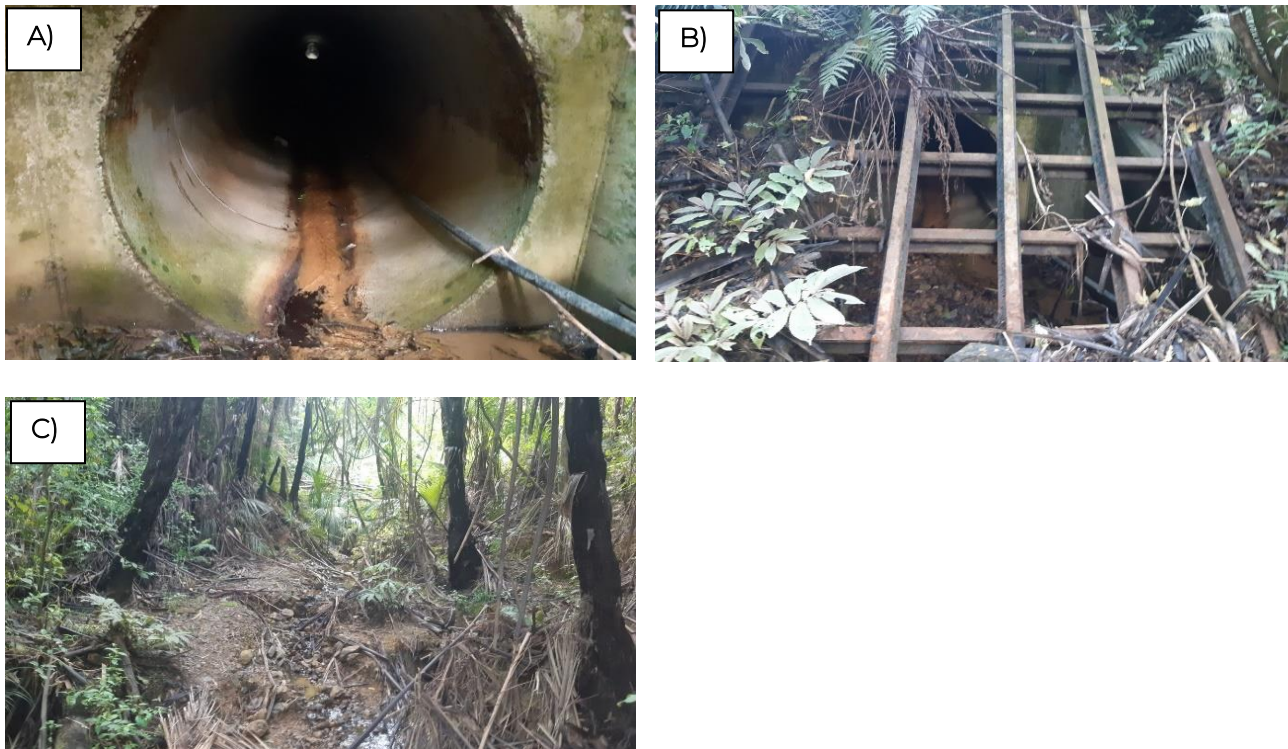
Figure A5. Site I: A/B) existing culvert inlet and grate, C) upstream stream habitat

Baffles could be installed throughout culvert to improve fish passage. Downstream of the road the outlet has not been observed and may require some type of retrofit such as spat rope lined with PVC if the outlet is perched.

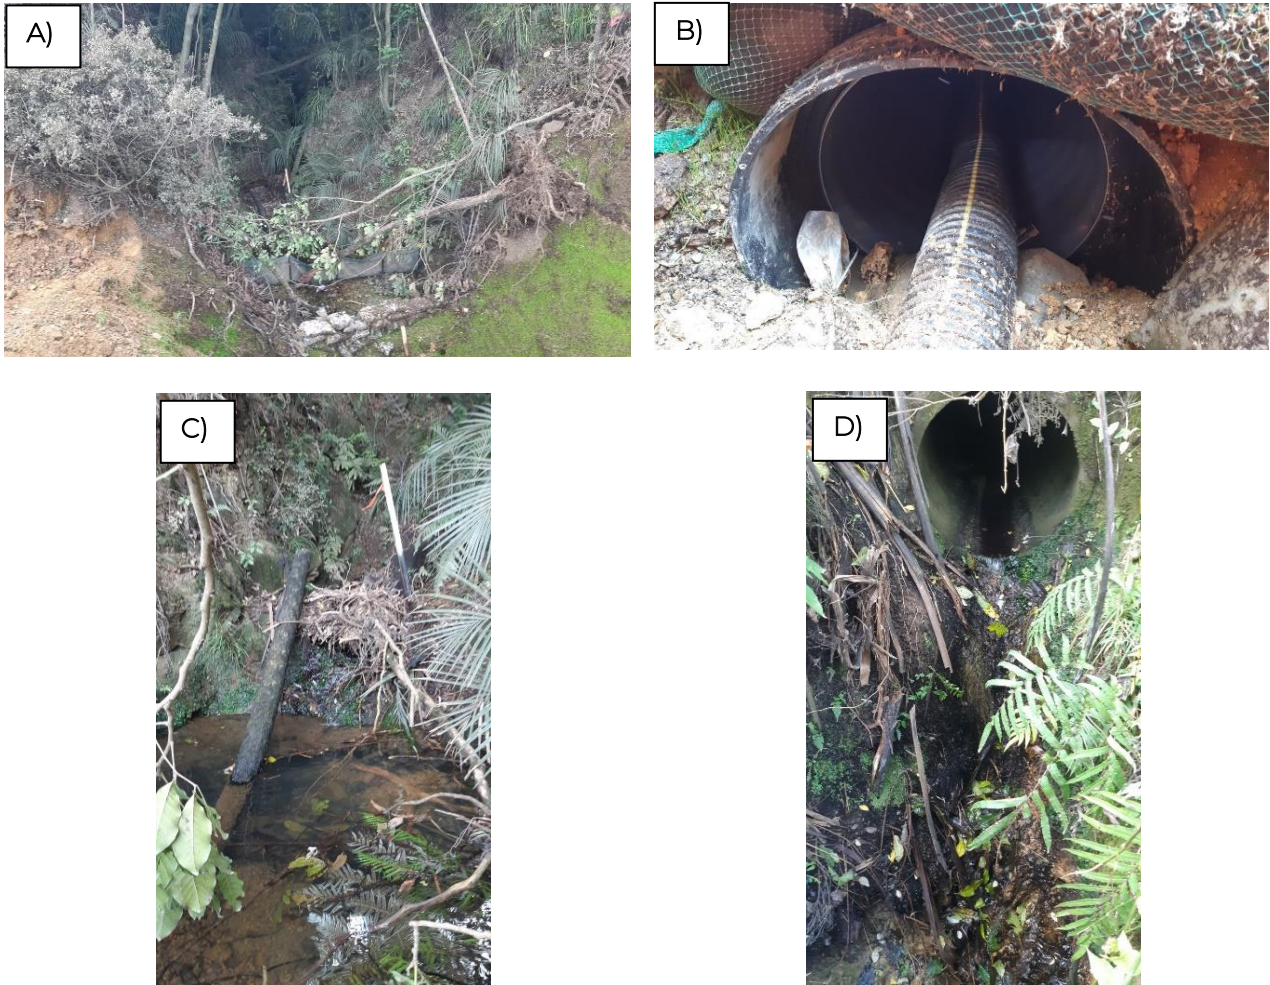
Retrofits are proposed at Site J to meet the requirements of the WK-OIC. Upstream of the road the culvert is undersized at 600mm diameter compared to the size of the stream.

Figure A6. Site J: A/C) existing upstream stream habitat, B) newly installed emergency overflow at inlet that is offline to the main stream bed, D) perched outlet.

Downstream of the road there is an approximately 50mm overhang at outlet (Figure A6). It is proposed that some spat rope lined with PVC is installed at the outlet. It is not possible to retrofit this culvert with baffles as it is approximately 0.6m in diameter therefore spat rope is proposed to be installed throughout the length of the culvert.
