Tāniko (Te Paki Dune Lake) was assessed during the following years: 2005, 2007, 2013, 2015, 2019 and 2024.

Tāniko (34°31'52"S 172°47'36"E) is a small (2.2 ha) shallow (2.7 m) lake situated on the west coast of the far north near Kahokawa Beach. The lake is impounded by tall mobile dunes along the western end and surrounded by lacustrine wetlands along the remaining perimeter. The water is clear with a subtle brown stain from the emergent vegetation and surrounding native bush sub-catchment.

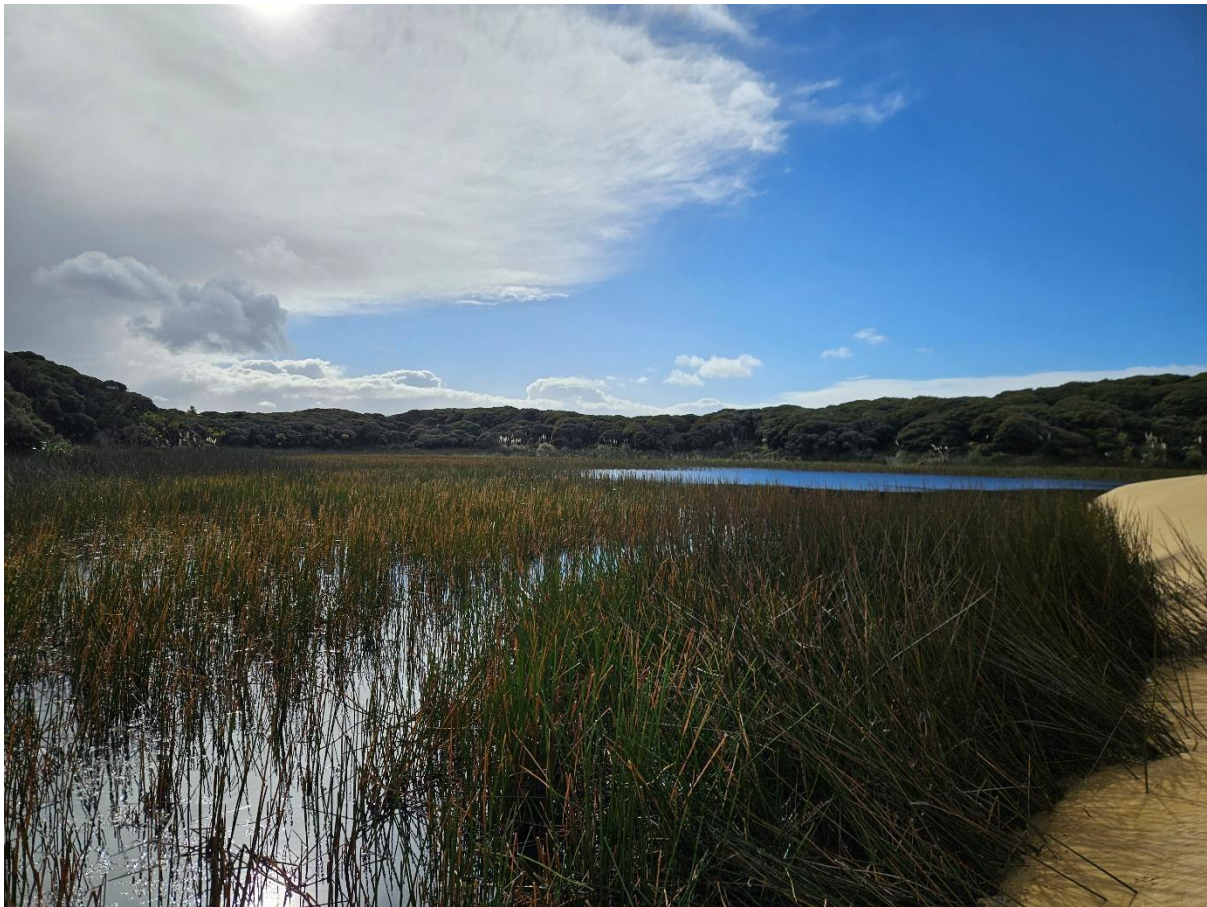
Tāniko - Southern view indicating the impounding dune to the west and the surrounding lacustrine wetland

The face of the dune appears to have encroached further into the lake and there was an approximately 1.5 m band of buried macrophytes at the base of the dune face. This could have been a result of recent extreme weather events. The remainder of the lake was fully vegetated.

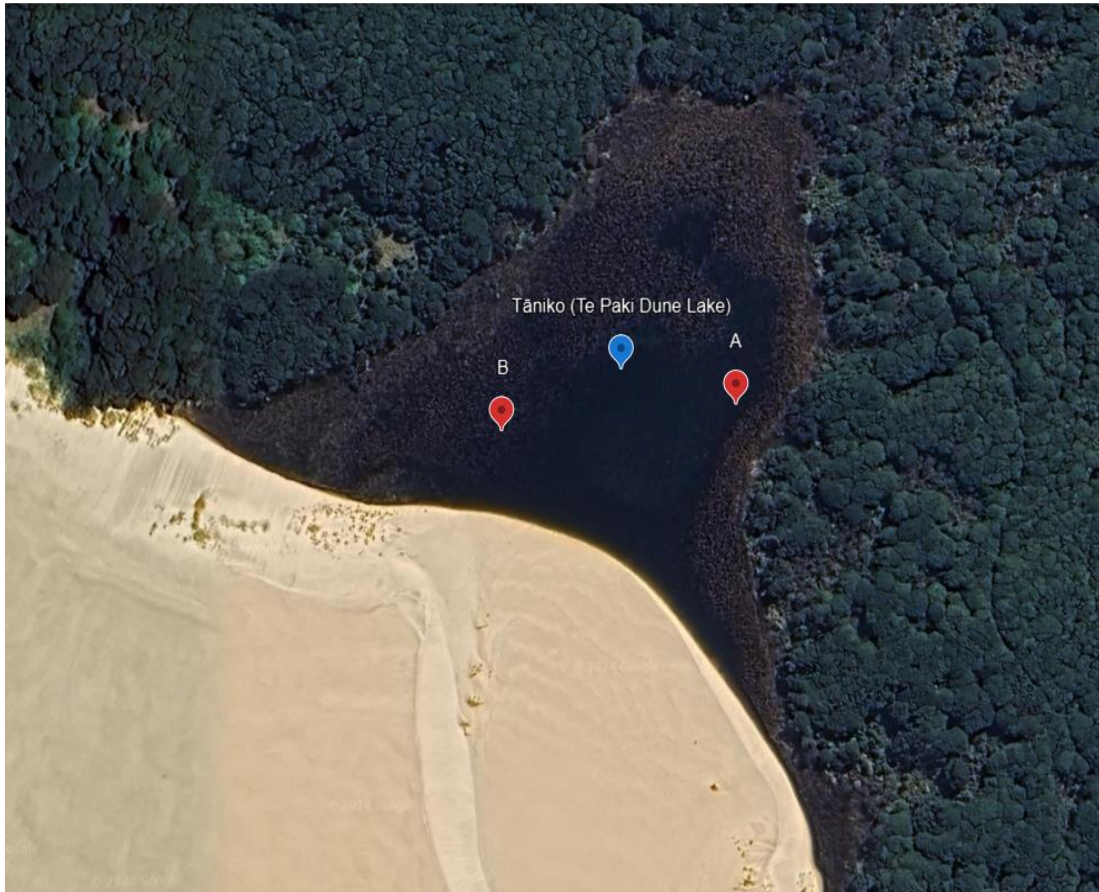
Only 10 stems of the Nationally Critical *Utricularia australis* were observed during the 2024 survey. One stem was seen in the shallows near the dune face and the other 9 were located in a small shallow area along the eastern end of the lake near transect A. The stems were sparsely spaced, forming covers of less than 5%, the tallest stem was 23 cm, and the average height was 16 cm. This is concerning considering the previous 2019 survey noted lake-wide covers of up to 50%. The invasive *Utricularia gibba* is a significant contributor to this decline and it has overrun the majority of the available habitat.

Tāniko LakeSPI survey transects
