New Zealand Transport Agency - Waka Kotahi

BRYNDERWYN HILLS RECOVERY PROJECT ECOLOGICAL IMPACT ASSESSMENT

15 AUGUST 2024

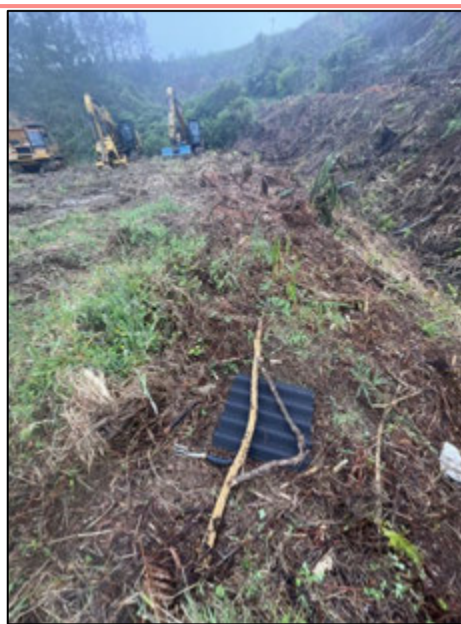
Photo 2: Site A Upstream: Section of stream upstream of the road during construction in December 2023. This section of stream was completely reclaimed by fill area A.

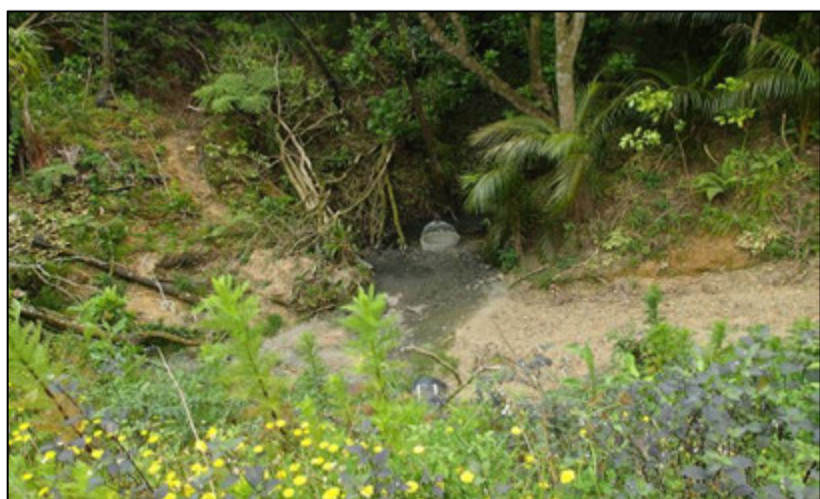
Photo 5: Site F1: Upstream Stream upstream of the road in December 2023 prior to construction. This lower section of stream was modified with a pipe extension and placement of rip rap.

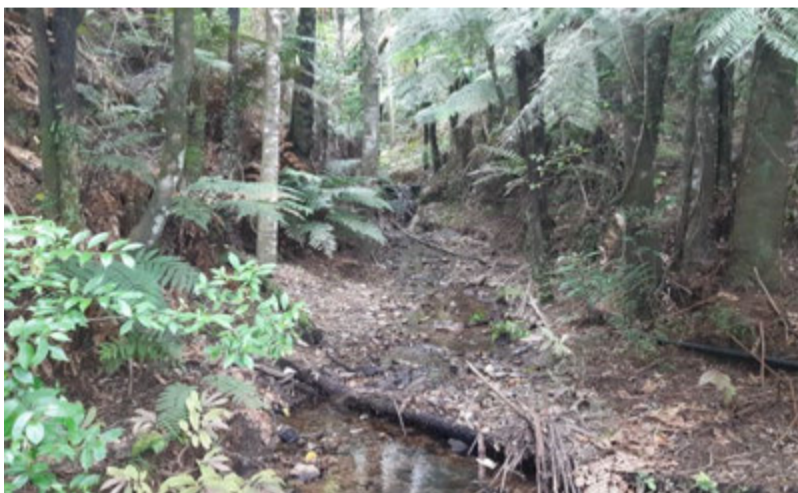
Photo 6: Site G4 Downstream: Stream downstream of the road after construction in April 2024. This section of stream was not directly impacted but is within the receiving environment from the road.

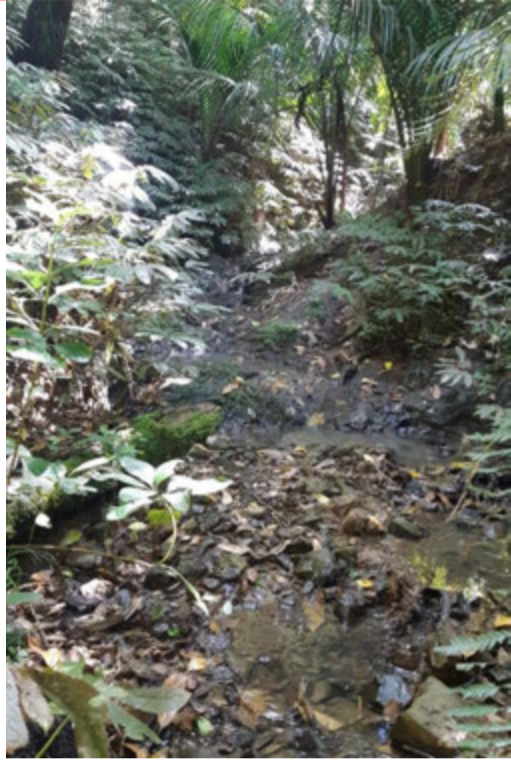
Photo 7: Site H1 Upstream: Stream upstream of the road during construction in February 2024. This section of stream had a pipe extension and placement of rip rap.

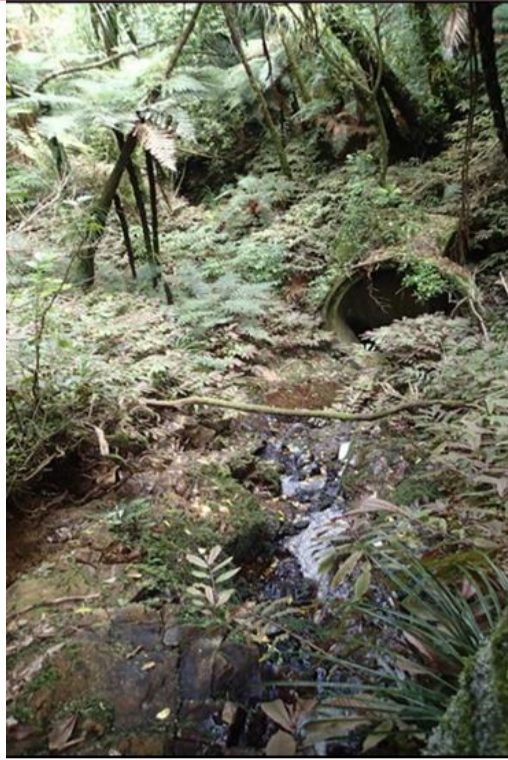
Photo 8: Site H Downstream: Stream habitat downstream of the road during construction in April 2024. This section of stream was not directly impacted but was within the receiving environment of the road.

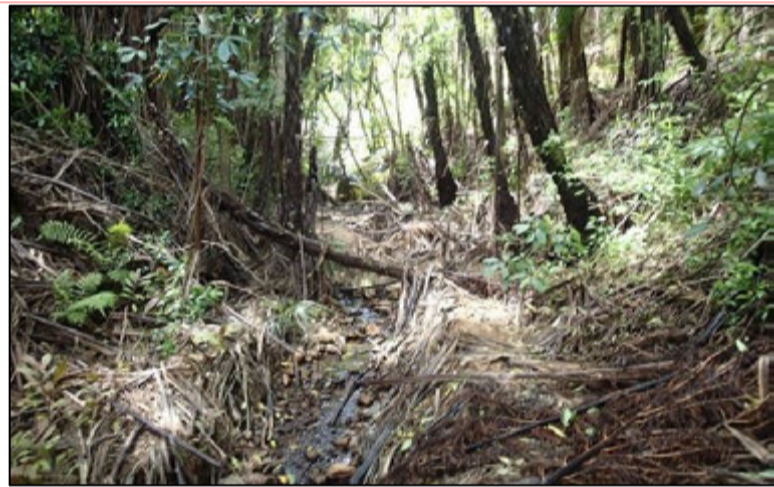
Photo 9: Site I Upstream: Stream habitat upstream of the road during construction in April 2024. This section of stream was not directly impacted.

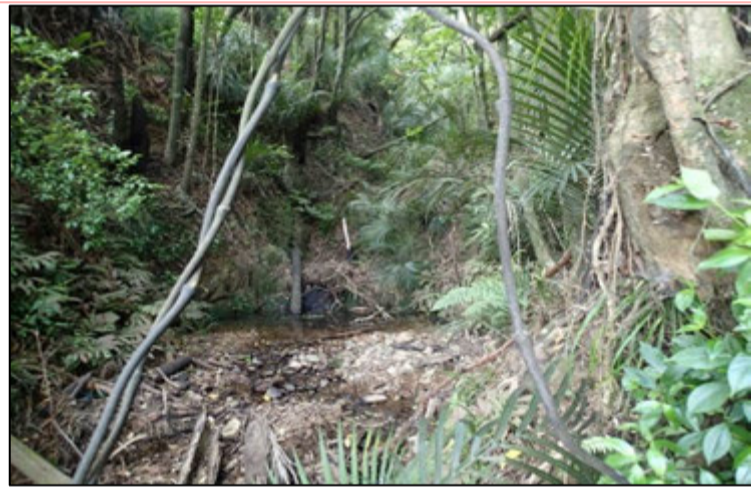
Photo 10: Site J: Stream habitat upstream of the road during construction in April 2024. Part of the section of stream was modified with a pipe extension and placement of rip rap.

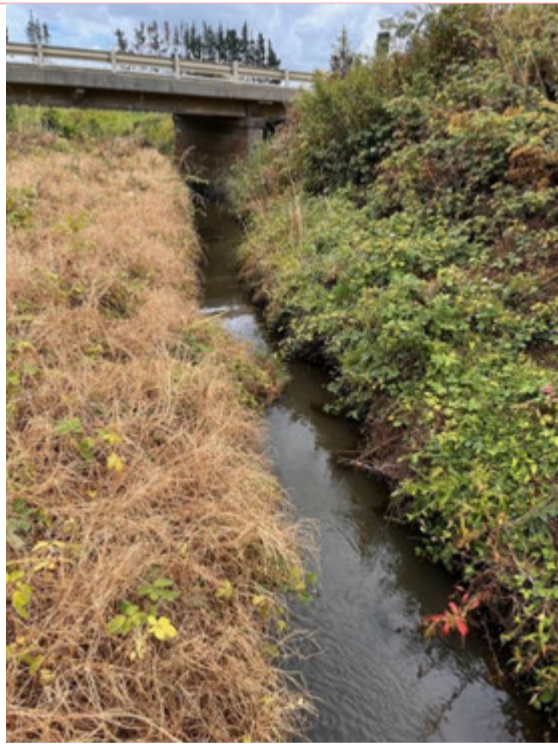
Photo 11: Site Piroa Stream Quarry: Stream habitat upstream of the road bridge within Atlas Quarry. The riparian vegetation was removed and a temporary culvert was installed.

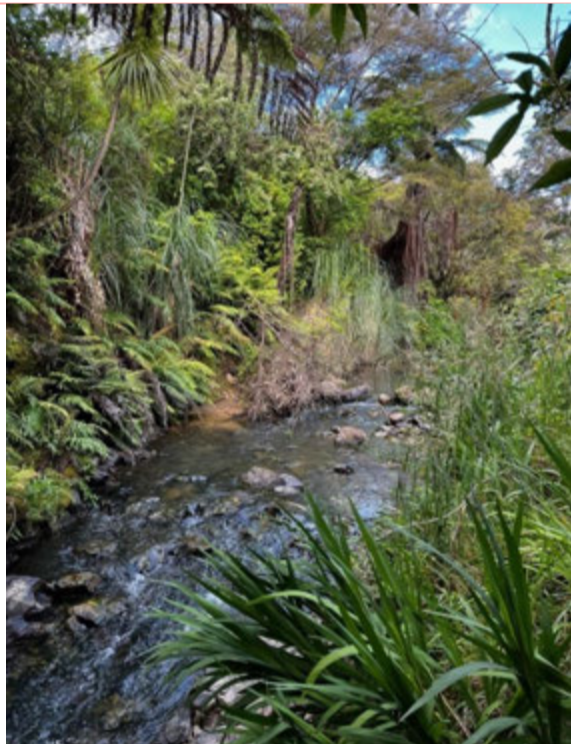
Photo 12: Site Piroa Stream Farm: representative section of stream habitat downstream of the road. This site was not directly impacted by the works.

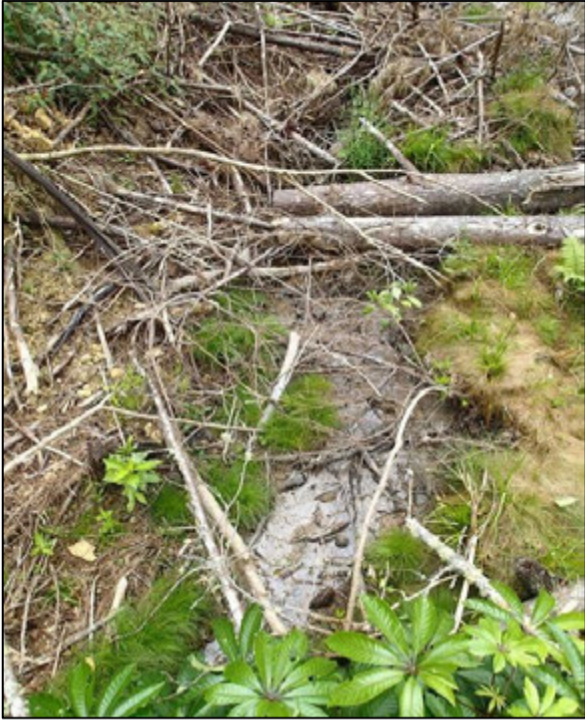
Photo 13: Site B1 Upstream: Wetland and stream upstream of the road prior to construction in December 2024. This wetland complex and stream habitat was completely reclaimed by fill area B.

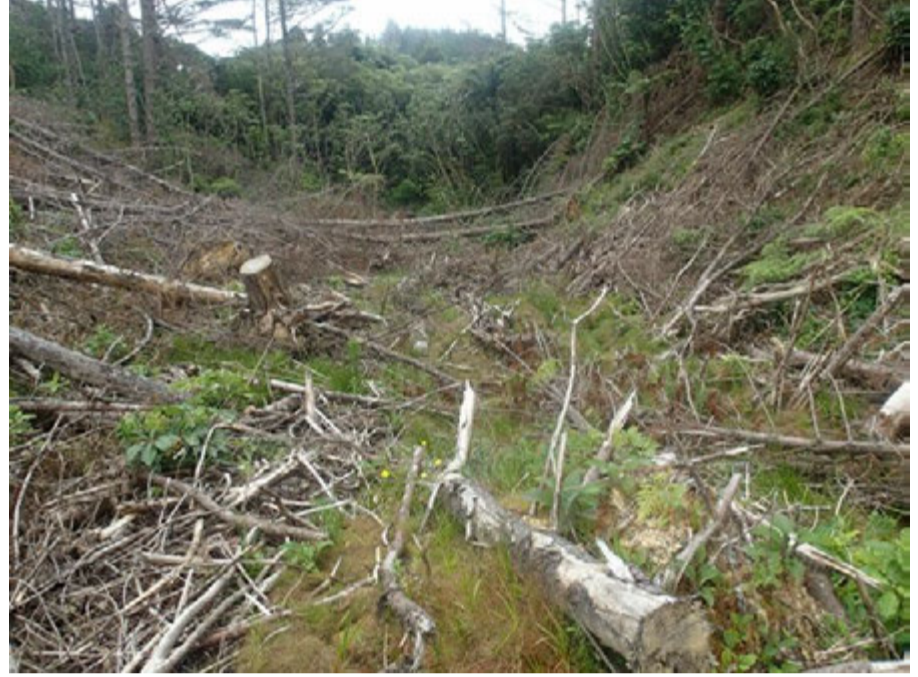
Photo 14: Site B1 Upstream: Wetland and stream upstream of the road prior to construction in December 2024. This wetland complex and stream was completely reclaimed by fill area B.

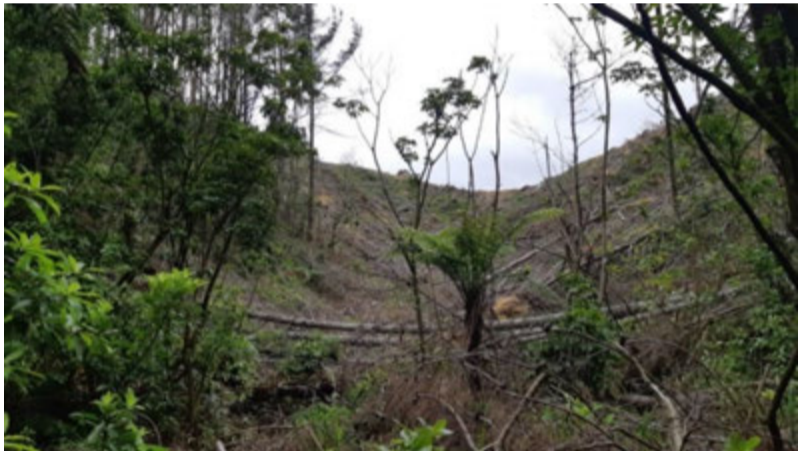
Photo 15: Site B1 Upstream: Wetland and stream upstream of the road prior to construction in December 2024. This shows the recently semi-felled exotic forest. This wetland complex and stream habitat was completely reclaimed by fill area B.

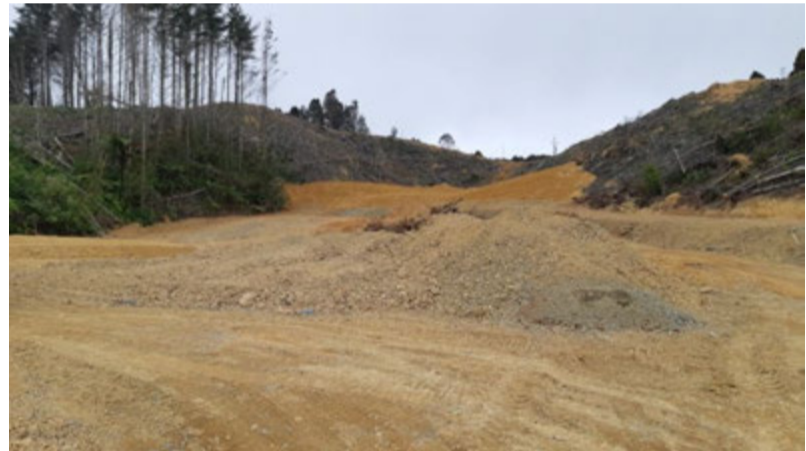
Photo 16: Site B1 Upstream: The wetland complex and stream during construction in April 2024. This has been completely reclaimed by fill area B.

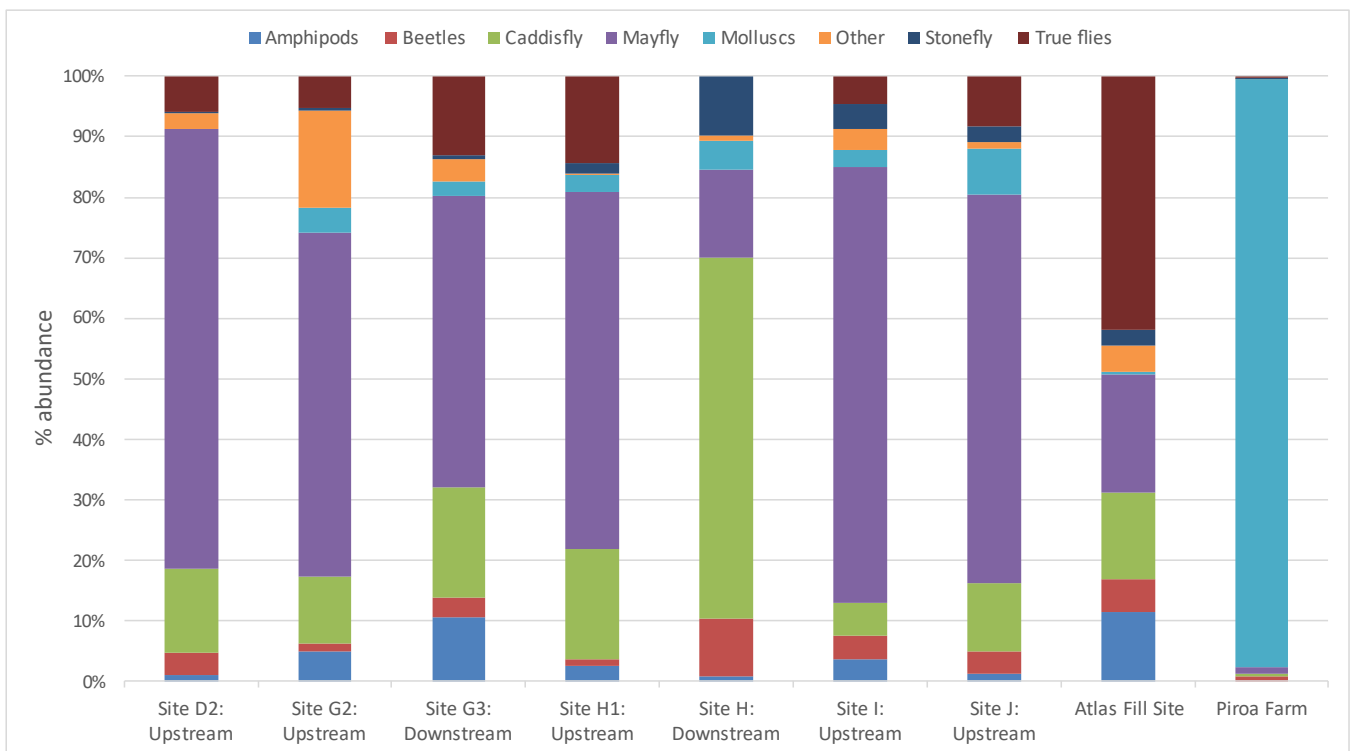
Figure C-5: Composition of macroinvertebrate assemblages at sites sampled during baseline surveys.

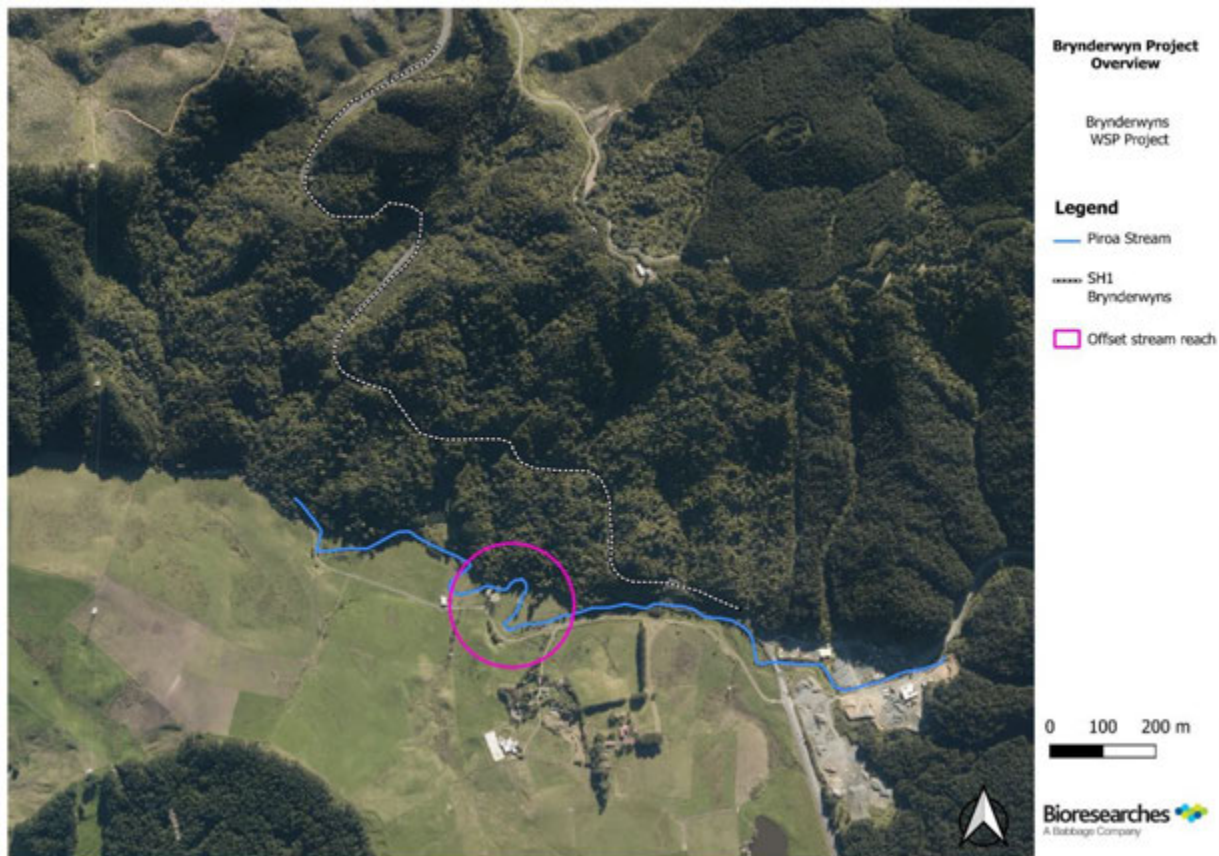
Figure 1. Piroa Stream proposed offset site and SH1 Brynderwyn Hills.

No landowner agreements have been reached, but the proposed stream offset site for the stream loss is the Piroa Stream (Photo 2 and Photo 2).

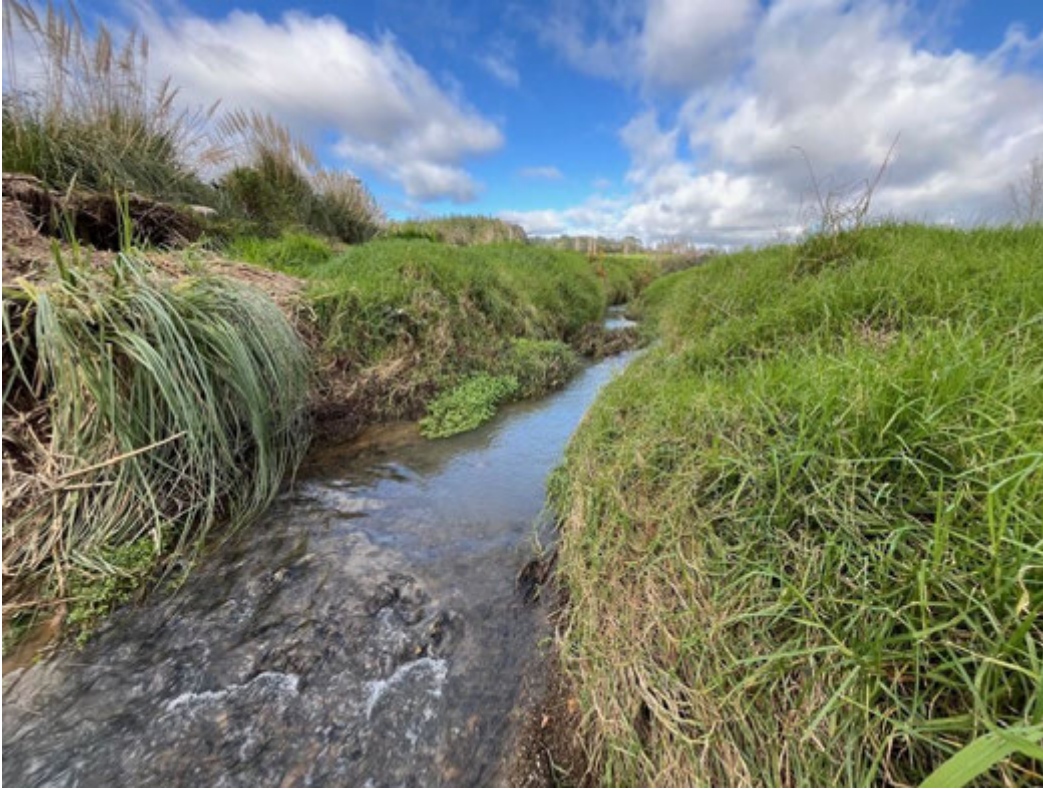
Photo 1. Piroa Stream proposed offset site.

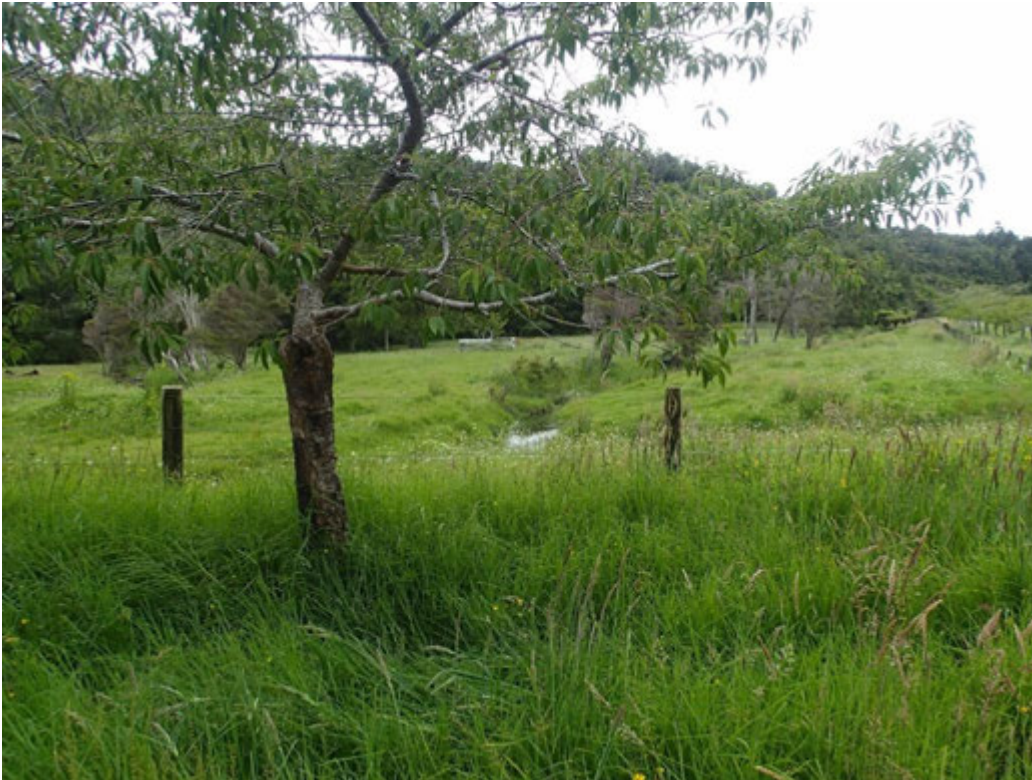
Photo 2. Piroa Stream proposed offset site, located at the base of the Brynderwyn Hills (background).

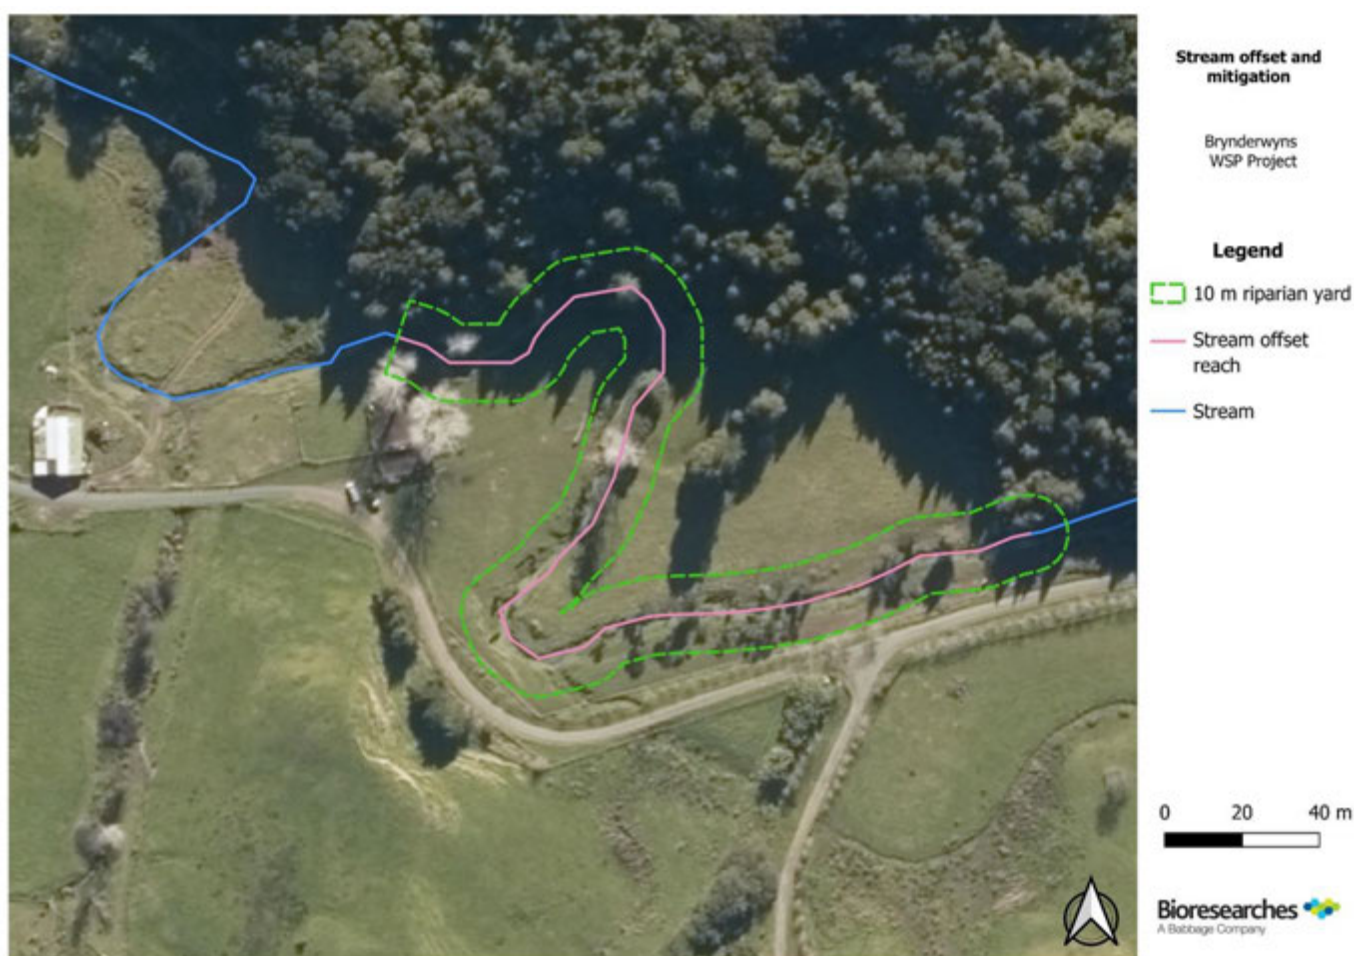
Figure 2. Indicative Area for Proposed Stream Offset (332m) on the Piroa Stream (subject to landowner engagement).

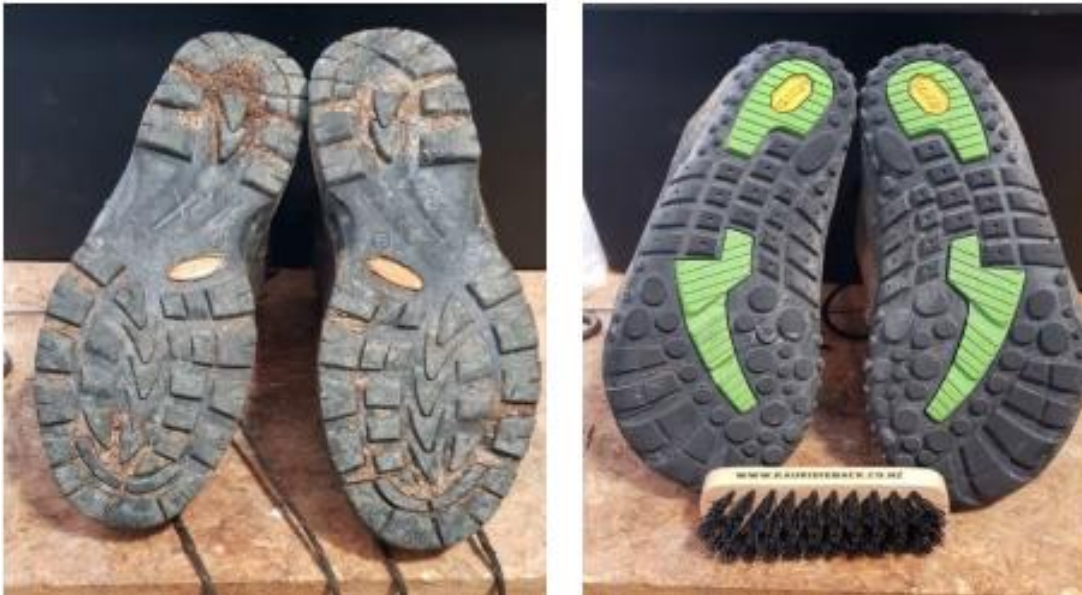
Figure 10-5 Cleaning of footwear. Left image is unacceptable, Right image is acceptable.
