Memo

Subject: Meridian Energy Ruakākā Solar Energy Park – site visit to wetland areas

Author: Katrina Hansen, NRC Biodiversity Advisor

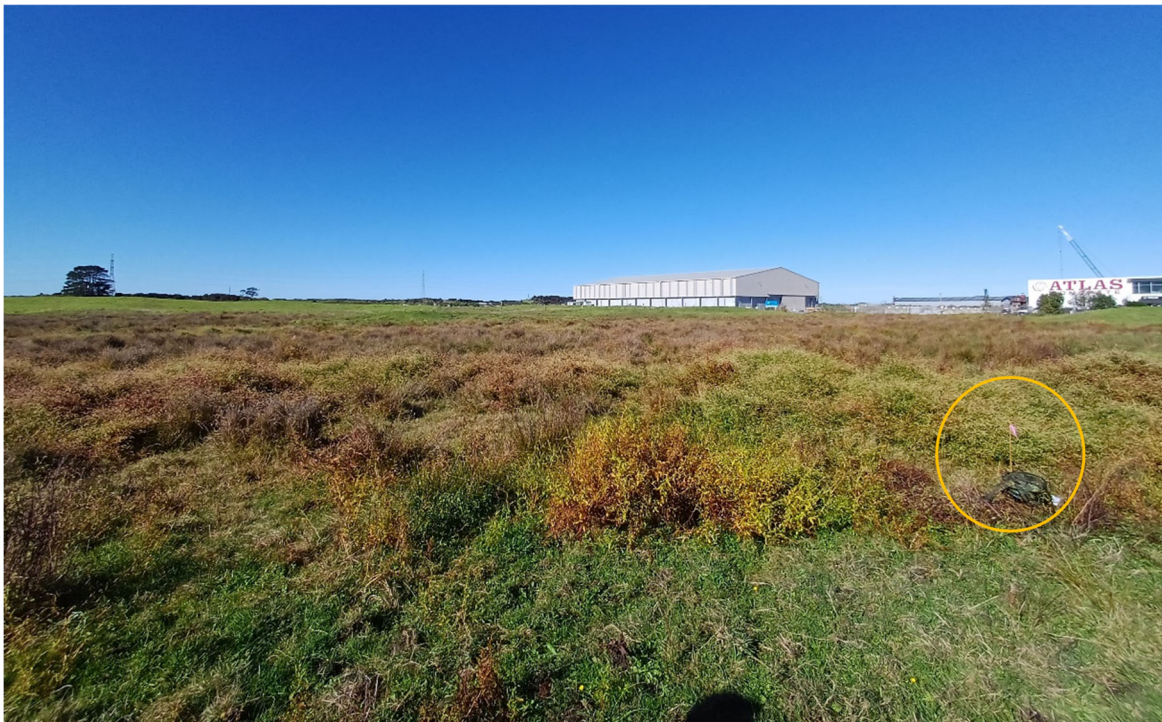
Figure 2. Pink flagged pole showing location of RDL plot.

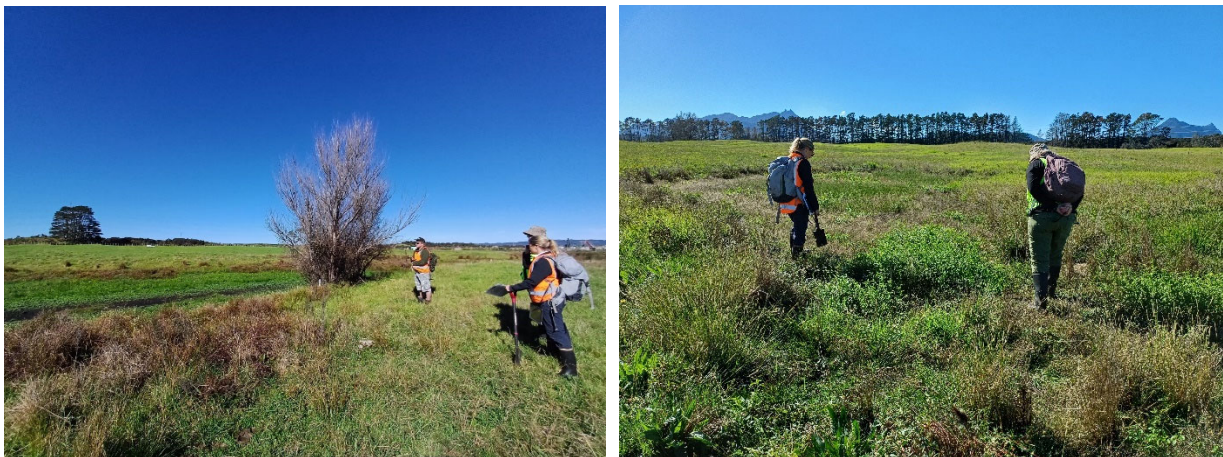
We continued north across Sites 1C and 1B, looking at the dune slack wetlands, hollows and vegetation present (Fig. 3 and 4), noting the presence of wetland vegetation including rushes, sedges and herbs such as *Persicaria*.

Figures 3 and 4. Open water area and dune slack hollows.

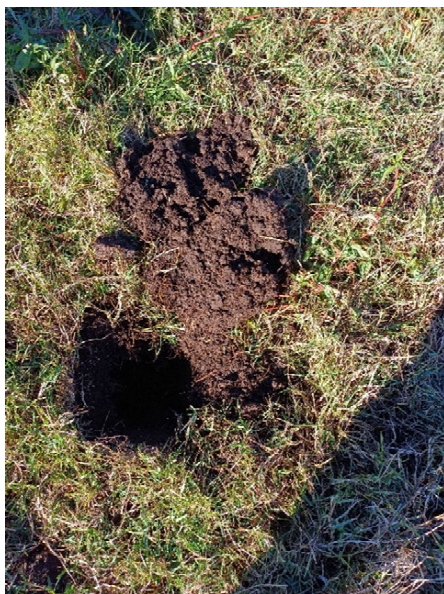
We noted the wetland areas as mapped by BM and covering a further extent, based on the presence of wetland vegetation at the time of the visit, as well as the hydrology and soil of the site (Fig. 5). We didn't carry out wetland delineation or soil or hydrology tests as per the Ministry of Environment guidelines, rather a visual assessment. The wetland vegetation is indicative of the hydrology and soils present.

Figure 5. Shallow test hole showing peat soil.

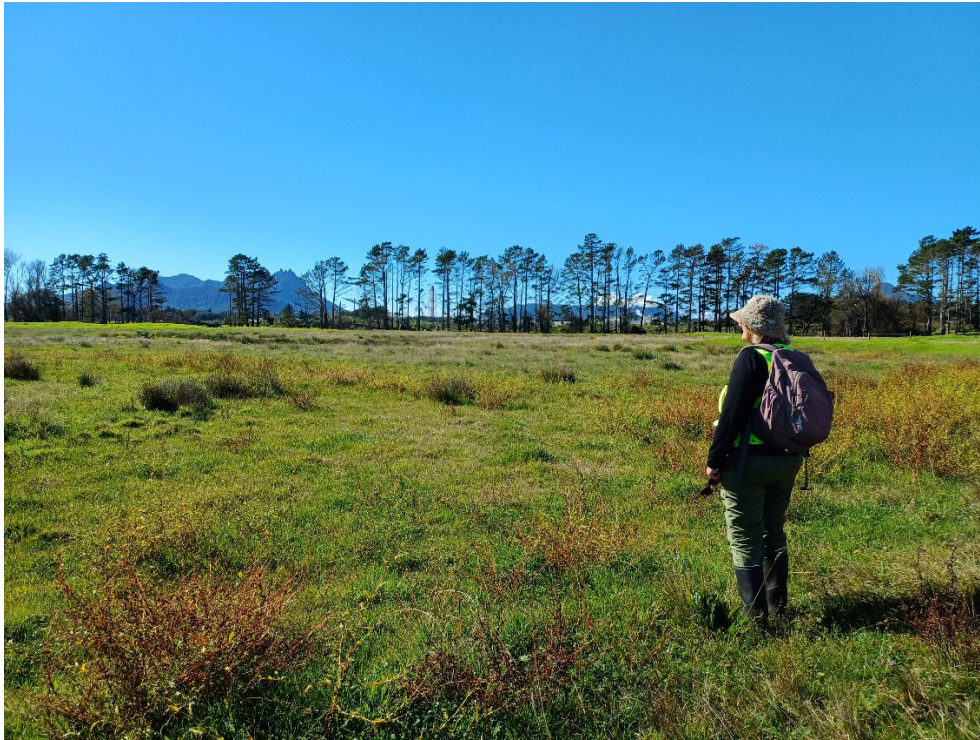
On the north-eastern side of Site 1B we looked at an area where BM had recorded a dominance of kikuyu during their site visit of March 2023. We noted the presence of wetland vegetation but no evidence of extensive presence of kikuyu, e.g., stolons (Fig. 6).

Figure 6. Site 1B looking north across area of the presence of kikuyu in March 2023.
