Lake Waitahi (Morehurehu South 2)

30/04/2024

NRC Lake Number: 36

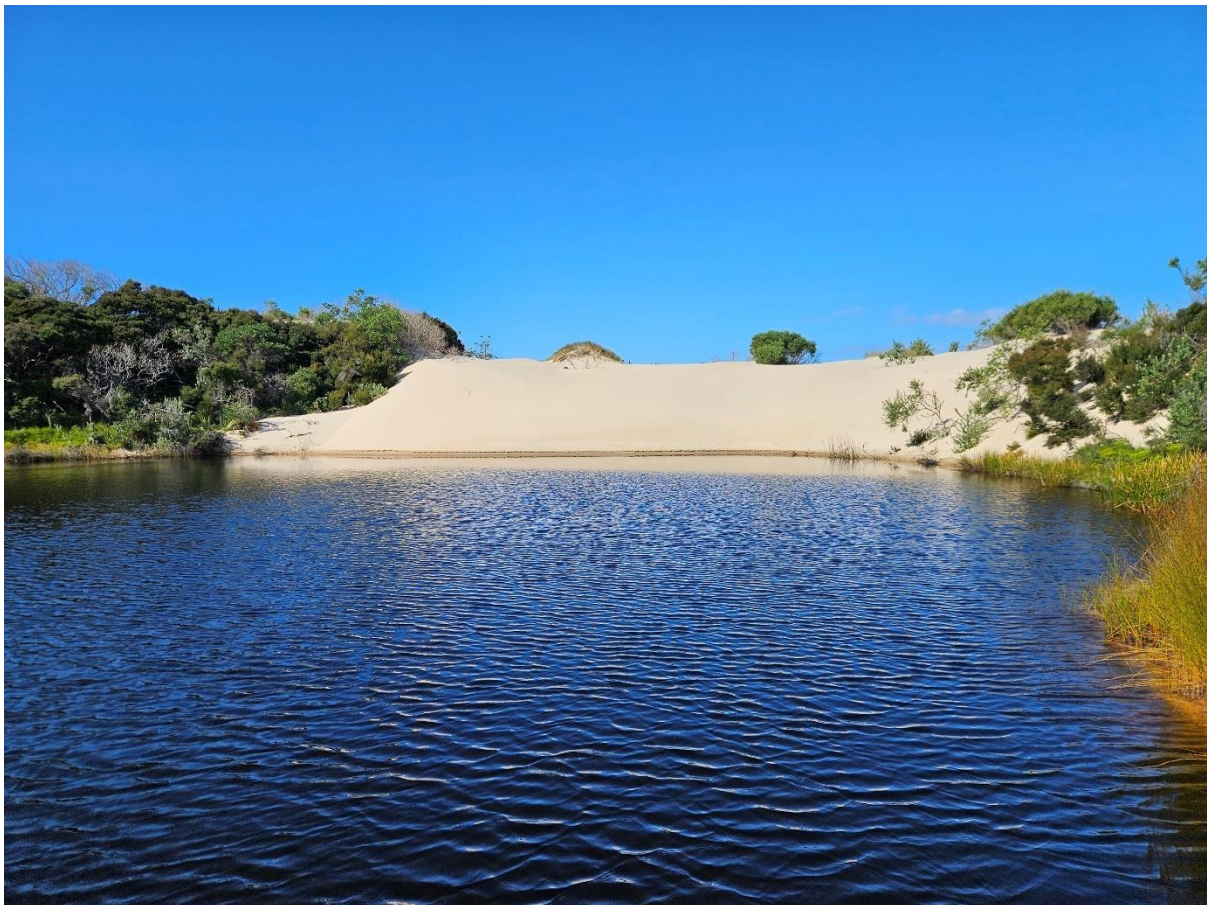
The lake (34°39'01"S 173°00'20"E) is small (0.78 ha) dystrophic lake located south of the larger Lake Morehurehu. It has a maximum depth of 3.6 m and is impounded by large sand dunes along the eastern and southern boundary. The remainder of the lake is surrounded by native scrub and harvested plantation forestry.

Lake Waitahi (Morehurehu South 2) - Eastern view indicating the impounding dune, emergent riparian vegetation and tannin-stained water

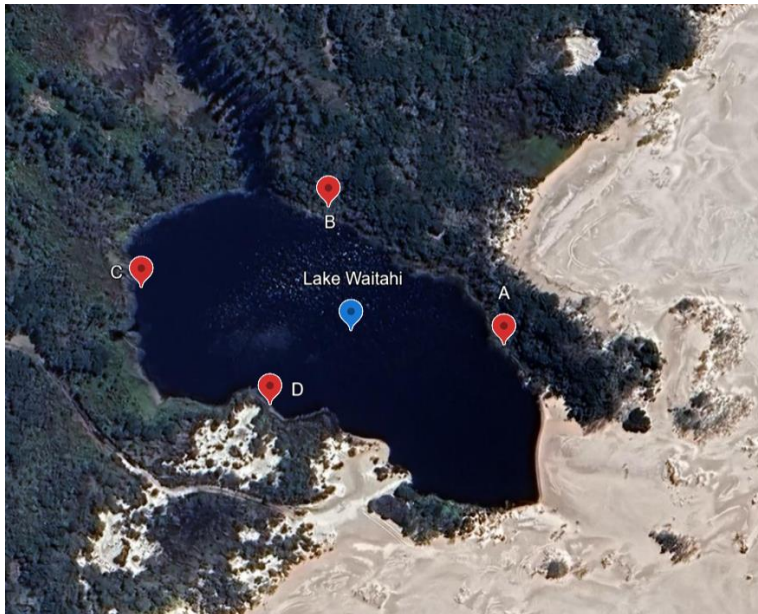
Lake Waitahi (Morehurehu South 2) is categorised as being in moderate condition with a LakeSPI Index of 29%. Since 2013 the lake has been fluctuating between vegetated and non-vegetated states with the last survey in 2016 concluding that the lake was non-vegetated. The 2024 survey results indicate that the lake has recovered and still has a high macrophyte biomass.

The maximum Potential Native Condition Score for this lake is 15 and the current assessment score is 3 (Native Condition Score of 20.00%). This low score is a result of only one native species being found and a limited vegetated depth extent. The maximum Potential Invasive Condition Score is 27 with a current assessment score of 18 (Invasive Condition Score of 66.67%). This is largely due to the widespread establishment of *Utricularia gibba* across the lake. The maximum Potential LakeSPI Score is 35 and the current score is 10 (total LakeSPI Score of 28.57%). This score reflects the high level of invasive species impact and deteriorating vegetation extent.

Lake Waitahi (Morehurehu South 2) LakeSPI survey transects
