APPENDIX H Fish Passage Assessment

New Zealand Transport Agency Waka Kotahi

BRYNDERWYN HILLS RECOVERY WORKS: FISH PASSAGE ASSESSMENT

13 AUGUST 2024

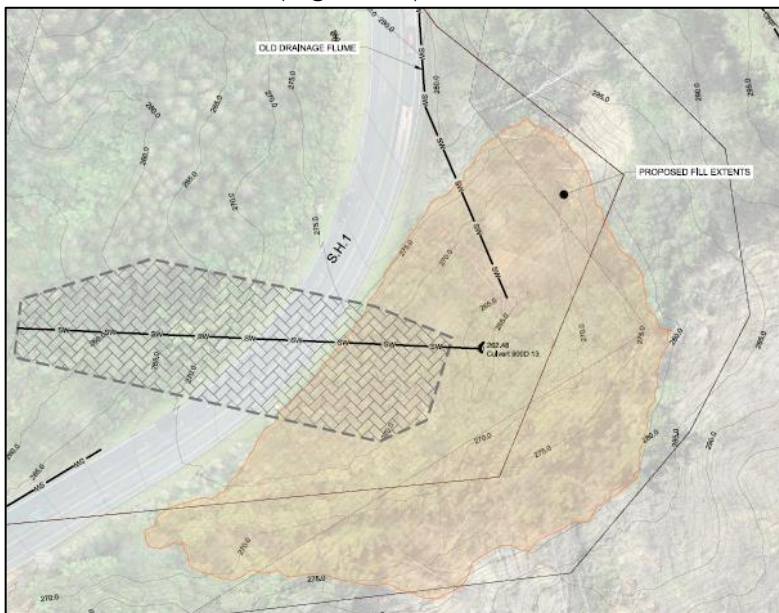
The gully above the road at Site A was cleared and filled to stabilise the bank and create a stockpile area for cut material (Figure 3-1).

Figure 3-1: Site A fill area (red).

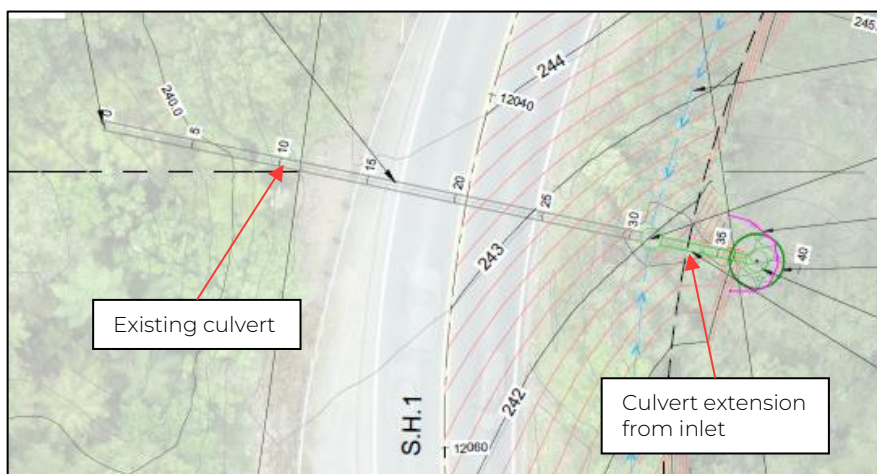
Figure 3-3: Site B2 existing culvert shown in grey and new extension and scruffy dome manhole in green.

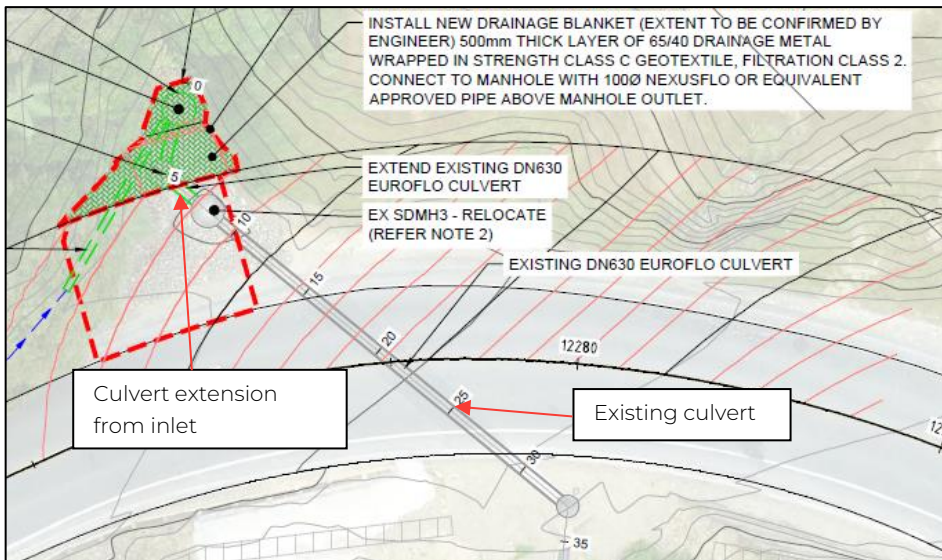
An existing 25 m long, 500 mm wide culvert beneath SH1 was extended by 7 m upstream from a manhole inlet (Figure 3-4).

Figure 3-4: Site D1 existing culvert shown in grey and new extension, manholes and drainage blanket scruffy in green.

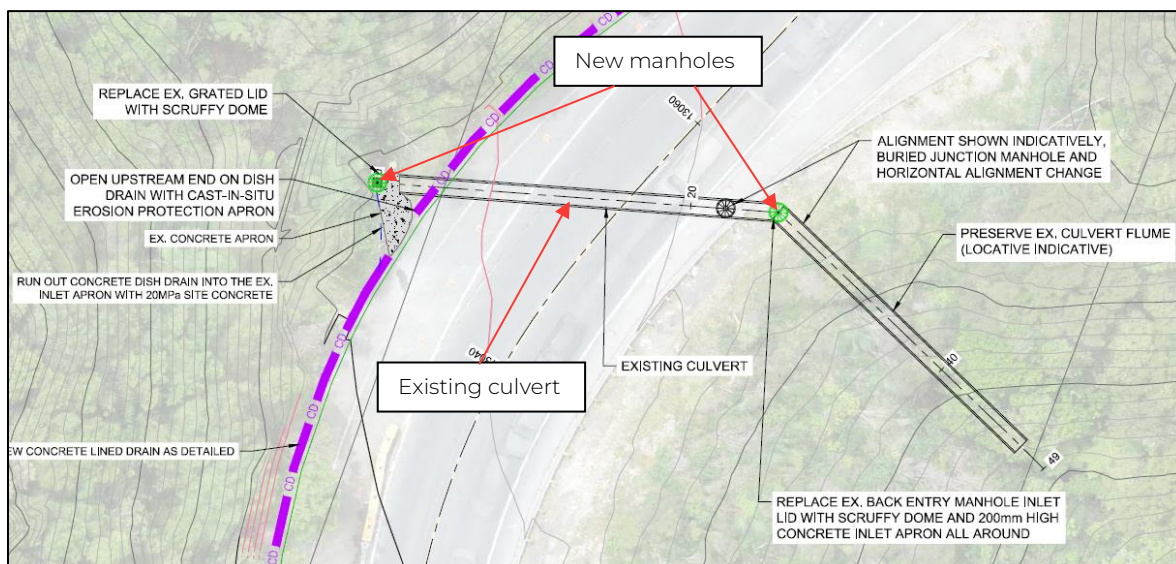
New scruffy domes have been attached to two manholes, part of the existing culvert, which is made up of a 26 m long, 600 mm wide pipe and a 26 m long corrugated flume down a steeper grade (Figure 3-8). A concrete apron will also be constructed at the culvert's inlet.

Figure 3-8: Site G3 existing culvert shown in black and manholes in green.

To reduce velocities of water running through pipes in large storm events it has been confirmed that weir baffles can and have been installed into plastic flume pipes before they are installed onsite.⁴⁸ These should also be installed into current flume pipes that have been installed within the site. There is also the option to retrofit Site G3 with a combination of baffles and spat rope to facilitated fish passage.

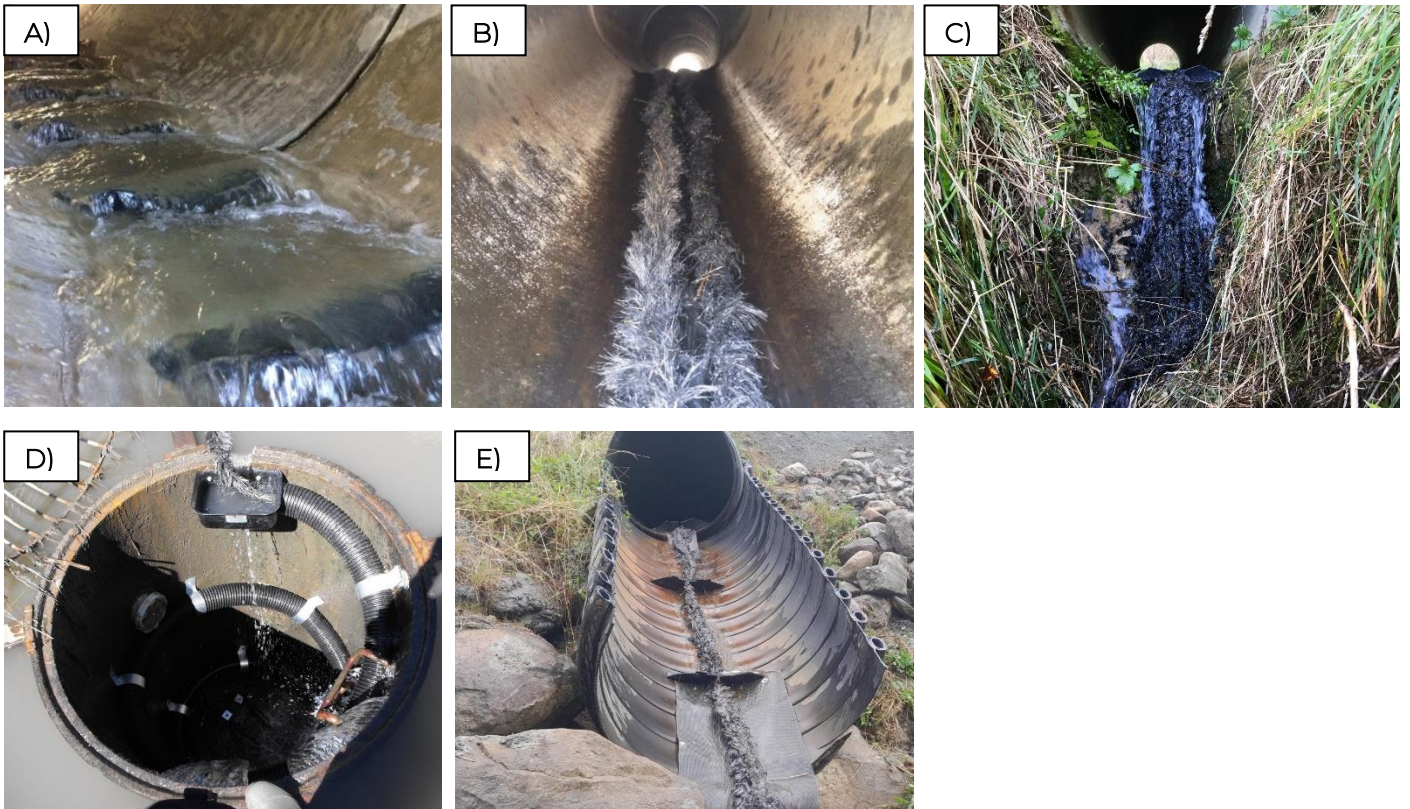
Figure A1. Low cost retrofit fish passage solutions A) baffles, B) mussel spat rope through culverts, C) mussel spat rope lined with PVC felt at outlets, D) combination of spat rope and pipe through manhole, E) spat rope and baffles through flume pipe.
