# BRYNDERWYNS HILLS RECOVERY WORKS BRYNDERWYNS RP11.46 TO 13.79 STORMWATER DESIGN REPORT

27 JUNE 2024

#### BRYNDERWYNS SPANNING FROM RP11.46 TO 13.79 STORMWATER DESIGN REPORT

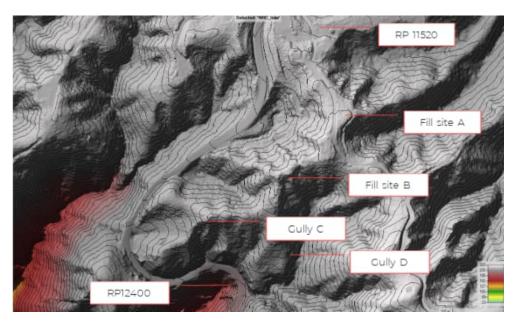
Figure 1-1: Gullies A–D, 5 m contours

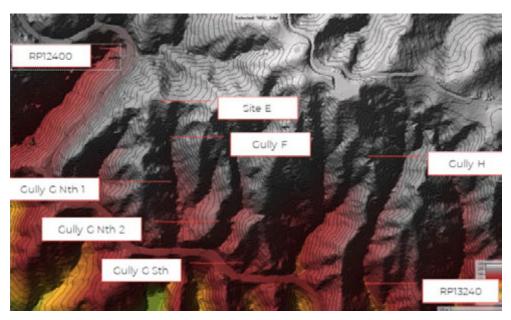
Figure 1-2: Gullies E–H, 5m contours

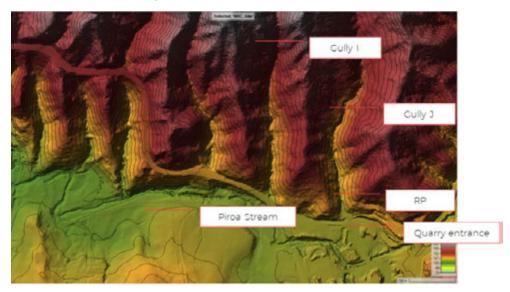
Figure 1-3: Gullies I, J, 5 m contours.

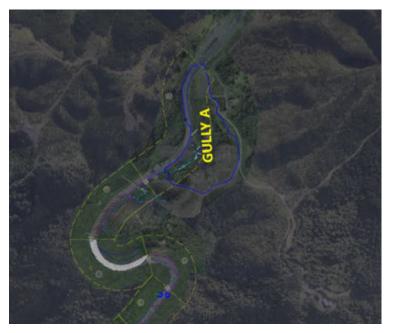
Fill site A is a 3.3 Ha bush catchment planted in pine which receives runoff from approximately 0.3 Ha of the outlet culvert is a DN900 mm RCRRJ culvert laid at approximately 23% gradient below the road embankment constructed circa 1990 with the inlet sited in the bottom of the gully. The inlet location was preserved with a 2050 inlet manhole & scruffy dome with additional risers placed as filling commenced >100,000 m<sup>3</sup> of fill material has been placed uphill of the road embankment. The existing culvert is the only drainage outlet from the gully (there are no emergency overflows).

The culvert inlet is approximately 8 m below the road edge.

Figure 3-1: Gully A -5 m contours

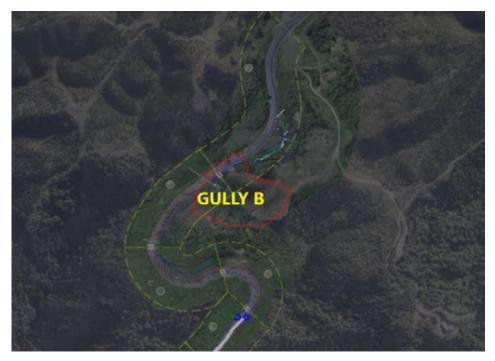
Fill site B is a 2 Ha bush catchment planted in pine which receives runoff from approximately 0.26 Ha catchment. The outlet culvert is a DN375 RCRRJ culvert laid at approximately 6 % gradient below the road embankment constructed circa 1990.

The culvert inlet is approximately 11 m below the road edge.

Figure 3-2: Gully B - 5 m contours

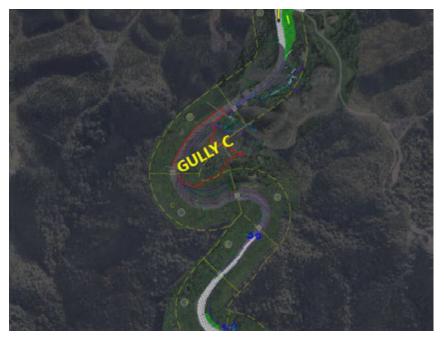
Gully Site C is a 1.3 Ha bush catchment planted in pine which receives runoff from approximately 0.3 Ha of the outlet culvert is a DN450 RCRRJ culvert laid at approximately 6.26 % gradient below the road embankment constructed circa 1990.

The culvert inlet is approximately 11 m below the road edge.

Figure 3-3: Gully C - 5 m contours.

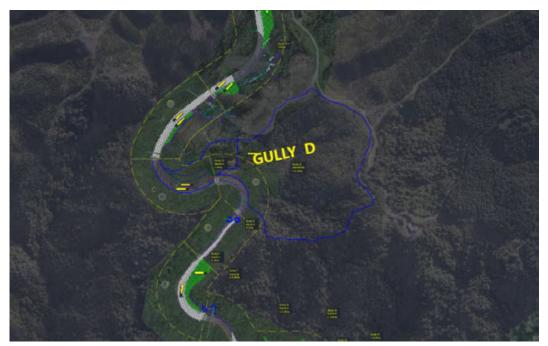
Gully Extension D is a 2.1 Ha bush catchment planted in pine which receives runoff from approximately 0.5 Ha of the outlet culvert is a DN630 Euroflo laid at approximately 9.54 % gradient below the road embankment constructed circa 1990.

Figure 3-4: Gully D

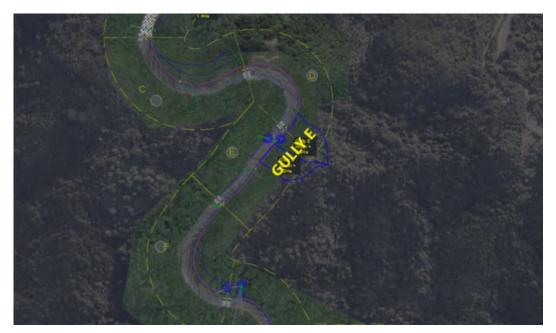
Gully Extension E is a 0.5 Ha bush catchment planted in pine, which receives runoff from approximately 0.09 Ha of the outlet culverts are two DN500 Euroflo laid at approximately 5 % and 2% gradient below the road embankment.

Figure 3-5: Gully E

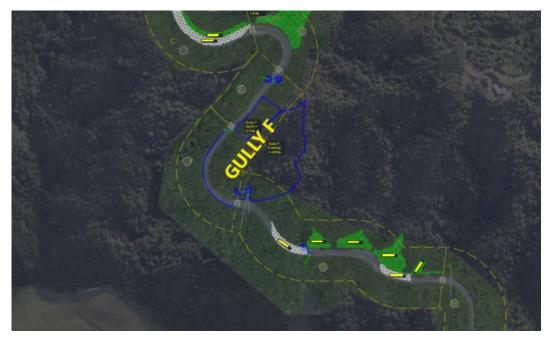
Gully Extension F is a 2.6 Ha bush catchment planted in pine which receives runoff from approximately 0.35 Ha of the outlet culverts are two DN375 and DN800 laid at approximately 3% and 0% gradient below the road embankment.

Figure 3-6: Gully F

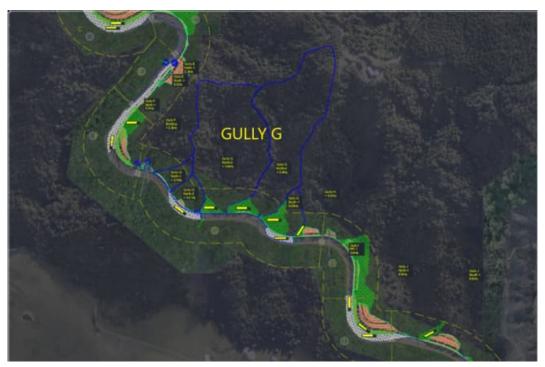
Gully Extension G is an 8.7 Ha bush catchment planted in pine which receives runoff from approximately 0.18 Ha of the outlet culverts are five pipes two DN375, two DN600 and DN630 laid at approximately 4%, 6%, 3% 7% and 2% gradient below the road embankment.

Figure 3-7: Gully G

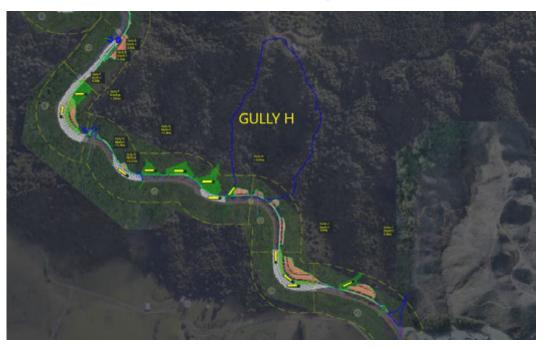
Gully H is a 6 Ha bush catchment planted in pine which receives runoff from approximately 0.13 Ha of the outlet culvert is DN600 Euroflo laid at approximately 11% below the road embankment.

Figure 3-8: Gully H

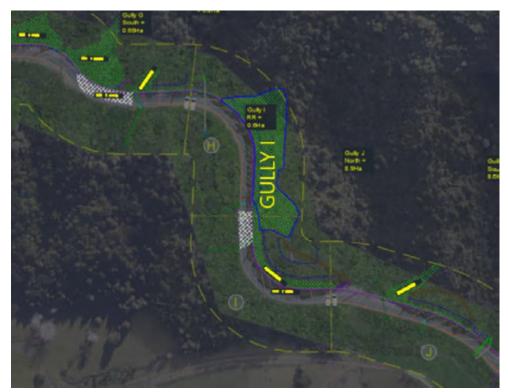
Gully I is a 0.6 Ha bush catchment planted in pine which receives runoff from approximately 0.05 Ha of the outlet culvert is DN500 Euroflo laid at approximately 1% below the road embankment.

Figure 3-9: Gully I

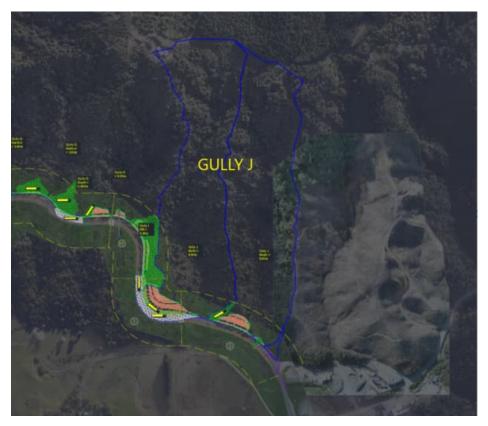
Gully J is a 15.3 Ha bush catchment planted in pine which receives runoff from approximately 0.2 Ha of the outlet culverts are two DN1200 and DN500 culverts laid at approximately 13% and 5% gradient below the road embankment.

Figure 3-10: Gully J

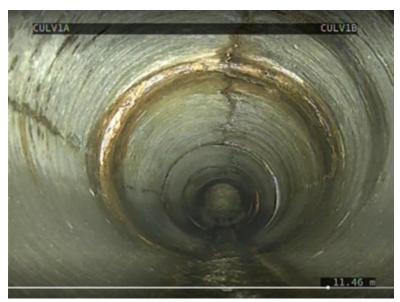
#### 2.2 Culvert 12747

#### Figure 2 Culvert 12747

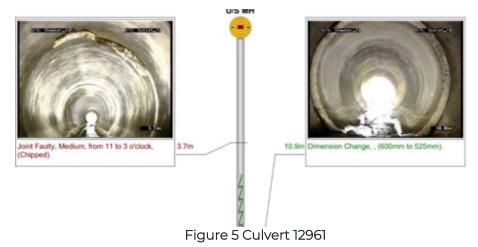
#### 2.5 Culvert 12961

In general, the pipe is in a good condition. There is a significant crack near the joint at 3.74 m, exposing the steel shown in the CCTV pipeline Images Report. Action needs to be taken to prevent the crack being developed. Patches or mechanical seals can be used to seal the joints.

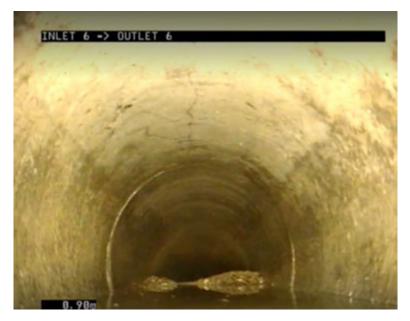
Figure 7 Culvert 12672 pipe has blockage (>30% Pipe Capacity)

Figure 7 above represents of blockage of >30% pipe capacity. This is a maintenance issue which is required to be addressed to ensure continued functionality of the culvert. And it also shows that there is a small cracking along a single pipe length through culvert 12672. The pipe is a concrete pipe, and it is in reasonable condition given its apparent age and would not require immediate replacement.

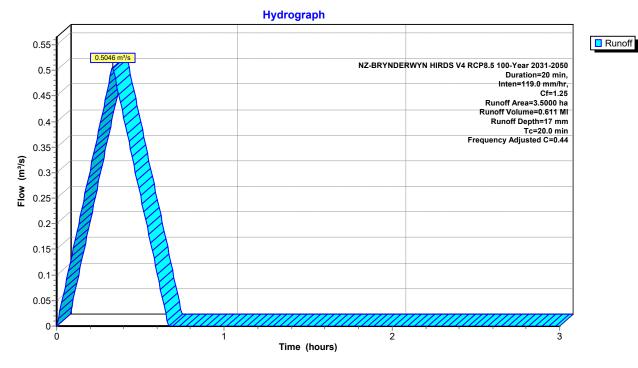
#### Subcatchment Bush-1: Bush 1

A	rea (ha)	C	; Adj	Descri	ption					
	3.5000	0.35	;	mediur	medium soakage bush and scrub cover 0.25 + 0.1 for steep slope					
	3.5000	0.35	0.44	0	•	e, Frequency Adjusted				
	3.5000			100.00	% Pervious	Area				
Т	rc Lei	ngth	Slope	Velocity	Capacity	Description				
(mii	n) (met	ers)	(m/m)	(m/sec)	(m³/s)					
20	.0					Direct Entry,

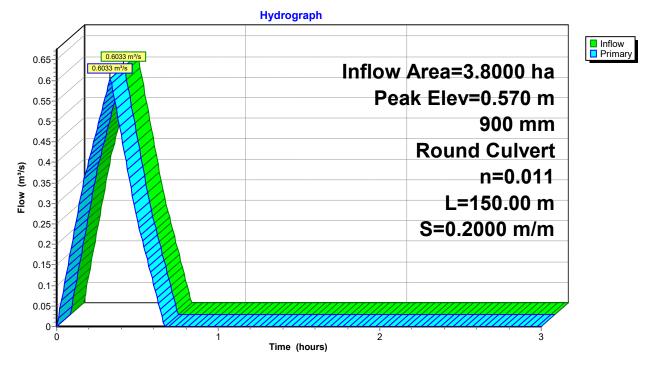
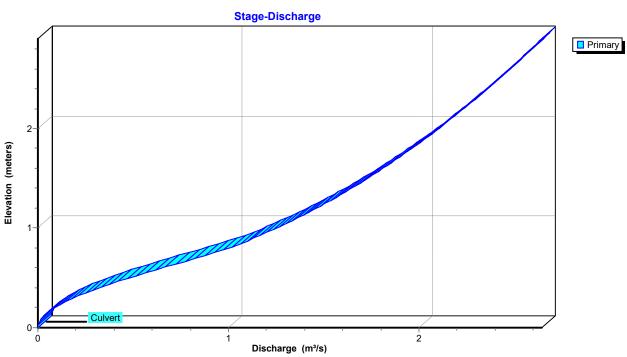
# Pond Culvert-1: Culvert 01

Inflow Area = 3.8000 ha. 7.89% Impervious, Inflow Depth = 19 mm for 100-Year 2031-2050 event Inflow 0.33 hrs, Volume= = 0.6033 m<sup>3</sup>/s @ 0.730 MI 0.33 hrs, Volume= = 0.730 MI, Atten= 0%, Lag= 0.0 min Outflow 0.6033 m<sup>3</sup>/s @ 0.6033 m<sup>3</sup>/s @ 0.33 hrs, Volume= 0.730 MI Primary = Routing by Stor-Ind method, Time Span= 0.00-3.00 hrs, dt= 0.01 hrs Peak Elev= 0.570 m @ 0.33 hrs Flood Elev= 2.900 m Device Routing Invert **Outlet Devices** 0.000 m 900 mm Round Culvert L= 150.00 m Ke= 0.500 #1 Primary Inlet / Outlet Invert= 0.000 m / -30.000 m S= 0.2000 m/m Cc= 0.900 n= 0.011 Concrete pipe, straight & clean, Flow Area= 0.636 m<sup>2</sup>

**Primary OutFlow** Max=0.6019 m<sup>3</sup>/s @ 0.33 hrs HW=0.570 m (Free Discharge) **1=Culvert** (Inlet Controls 0.6019 m<sup>3</sup>/s @ 1.42 m/s)

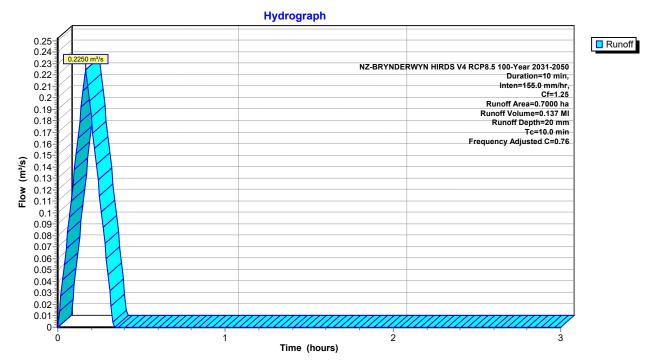
#### Subcatchment 10S: Road

Runoff = 0.2250 m<sup>3</sup>/s @ 0.17 hrs, Volume= 0.137 Ml, Depth= 20 mm Routed to Reach 6R : Parabolic channel 600 wide, 100 deep

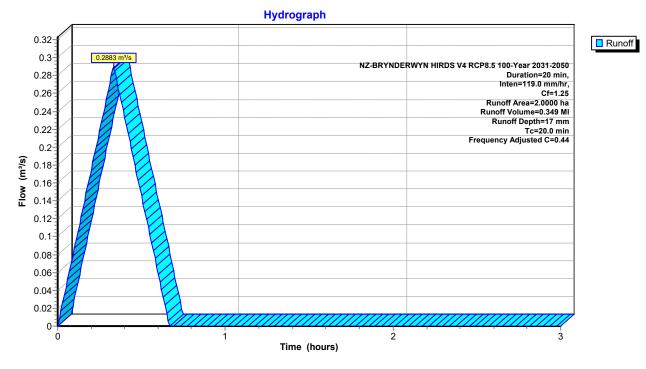
# Subcatchment Bush: Bush

# Summary for Subcatchment Bush: Bush

Runoff = 0.2883 m<sup>3</sup>/s @ 0.33 hrs, Volume= 0.349 Ml, Depth= 17 mm Routed to Pond Culvert-2 : Culvert 02

_	Area	a (ha)	С	Adj	Descri	ption							
_	2.	0000	0.35		mediur	medium soakage bush and scrub cover 0.25 + 0.1 for steep slope							
	2.	2.0000 0.35 0.44 Weighted Average, Frequency Adjusted											
	2.	0000			100.00	% Pervious	s Area						
_	Tc (min)	Len (mete	•	Slope (m/m)	Velocity (m/sec)	Capacity (m³/s)	Description						
	20.0						Direct Entry,

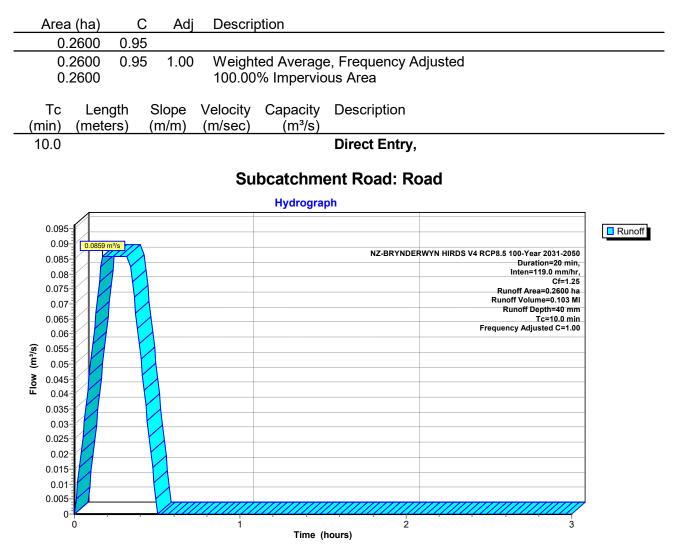
#### Summary for Subcatchment Road: Road

Runoff = 0.0859 m<sup>3</sup>/s @ 0.17 hrs, Volume= 0.103 Ml, Depth= 40 mm Routed to Pond Culvert-2 : Culvert 02

Runoff by Rational method, Rise/Fall=1.0/1.0 xTc, Time Span= 0.00-3.00 hrs, dt= 0.01 hrs NZ-BRYNDERWYN HIRDS V4 RCP8.5 100-Year 2031-2050 Duration=20 min, Inten=119.0 mm/hr, Cf=1.25

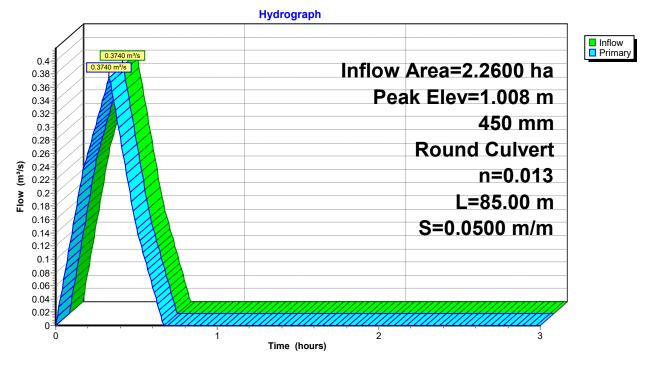
# Pond Culvert-2: Culvert 02

# Summary for Pond Culvert-2: Culvert 02

Inflow Area = 2.2600 ha, 11.50% Impervious, Inflow Depth = 20 mm for 100-Year 2031-2050 event = 0.33 hrs, Volume= Inflow 0.3740 m<sup>3</sup>/s @ 0.452 MI 0.33 hrs, Volume= = 0.452 MI, Atten= 0%, Lag= 0.0 min Outflow 0.3740 m<sup>3</sup>/s @ 0.3740 m<sup>3</sup>/s @ 0.33 hrs, Volume= 0.452 MI Primary = Routing by Stor-Ind method, Time Span= 0.00-3.00 hrs, dt= 0.01 hrs Peak Elev= 1.008 m @ 0.33 hrs Flood Elev= 2.900 m Device Routing Invert **Outlet Devices 450 mm Round Culvert** L= 85.00 m Ke= 0.500 #1 Primary 0.000 m Inlet / Outlet Invert= 0.000 m / -4.250 m S= 0.0500 m/m Cc= 0.900 n= 0.013 Corrugated PE, smooth interior, Flow Area= 0.159 m<sup>2</sup>

Primary OutFlow Max=0.3734 m³/s @ 0.33 hrs HW=1.006 m (Free Discharge) ☐ 1=Culvert (Inlet Controls 0.3734 m³/s @ 2.35 m/s)

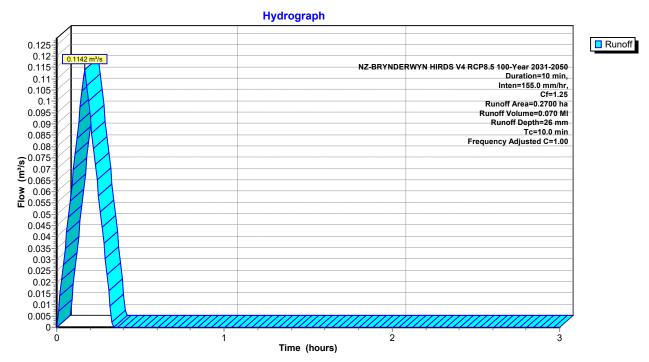
# Subcatchment 9S: Road

# Summary for Subcatchment 9S: Road

Runoff = 0.1142 m<sup>3</sup>/s @ 0.17 hrs, Volume= 0.070 Ml, Depth= 26 mm Routed to Reach 6R : Parabolic channel 600 wide, 100 deep

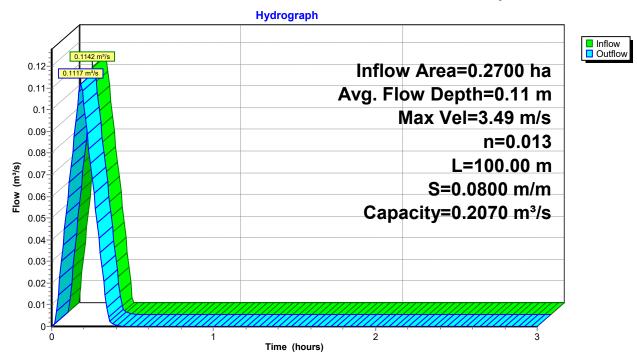
# Summary for Reach 6R: Parabolic channel 600 wide, 100 deep

Inflow Area = 0.2700 ha, 96.30% Impervious, Inflow Depth = 26 mm for 100-Year 2031-2050 event Inflow =  $0.1142 \text{ m}^3/\text{s}$  @ 0.17 hrs, Volume= 0.070 MIOutflow =  $0.1117 \text{ m}^3/\text{s}$  @ 0.18 hrs, Volume= 0.070 MI, Atten= 2%, Lag= 0.8 min

0.50 m x 0.15 m deep Parabolic Channel, n= 0.013 Length= 100.00 m Slope= 0.0800 m/m Inlet Invert= 100.000 m, Outlet Invert= 92.000 m

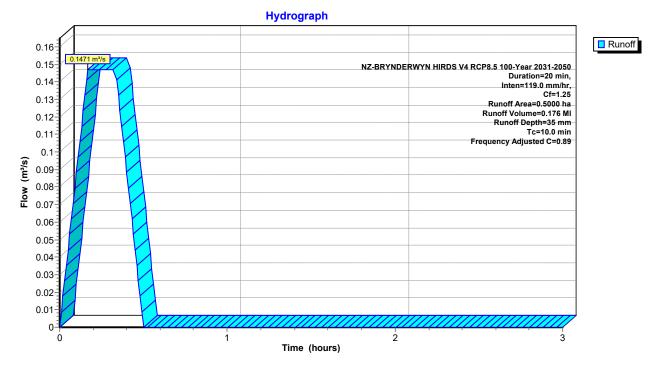
#### Subcatchment 9S: Road

# Summary for Subcatchment 9S: Road

Runoff = 0.1471 m<sup>3</sup>/s @ 0.17 hrs, Volume= 0.176 Ml, Depth= 35 mm Routed to Reach 6R : Parabolic channel 600 wide, 100 deep

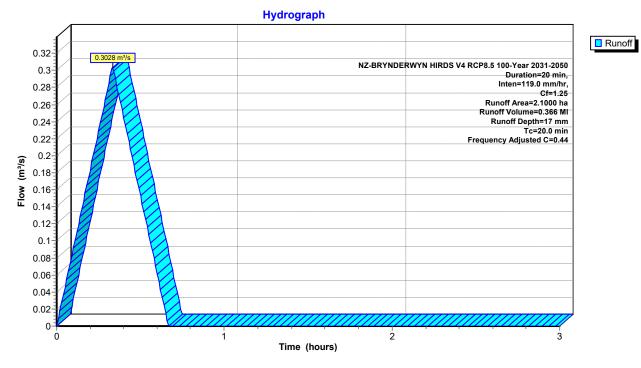
# Subcatchment Bush: Bush

# Summary for Subcatchment Bush: Bush

Runoff = 0.3028 m<sup>3</sup>/s @ 0.33 hrs, Volume= 0.366 Ml, Depth= 17 mm Routed to Pond Culvert-1 : (new Pond)

Area	a (ha)	С	Adj	Descri	ption						
 2.	1000	0.35		mediur	medium soakage bush and scrub cover 0.25 + 0.1 for steep slope						
	1000	0.35	0.44			e, Frequency Adjusted					
2.	1000			100.00	% Pervious	s Area					
Tc (min)	Len (mete	•	Slope (m/m)	Velocity (m/sec)	Capacity (m³/s)	Description					
20.0						Direct Entry,

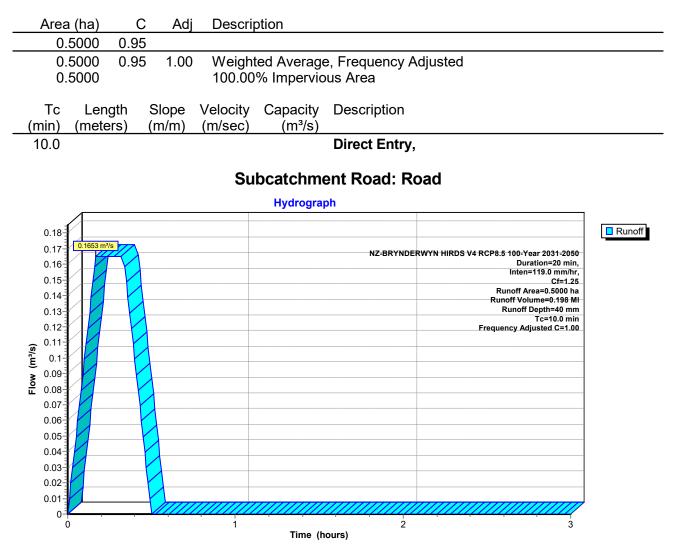
#### Summary for Subcatchment Road: Road

Runoff = 0.1653 m<sup>3</sup>/s @ 0.17 hrs, Volume= 0.198 Ml, Depth= 40 mm Routed to Pond Culvert-1 : (new Pond)

Runoff by Rational method, Rise/Fall=1.0/1.0 xTc, Time Span= 0.00-3.00 hrs, dt= 0.01 hrs NZ-BRYNDERWYN HIRDS V4 RCP8.5 100-Year 2031-2050 Duration=20 min, Inten=119.0 mm/hr, Cf=1.25

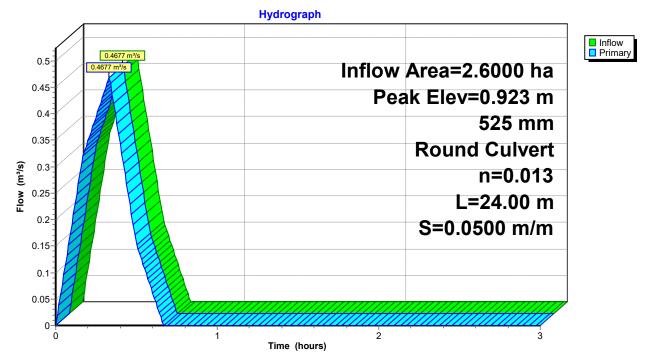
# Pond Culvert-1: (new Pond)

# Summary for Pond Culvert-1: (new Pond)

22 mm for 100-Year 2031-2050 event Inflow Area = 2.6000 ha, 19.23% Impervious, Inflow Depth = Inflow 0.33 hrs, Volume= = 0.4677 m<sup>3</sup>/s @ 0.565 MI 0.33 hrs, Volume= = 0.4677 m<sup>3</sup>/s @ 0.565 MI, Atten= 0%, Lag= 0.0 min Outflow 0.4677 m<sup>3</sup>/s @ 0.33 hrs, Volume= 0.565 MI Primary = Routing by Stor-Ind method, Time Span= 0.00-3.00 hrs, dt= 0.01 hrs Peak Elev= 0.923 m @ 0.33 hrs Flood Elev= 1.375 m Device Routing Invert **Outlet Devices** 0.000 m 525 mm Round Culvert L= 24.00 m Ke= 0.500 #1 Primary Inlet / Outlet Invert= 0.000 m / -1.200 m S= 0.0500 m/m Cc= 0.900 n= 0.013 Corrugated PE, smooth interior, Flow Area= 0.216 m<sup>2</sup>

**Primary OutFlow** Max=0.4675 m<sup>3</sup>/s @ 0.33 hrs HW=0.923 m (Free Discharge) **1=Culvert** (Inlet Controls 0.4675 m<sup>3</sup>/s @ 2.16 m/s)

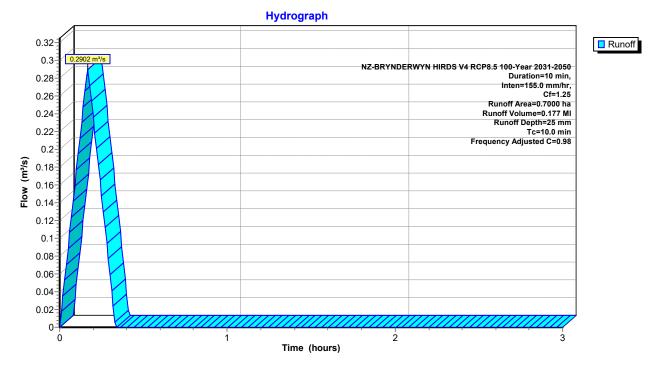
#### Subcatchment 9S: Road

# Summary for Subcatchment 9S: Road

Runoff = 0.2902 m<sup>3</sup>/s @ 0.17 hrs, Volume= 0.177 Ml, Depth= 25 mm Routed to Reach 6R : Parabolic channel 600 wide, 100 deep

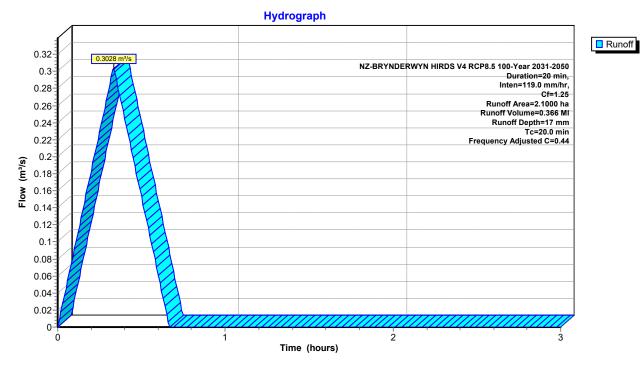
# Subcatchment Bush-7: Bush 4

# Summary for Subcatchment Bush-7: Bush 4

Runoff = 0.3028 m<sup>3</sup>/s @ 0.33 hrs, Volume= 0.366 Ml, Depth= 17 mm Routed to Pond Culvert-1 : (new Pond)

Area	ı (ha)	С	Adj	Descri	otion							
2.	1000	0.35		mediur	medium soakage bush and scrub cover 0.25 + 0.1 for steep slope							
	.1000 0.35 0.44 Weighted Average, Frequency Adjusted											
2.	1000			100.00	% Pervious	s Area						
Тс	Leng	gth	Slope	Velocity	Capacity	Description						
 (min)	(mete	rs)	(m/m)	(m/sec)	(m³/s)	·						
20.0						Direct Entry,

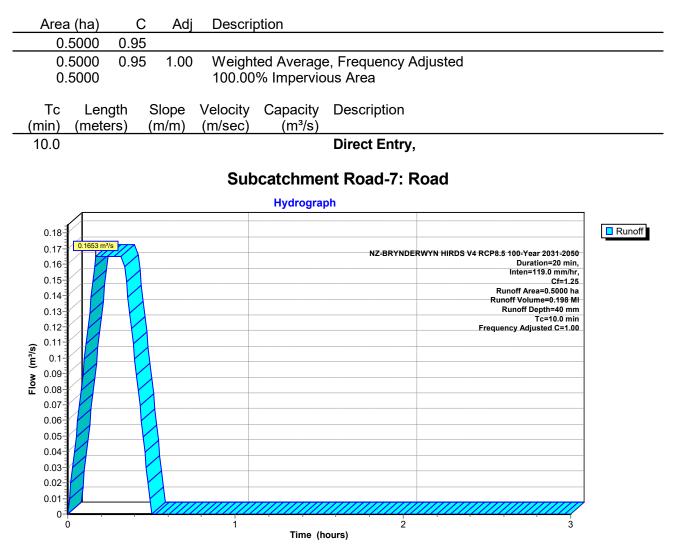
#### Summary for Subcatchment Road-7: Road

Runoff = 0.1653 m<sup>3</sup>/s @ 0.17 hrs, Volume= 0.198 Ml, Depth= 40 mm Routed to Pond Culvert-1 : (new Pond)

Runoff by Rational method, Rise/Fall=1.0/1.0 xTc, Time Span= 0.00-3.00 hrs, dt= 0.01 hrs NZ-BRYNDERWYN HIRDS V4 RCP8.5 100-Year 2031-2050 Duration=20 min, Inten=119.0 mm/hr, Cf=1.25

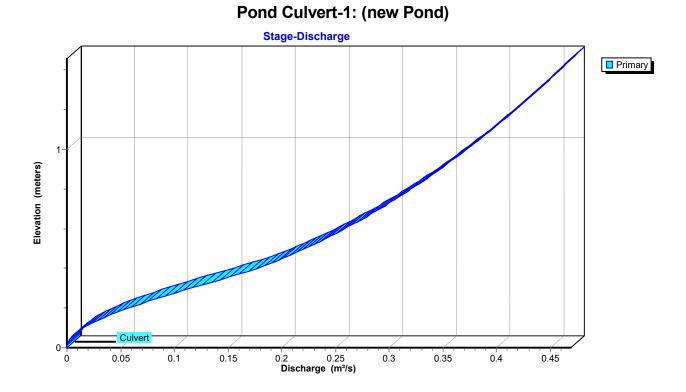
# Pond Culvert-1: (new Pond)

# Summary for Pond Culvert-1: (new Pond)

Inflow Area = 2.6000 ha, 19.23% Impervious, Inflow Depth = 22 mm for 100-Year 2031-2050 event 0.33 hrs, Volume= Inflow = 0.4677 m<sup>3</sup>/s @ 0.565 MI 0.33 hrs, Volume= = 0.4677 m<sup>3</sup>/s @ 0.565 MI, Atten= 0%, Lag= 0.0 min Outflow 0.4677 m<sup>3</sup>/s @ 0.33 hrs, Volume= 0.565 MI Primary = Routing by Stor-Ind method, Time Span= 0.00-3.00 hrs, dt= 0.01 hrs Peak Elev= 1.449 m @ 0.33 hrs Flood Elev= 1.375 m Device Routing Invert **Outlet Devices 450 mm Round Culvert** L= 80.00 m Ke= 0.500 #1 Primary 0.000 m Inlet / Outlet Invert= 0.000 m / -4.000 m S= 0.0500 m/m Cc= 0.900 n= 0.013, Flow Area= 0.159 m<sup>2</sup>

#### Hydrograph Inflow Primary 0.46 0.5 Inflow Area=2.6000 ha 0.45 Peak Elev=1.449 m 0.4 450 mm 0.35 Round Culvert 0.3 Flow (m³/s) n=0.013 0.25 L=80.00 m 0.2 S=0.0500 m/m 0.15 0.1 0.05 0-1 ż Time (hours)

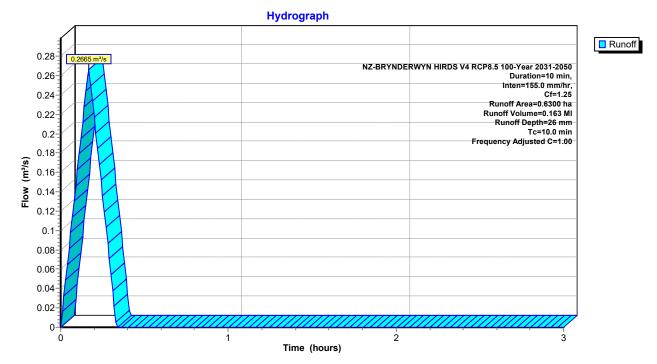
#### Subcatchment 9S: Road

# Summary for Subcatchment 9S: Road

Runoff = 0.2665 m<sup>3</sup>/s @ 0.17 hrs, Volume= 0.163 Ml, Depth= 26 mm Routed to Reach 6R : Parabolic channel 600 wide, 150 deep

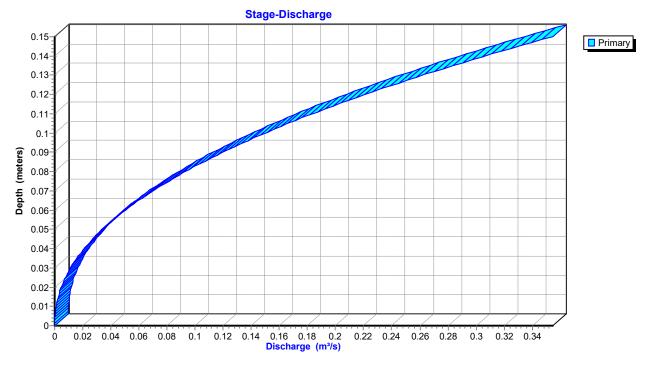
# Reach 6R: Parabolic channel 600 wide, 150 deep

#### Summary for Reach 6R: Parabolic channel 600 wide, 150 deep

Inflow Area = 0.6300 ha, 79.37% Impervious, Inflow Depth = 26 mm for 100-Year 2031-2050 event 0.17 hrs, Volume= Inflow = 0.2665 m<sup>3</sup>/s @ 0.163 MI 0.20 hrs. Volume= Outflow 0.163 MI, Atten= 7%, Lag= 2.2 min 0.2492 m<sup>3</sup>/s @ Routing by Stor-Ind+Trans method, Time Span= 0.00-3.00 hrs, dt= 0.01 hrs / 3 Max. Velocity= 4.00 m/s, Min. Travel Time= 1.4 min Avg. Velocity = 1.35 m/s, Avg. Travel Time= 4.3 min Peak Storage= 21.7 m<sup>3</sup> @ 0.18 hrs Average Depth at Peak Storage= 0.13 m, Surface Width= 0.74 m Bank-Full Depth= 0.15 m Flow Area= 0.08 m<sup>2</sup>, Capacity= 0.3547 m<sup>3</sup>/s 0.80 m x 0.15 m deep Parabolic Channel, n= 0.013 Length= 347.00 m Slope= 0.0800 m/m Inlet Invert= 100.000 m, Outlet Invert= 72.240 m Reach 6R: Parabolic channel 600 wide, 150 deep Hydrograph Inflow
Outflow 0.28 Inflow Area=0.6300 ha 0.26 Avg. Flow Depth=0.13 m 0 24 Max Vel=4.00 m/s 0.22 n=0.013 0.2 0.18 L=347.00 m Flow (m<sup>3</sup>/s) 0.16 S=0.0800 m/m 0.14 Capacity=0.3547 m<sup>3</sup>/s 0.12 0.1 0.08 0.06 0.04 0.02 0 1 Ż 3 Time (hours)

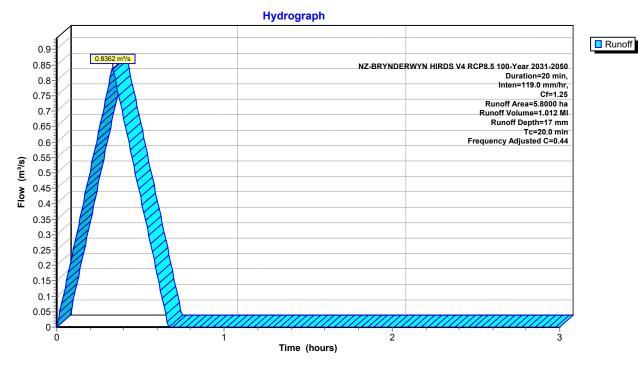
#### Subcatchment Bush-13: Bush CA

#### Summary for Subcatchment Bush-13: Bush CA

Runoff = 0.8362 m<sup>3</sup>/s @ 0.33 hrs, Volume= 1.012 Ml, Depth= 17 mm Routed to Pond 6P : (new Pond)

Area	a (ha)	С	Adj	Descri	ption	
5.	8000	0.35		mediur	n soakage l	bush and scrub cover 0.25 + 0.1 for steep slope
-	8000	0.35	0.44			e, Frequency Adjusted
5.	8000			100.00	% Pervious	s Area
Тс	Leng	ath	Slope	Velocity	Capacity	Description
 (min)	(mete		(m/m)	(m/sec)	(m³/s)	·
20.0						Direct Entry,

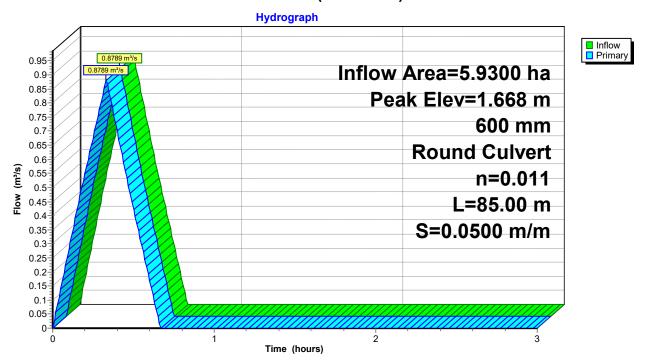
#### Pond 6P: (new Pond)

Inflow Area = 5.9300 ha, 2.19% Impervious, Inflow Depth = 18 mm for 100-Year 2031-2050 event = 0.33 hrs, Volume= Inflow 0.8789 m<sup>3</sup>/s @ 1.064 MI 0.33 hrs, Volume= = 1.064 MI, Atten= 0%, Lag= 0.0 min Outflow 0.8789 m<sup>3</sup>/s @ 0.8789 m<sup>3</sup>/s @ 0.33 hrs, Volume= 1.064 MI Primary = Routing by Stor-Ind method, Time Span= 0.00-3.00 hrs, dt= 0.01 hrs Peak Elev= 1.668 m @ 0.33 hrs Flood Elev= 1.375 m Device Routing Invert **Outlet Devices** 600 mm Round Culvert L= 85.00 m Ke= 0.500 #1 Primary 0.000 m Inlet / Outlet Invert= 0.000 m / -4.250 m S= 0.0500 m/m Cc= 0.900 n= 0.011, Flow Area= 0.283 m<sup>2</sup>

Primary OutFlow Max=0.8760 m<sup>3</sup>/s @ 0.33 hrs HW=1.659 m (Free Discharge) -1=Culvert (Inlet Controls 0.8760 m<sup>3</sup>/s @ 3.10 m/s)

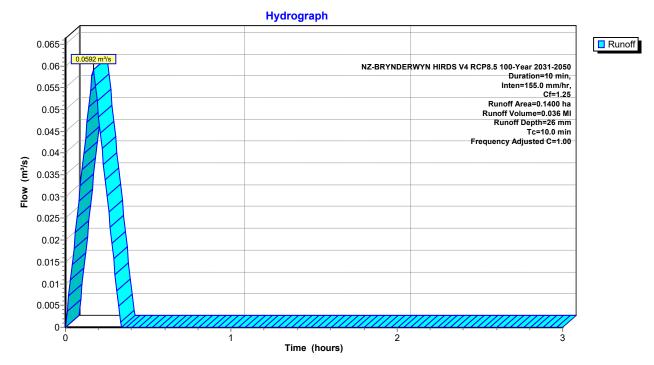
#### Subcatchment 9S: Road

## Summary for Subcatchment 9S: Road

Runoff = 0.0592 m<sup>3</sup>/s @ 0.17 hrs, Volume= 0.036 Ml, Depth= 26 mm Routed to Reach 6R : Parabolic channel 600 wide, 100 deep

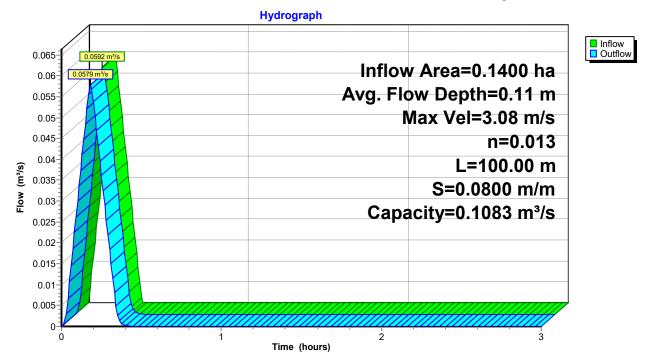
## Reach 6R: Parabolic channel 600 wide, 100 deep

## Summary for Reach 6R: Parabolic channel 600 wide, 100 deep

Inflow Area = 0.1400 ha, 92.86% Impervious, Inflow Depth = 26 mm for 100-Year 2031-2050 event Inflow =  $0.0592 \text{ m}^3/\text{s}$  @ 0.17 hrs, Volume= 0.036 MIOutflow =  $0.0579 \text{ m}^3/\text{s}$  @ 0.18 hrs, Volume= 0.036 MI, Atten= 2%, Lag= 0.9 min

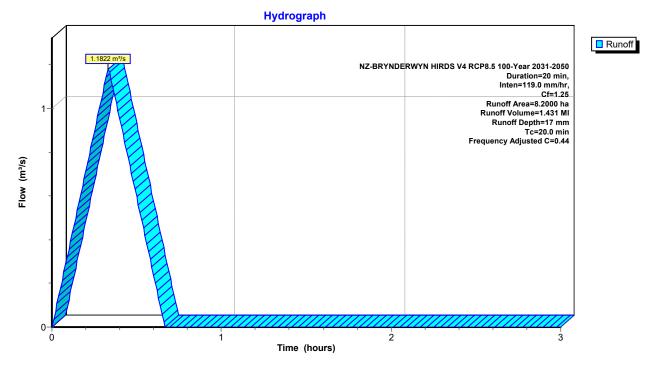
## Subcatchment Bush-15:

#### Summary for Subcatchment Bush-15:

Runoff = 1.1822 m<sup>3</sup>/s @ 0.33 hrs, Volume= 1.431 Ml, Depth= 17 mm Routed to Pond Culvert-2 : (new Pond)

Area (ł	ha) (	C Adj	Descri	ption	
8.20	00 0.3	5	mediur	n soakage	bush and scrub cover 0.25 + 0.1 for steep slope
8.20		5 0.44	•	•	e, Frequency Adjusted
8.20	000		100.00	% Pervious	s Area
	Length meters)	Slope (m/m)	Velocity (m/sec)	Capacity (m³/s)	Description
20.0					Direct Entry, Kerby-23.5 and Kri-4.6

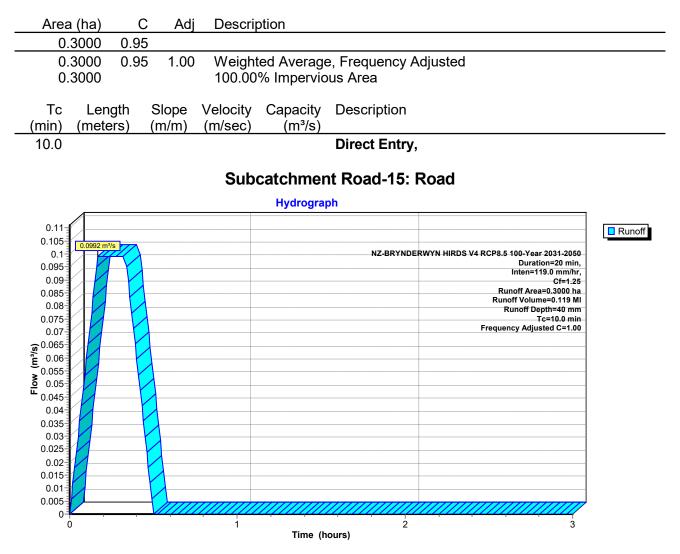
Runoff = 0.0992 m<sup>3</sup>/s @ 0.17 hrs, Volume= 0.119 Ml, Depth= 40 mm Routed to Pond Culvert-2 : (new Pond)

Runoff by Rational method, Rise/Fall=1.0/1.0 xTc, Time Span= 0.00-3.00 hrs, dt= 0.01 hrs NZ-BRYNDERWYN HIRDS V4 RCP8.5 100-Year 2031-2050 Duration=20 min, Inten=119.0 mm/hr, Cf=1.25

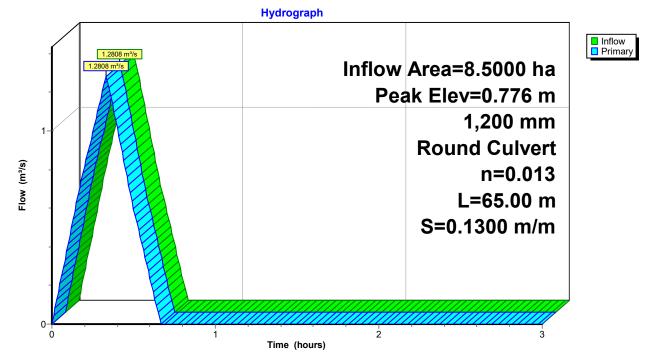
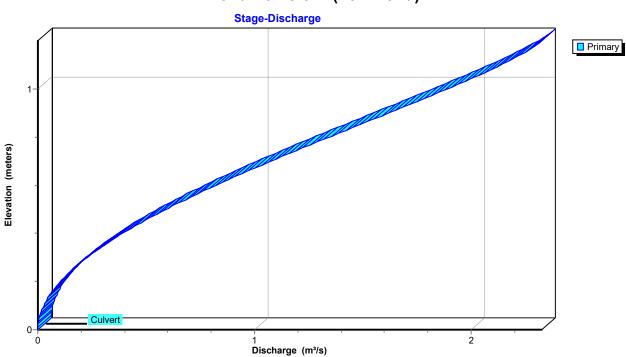
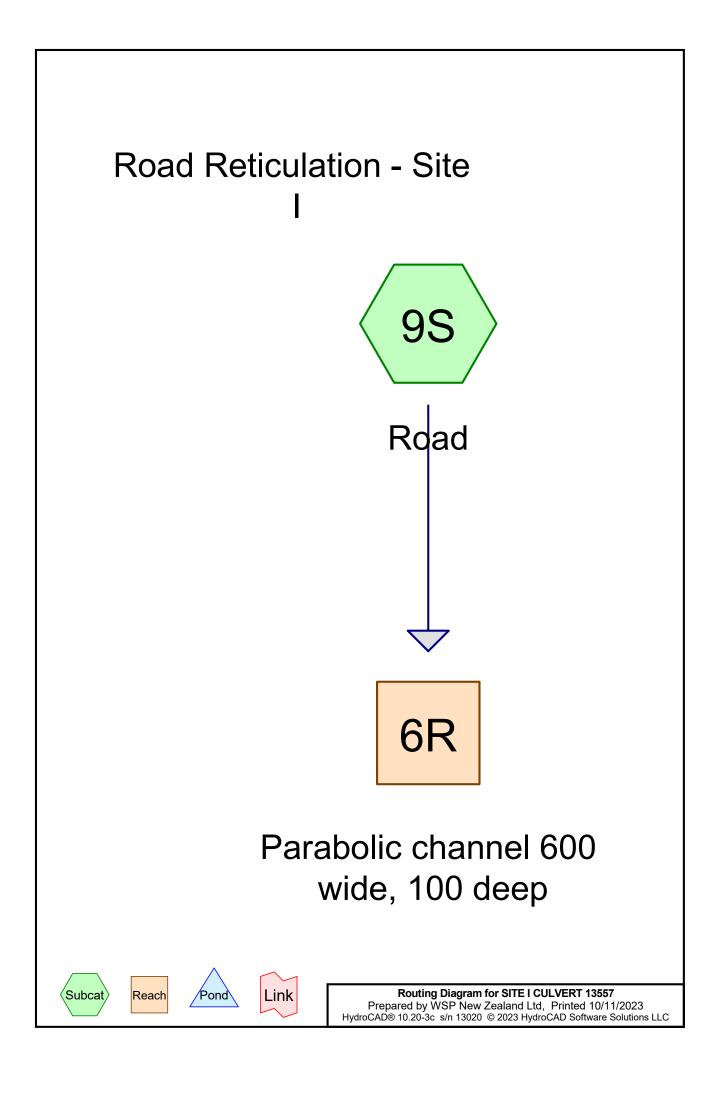
# Pond Culvert-2: (new Pond)

## Summary for Pond Culvert-2: (new Pond)

Inflow Are	a =	8.5000 ha,	3.53% Impervious, Infle	ow Depth = 18 mn	n for	100-Year 2031-2050 event
Inflow	=	1.2808 m³/s @	0.33 hrs, Volume=	1.550 MI		
Outflow	=	1.2808 m³/s @	0.33 hrs, Volume=	1.550 MI, Atte	n= 0%,	Lag= 0.0 min
Primary	=	1.2808 m³/s @	0.33 hrs, Volume=	1.550 MI

Primary OutFlow Max=1.2768 m³/s @ 0.33 hrs HW=0.775 m (Free Discharge) ☐ 1=Culvert (Inlet Controls 1.2768 m³/s @ 1.65 m/s)

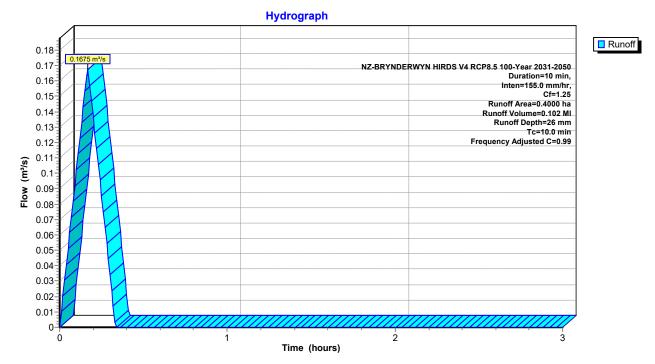
#### Subcatchment 9S: Road

## Summary for Subcatchment 9S: Road

Runoff = 0.1675 m<sup>3</sup>/s @ 0.17 hrs, Volume= 0.102 Ml, Depth= 26 mm Routed to Reach 6R : Parabolic channel 600 wide, 100 deep

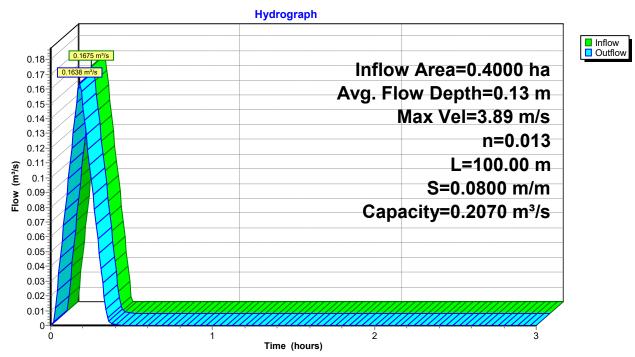
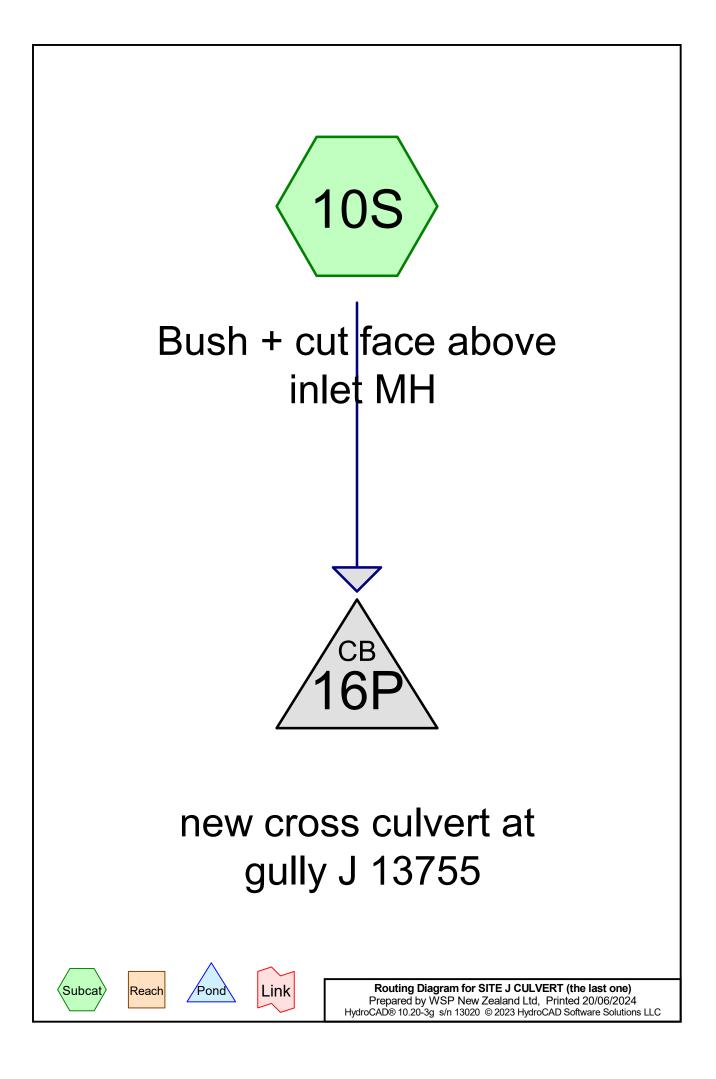
## Reach 6R: Parabolic channel 600 wide, 100 deep

#### Summary for Reach 6R: Parabolic channel 600 wide, 100 deep

Inflow Area = 0.4000 ha, 75.00% Impervious, Inflow Depth = 26 mm for 100-Year 2031-2050 event Inflow = 0.1675 m<sup>3</sup>/s @ 0.17 hrs, Volume= 0.102 MI Outflow = 0.1638 m<sup>3</sup>/s @ 0.18 hrs, Volume= 0.102 MI, Atten= 2%, Lag= 0.7 min

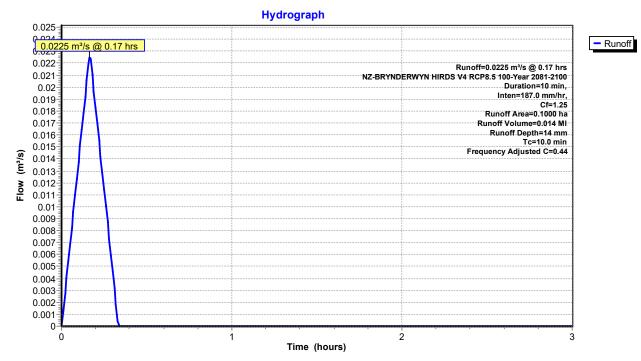
## Subcatchment 10S: Bush + cut face above inlet MH

#### Summary for Subcatchment 10S: Bush + cut face above inlet MH

Runoff = 0.0225 m<sup>3</sup>/s @ 0.17 hrs, Volume= 0.014 Ml, Depth= 14 mm Routed to Pond 16P : new cross culvert at gully J 13755

Area	a (ha)	С	Adj	Descrip	otion						
 0.	1000	0.35		bush +	bush + cut face						
	1000	0.35	0.44			e, Frequency Adjusted					
0.	1000			100.00	% Pervious	Area					
 Tc (min)	Len (mete	•	Slope (m/m)	Velocity (m/sec)	Capacity (m³/s)	Description					
10.0						Direct Entry,

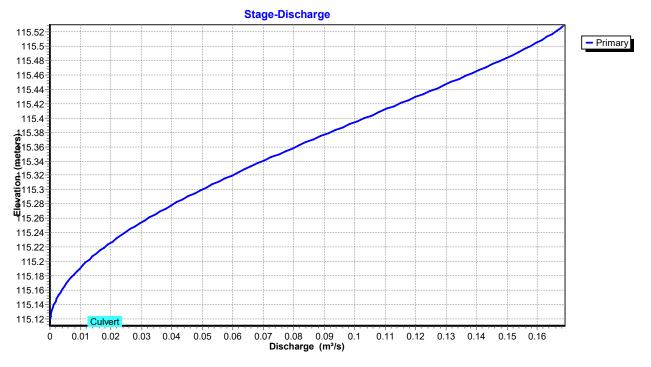
#### Pond 16P: new cross culvert at gully J 13755

#### Summary for Pond 16P: new cross culvert at gully J 13755

Inflow Area = 0.1000 ha, 0.00% Impervious, Inflow Depth = 14 mm for 100-Year 2081-2100 event Inflow 0.17 hrs, Volume= = 0.0225 m<sup>3</sup>/s @ 0.014 MI = 0.17 hrs, Volume= Outflow 0.014 MI, Atten= 0%, Lag= 0.0 min 0.0225 m<sup>3</sup>/s @ 0.0225 m<sup>3</sup>/s @ 0.17 hrs, Volume= 0.014 MI Primary =

#### Hydrograph 0.025 0.024 5 m³/s @ 0.17 hrs - Inflow Primary 0.022 Inflow Area=0.1000 ha 0.021 0.02 Inflow=0.0225 m3/s @ 0.17 hrs 0.019-Primary=0.0225 m3/s @ 0.17 hrs 0.018 0.017-Peak Elev=115.234 m 0.016-420 mm 0.015 (% 0.014 0.013 **Round Culvert** Flow n=0.013 0.012 0.011 L=12.80 m 0.01 0.009 S=0.0900 m/m 0.008-0.007 0.006 0.005 0.004 0.003 0.002-0.001 0 Ż 0 1 3 Time (hours)

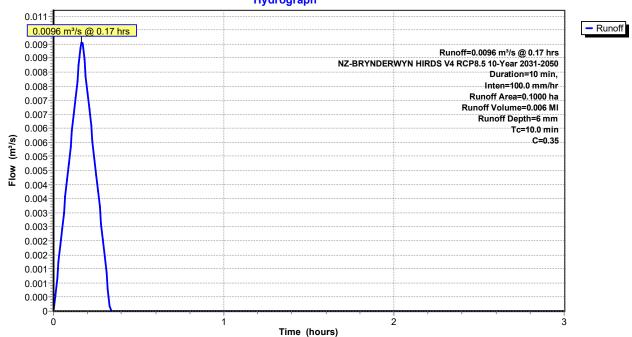
#### Subcatchment 10S: Bush + cut face above inlet MH

Area	ı (ha)	С	Desc	cription		
0.	1000	0.35	bush	+ cut fac	е	
0.	1000		100.	00% Pervi	ious Area	
Tc _(min)	Leng (mete	0	Slope m/m)	Velocity (m/sec)	Capacity (m³/s)	Description
10.0						Direct Entry,

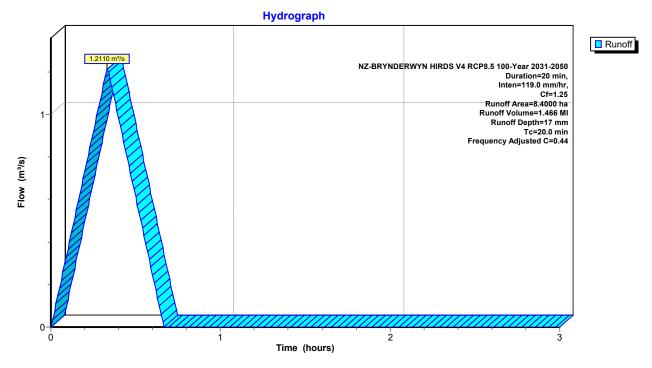
## Subcatchment Bush-16:

#### Summary for Subcatchment Bush-16:

Runoff = 1.2110 m<sup>3</sup>/s @ 0.33 hrs, Volume= 1.466 MI, Depth= 17 mm Routed to Pond Culvert-3 : (new Pond)

_	Area	ı (ha)	С	Adj	Descri	ption				
_	8.	4000	0.35		mediur	medium soakage bush and scrub cover 0.25 + 0.1 for steep slope				
	-	4000 4000	0.35	0.44	•	ted Average % Pervious	e, Frequency Adjusted			
	То	Lon	ath	Slope	Volocity	Consoity	Description			
_	Tc (min)	Leng mete)	0	Slope (m/m)	Velocity (m/sec)	Capacity (m³/s)	Description			
	20.0						Direct Entry, ker-23.3, kir-4.5

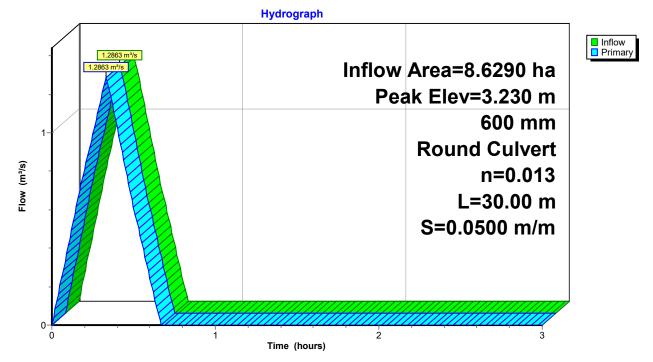
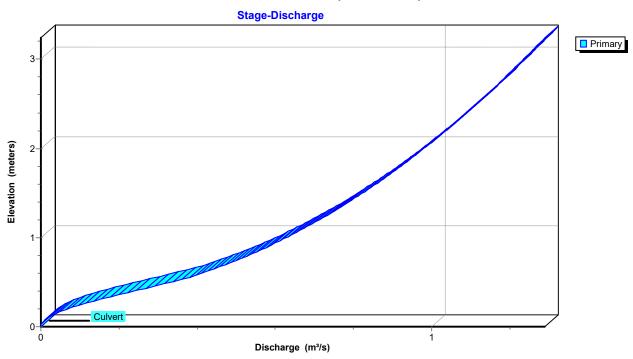
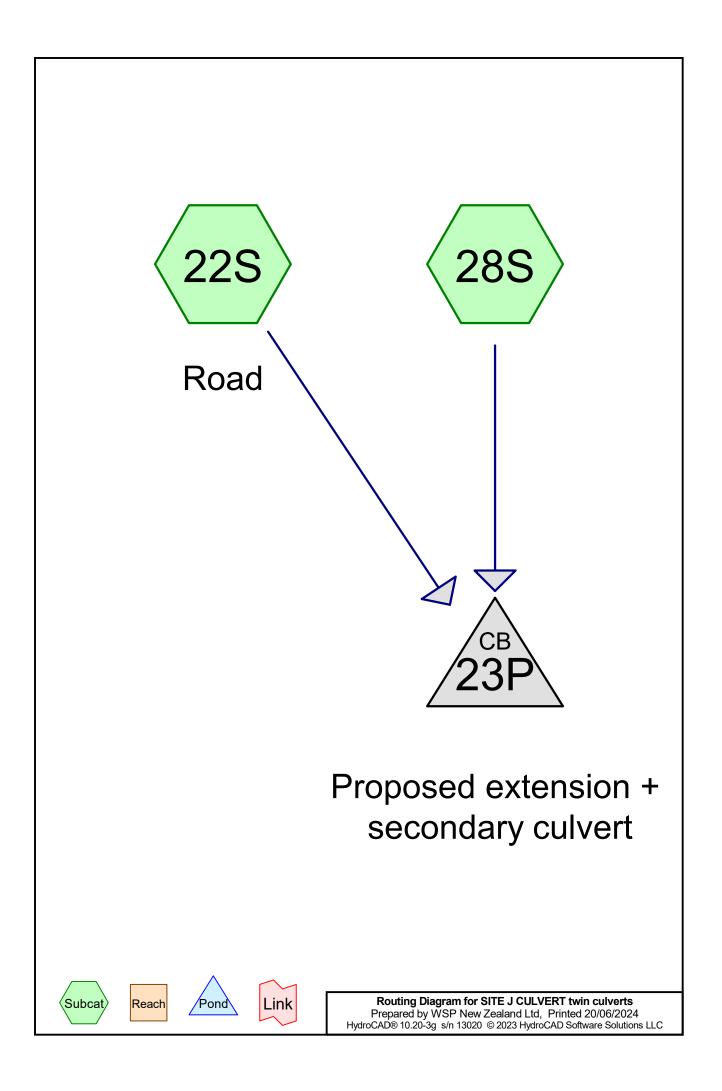
# Pond Culvert-3: (new Pond)

Primary OutFlow Max=1.2821 m³/s @ 0.33 hrs HW=3.211 m (Free Discharge) ←1=Culvert (Inlet Controls 1.2821 m³/s @ 4.53 m/s)

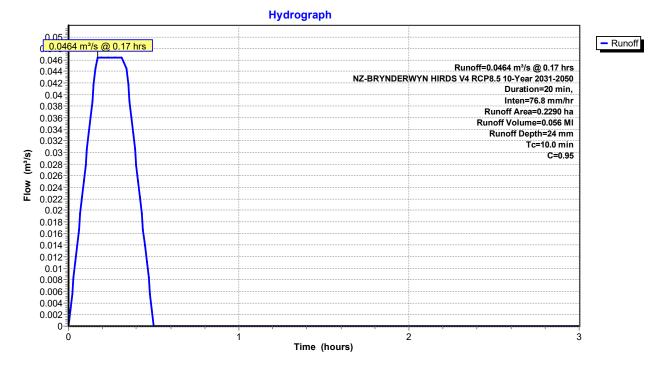
#### Subcatchment 22S: Road

### Summary for Subcatchment 22S: Road

Runoff = 0.0464 m<sup>3</sup>/s @ 0.17 hrs, Volume= 0.056 MI, Depth= 24 mm Routed to Pond 23P : Proposed extension + secondary culvert

Ar	ea (ha)	С	Des	cription		
	0.2290	0.95				
	0.2290		100.	00% Impe	rvious Area	3
To (min		0	Slope (m/m)	Velocity (m/sec)	Capacity (m³/s)	Description
10.0	)					Direct Entry,

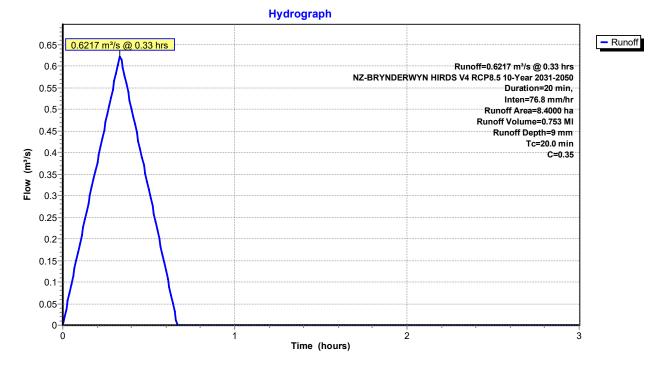
#### Subcatchment 28S:

### Summary for Subcatchment 28S:

Runoff = 0.6217 m<sup>3</sup>/s @ 0.33 hrs, Volume= 0.753 Ml, Depth= 9 mm Routed to Pond 23P : Proposed extension + secondary culvert

Area	a (ha)	С	Desc	cription		
8.	4000	0.35	med	ium soaka	ige bush ar	d scrub cover 0.25 + 0.1 for steep slope
8.4000 100.00% Pervious Area						
Tc _(min)	Lene (mete	<i>,</i>	Slope (m/m)	Velocity (m/sec)	Capacity (m³/s)	Description
20.0						Direct Entry, direct entry

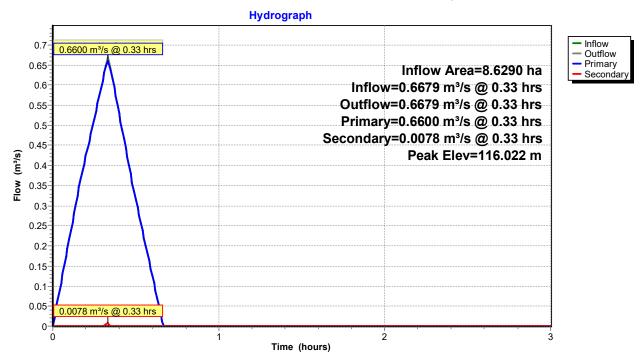
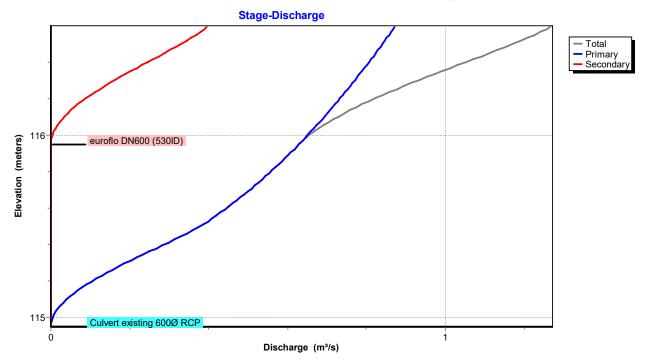
### Pond 23P: Proposed extension + secondary culvert

### Summary for Pond 23P: Proposed extension + secondary culvert

Inflow Are	a =	8.6290 ha,	2.65% Impervious,	Inflow Depth =	9 mm	for	10-Year 2031-2050 event
Inflow	=	0.6679 m³/s @	0.33 hrs, Volume	= 0.808 MI			
Outflow	=	0.6679 m³/s @	0.33 hrs, Volume	= 0.808 MI,	Atten= (	)%,	Lag= 0.0 min
Primary	=	0.6600 m³/s @	0.33 hrs, Volume	= 0.808 MI			
Secondar	y =	0.0078 m³/s @	0.33 hrs, Volume	= 0.001 MI

Secondary OutFlow Max=0.0072 m³/s @ 0.33 hrs HW=116.018 m (Free Discharge) ←1=euroflo DN600 (530ID) (Inlet Controls 0.0072 m³/s @ 0.39 m/s)

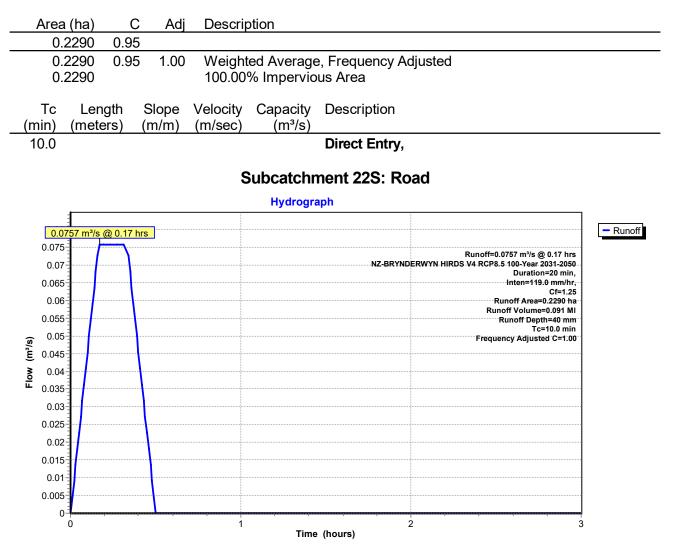
### Summary for Subcatchment 22S: Road

Runoff = 0.0757 m<sup>3</sup>/s @ 0.17 hrs, Volume= 0.091 MI, Depth= 40 mm Routed to Pond 23P : Proposed extension + secondary culvert

Runoff by Rational method, Rise/Fall=1.0/1.0 xTc, Time Span= 0.00-3.00 hrs, dt= 0.01 hrs NZ-BRYNDERWYN HIRDS V4 RCP8.5 100-Year 2031-2050 Duration=20 min, Inten=119.0 mm/hr, Cf=1.25

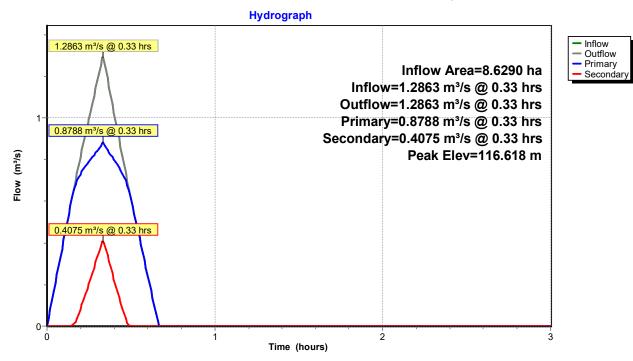
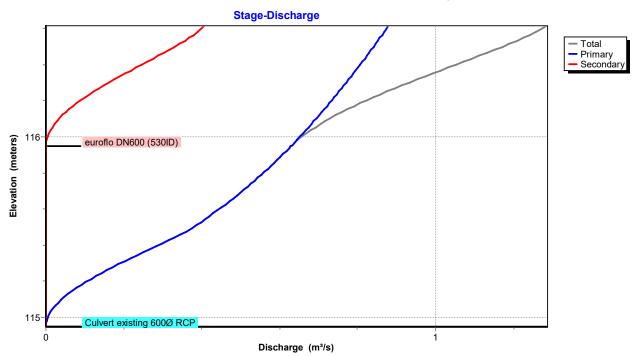
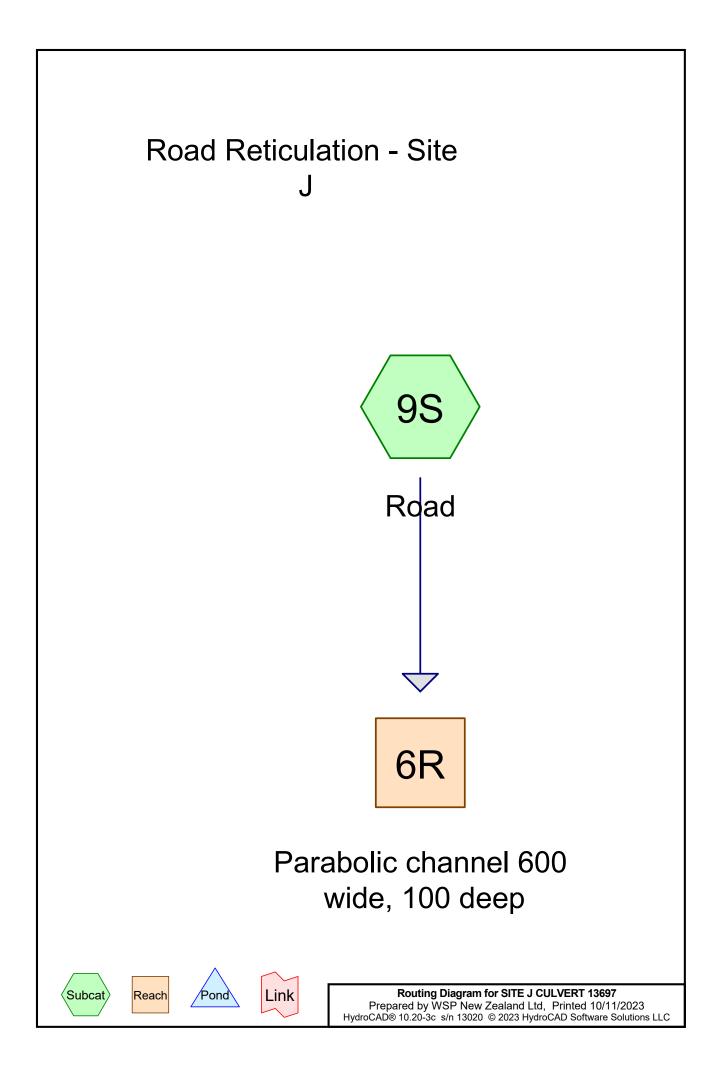
### Pond 23P: Proposed extension + secondary culvert

### Summary for Subcatchment 28S:

Runoff = 1.2110 m<sup>3</sup>/s @ 0.33 hrs, Volume= 1.466 Ml, Depth= 17 mm Routed to Pond 23P : Proposed extension + secondary culvert

Secondary OutFlow Max=0.4049 m³/s @ 0.33 hrs HW=116.613 m (Free Discharge) ←1=euroflo DN600 (530ID) (Inlet Controls 0.4049 m³/s @ 1.22 m/s)

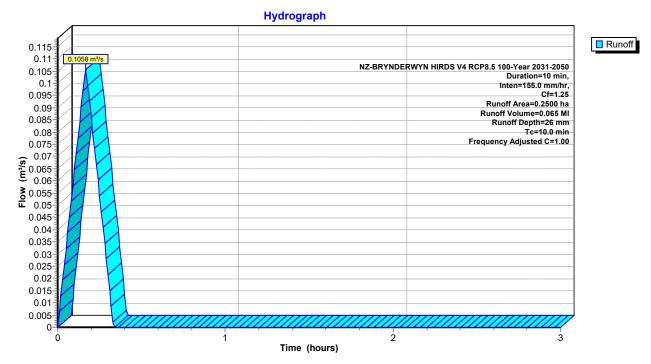
### Subcatchment 9S: Road

### Summary for Subcatchment 9S: Road
