# BRYNDERWYNS HILLS RECOVERY WORKS BRYNDERWYNS RP11.46 TO 13.79 STORMWATER DESIGN REPORT

27 JUNE 2024

#### BRYNDERWYNS SPANNING FROM RP11.46 TO 13.79 STORMWATER DESIGN REPORT

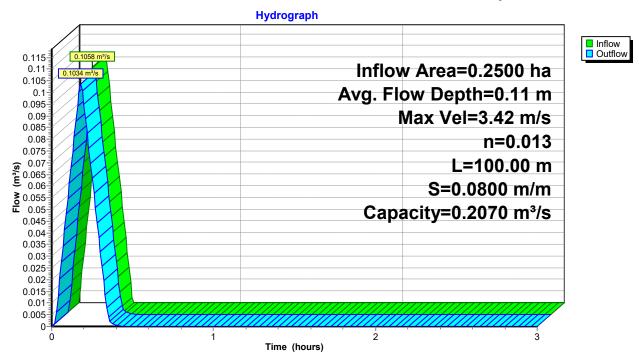
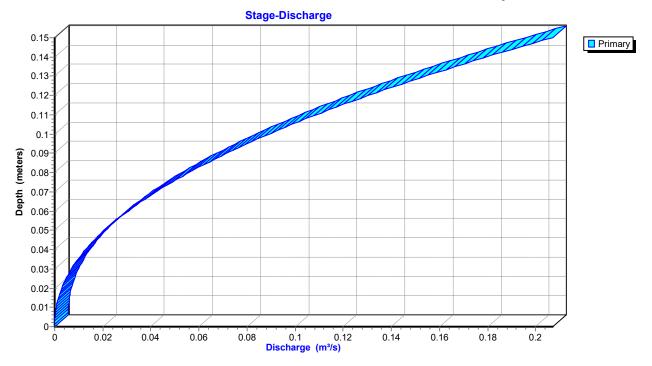
### Reach 6R: Parabolic channel 600 wide, 100 deep

### Summary for Reach 6R: Parabolic channel 600 wide, 100 deep

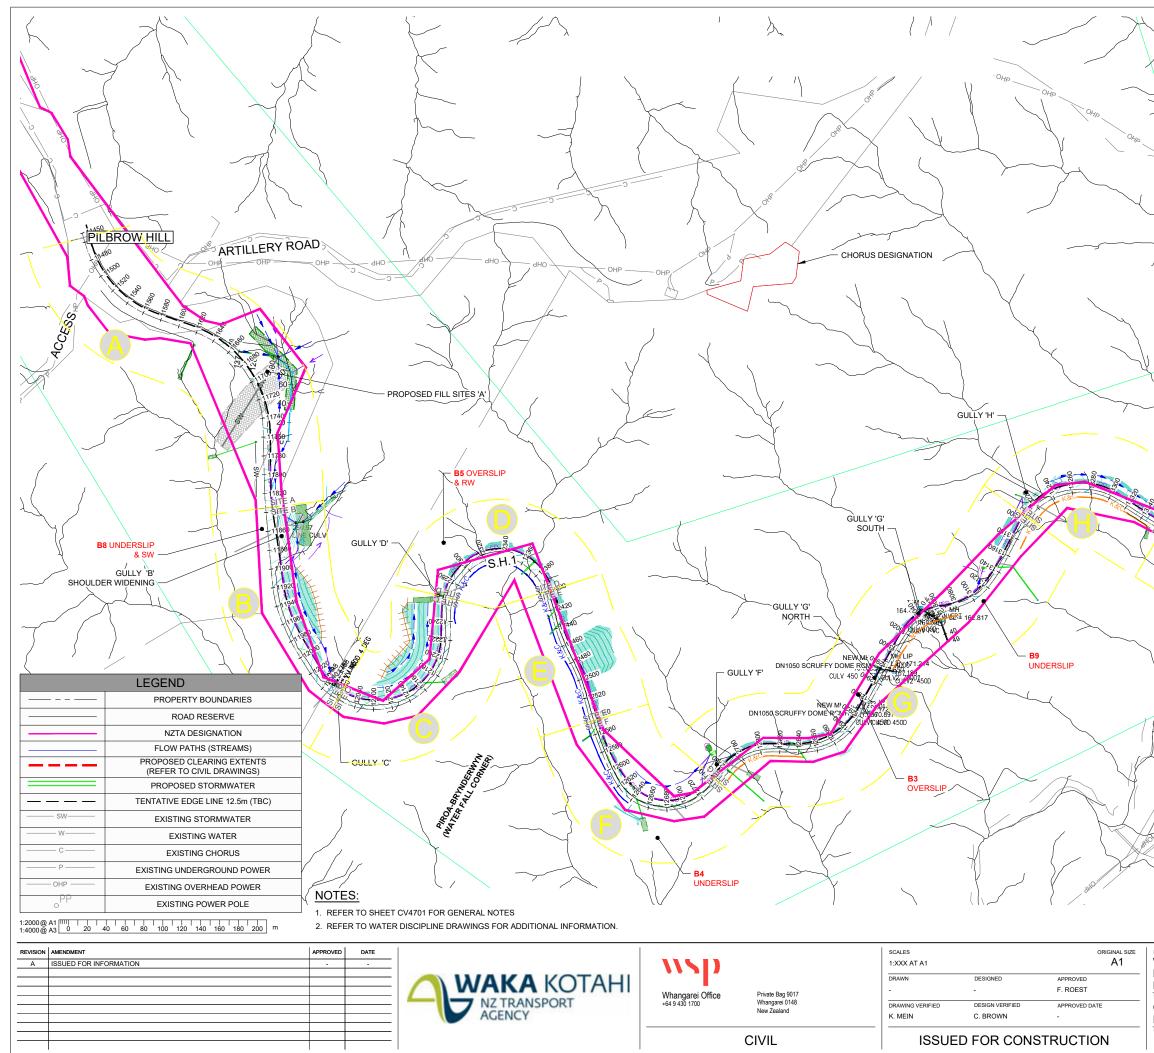
C:\DC\ACCDocs\WSP ANZ projects (AMER)\1-11264.01 Brynderwyn Hill Repairs\Project Files\01\_WIP\WA\Sheets\1-11264.01-WSP-EWGL-OA-DR-WA-4200.dwg WA-4200

the states			) M
		•	,
PROPOSED FILL SITE ATLAS	atto	airio	
	GULLY 'J' -	6440	100
GULLY IT		A B CONTRACT	
		in the second se	Htter of
	2000 STALL		XI/
			01
	1	South Contraction	~
	HRP	C	<sup>- Онр</sup>
	- OHp		
	$\langle \rangle$		
		<b>N PROGRE</b> 24/02/2024 10:32:46 am	SS
ROJECT WAKA KOTAHI NZ TRANSPORT / BRYNDERWYN HILLS - S.H.1 BRYNDERWYN HILL REPAIRS	AGENCY R.S 303	R.P 11450.0 - R.P	13902.0
OVERALL SITE DRAINAGE PLAN MSP PROJECT NO. (SUB-PROJECT)		SHEET NO.	REVISION
1-11264.01-WSP-EWGL-OA-DR		WA4200	A

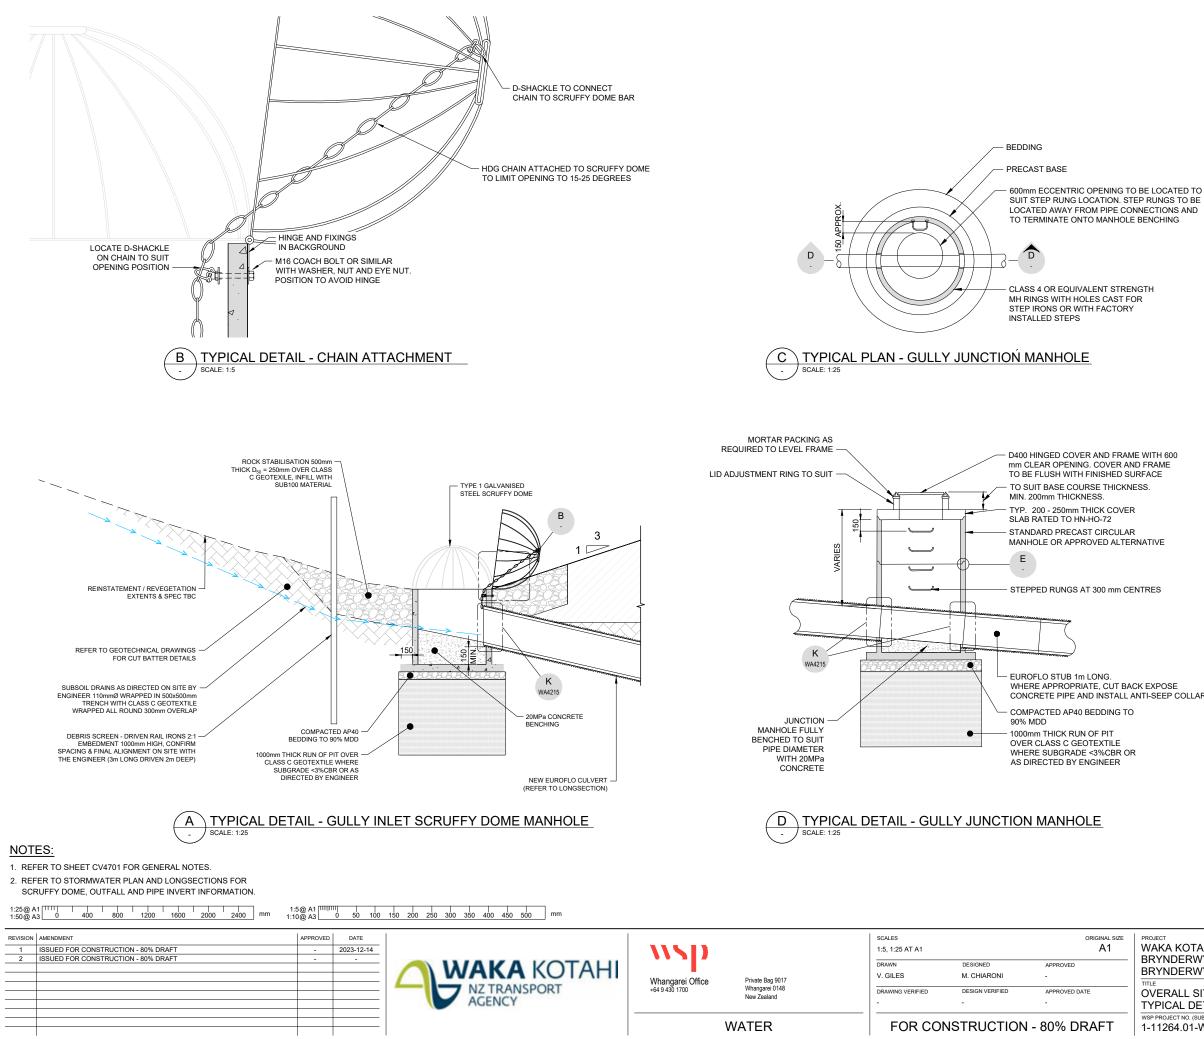
C:\DC\ACCDocs\WSP ANZ projects (AMER)\1-11264.01 Brynderwyn Hill Repairs\Project Files\01\_WIP\WA\Sheets\1-11264.01-WSP-EWGL-OA-DR-WA-4214.dwg WA4214

X EXPOSE TI-SEEP COLLAR
APPROVED HYDROPHILIC SEAL OR EPOXY MORTAR STRIP OR BUTYL MASTIC E DETAIL - JOINT - NTS
PROJECT WAKA KOTAHI NZ TRANSPORT AGENCY BRYNDERWYN HILLS - S.H.1 R.S 303 R.P 11450.0 - R.P 13902.0 BRYNDERWYN HILL REPAIRS - ENABLING WORKS TITLE
OVERALL SITE TYPICAL DETAILS - SHEET 1
WSP PROJECT NO. (SUB-PROJECT) SHEET NO. REVISION 1-11264.01-WSP-EWGL-OA-DR WA4214 2

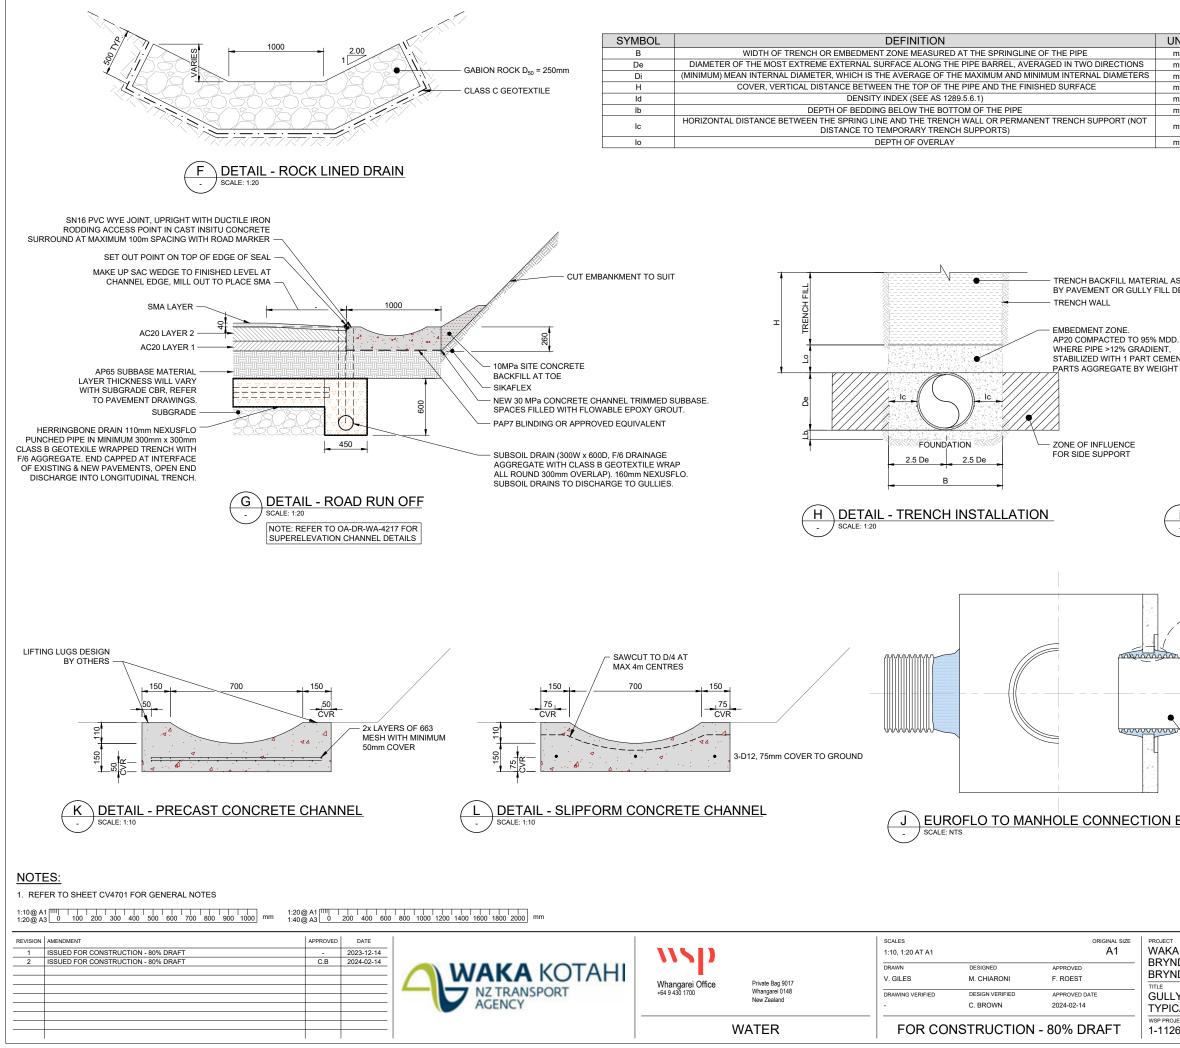
C:\DC\ACCDocs\WSP ANZ projects (AMER)\1-11264.01 Brynderwyn Hill Repairs\Project Files\01\_WIP\WA\Sheets\1-11264.01-WSP-EWGL-OA-DR-WA-4215.dwg WA4215 Original sheet size A1 (841x594) Plot Date 2024-02-24 at 10:33:02 am

_		MIN	IMUM VALU	ES	
nm	C	)e	lb	lc†	lo†	
nm	≥75	≤150	75	100	100	
nm	>150	≤300	100	150	150	
nm	>300	≤450	100	200	150	
nm	>450	≤900	150	300	150	
nm	>900	≤1500	150	350	200	
nm	>1500	≤4000	150	0.25 De	300	
nm	*THE OBJECTIVE	IS TO ACHIEVE TH	IE SAME (	CONDITION	S AND	
	MAY BE VARIED, CIRCUMSTANCE TECHNIQUES AR SUITABLE FOR D	IPACTION ALL ARC AT THE DISCRETIC S WHERE SPECIAL E USED OR WHERI IRECT EMBEDMEN N LOADS ARE APPL	ON OF THE CONSTREE NATIVE	E DESIGNE UCTION SOILS ARE	r, in	
		Ν				
S REQU	IRED	`\				
ESIGN						
			<u></u>			
NT : 20		1	$\sim$			
г <sup></sup>		/ `\o		\	<u> </u>	
		Y		\[]]		
	////14/5			X[]]]		
	=		1	\[]		
				\$ <u>  </u>		
		FOUNDATI	ON			
Γ	DETAIL - EMB		NSTA		N	
	CALE: 1:20					
	/ - · · · ·					
1			FIII	THE GAP E	ETWEEN	THE
1				E AND SLEI		
5				IG EPOXY		
	<u></u>			RTAR FOR A		4 + 4
www					0	
				IGH UP THI		
				ERNAL SUF E TO ENSUF		
				IESION	o thirt	
buyt						
$\backslash$						
	AVAILABLE FO EUROFLO® PI

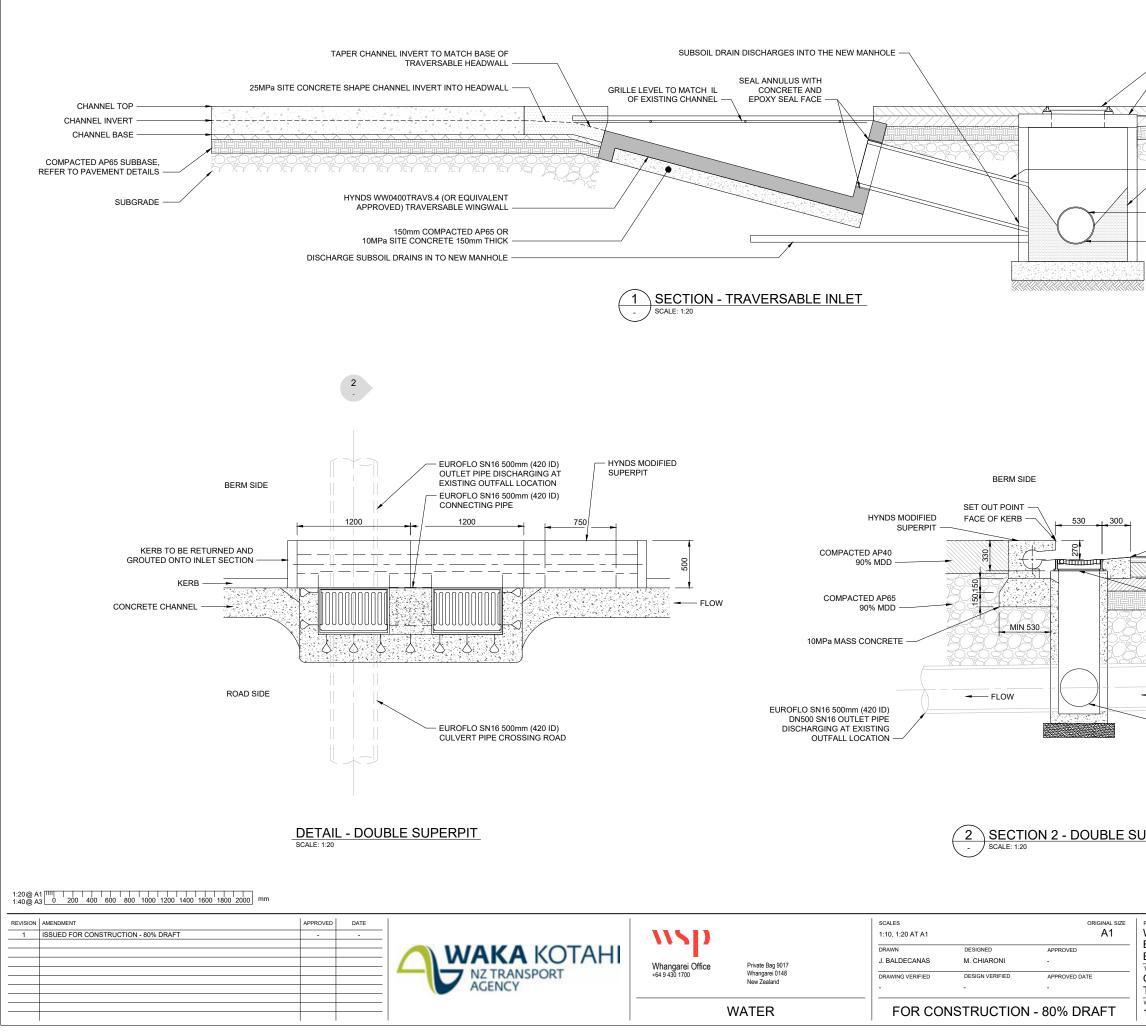
C:\DC\ACCDocs\WSP ANZ projects (AMER)\1-11264.01 Brynderwyn Hill Repairs\Project Files\01\_WIP\WA\Sheets\1-11264.01-WSP-EWGL-OA-DR-WA-4216.dwg WA4216

COVER AND FRAME		
HD PRECAST	CONCRETE LID		
	- AC20 LAYER 2 - AC20 LAYER 1 LAYER THICKNESS WILL VAR WITH SUBGRADE CBR, REFEI TO PAVEMENT DRAWINGS.		
EUROFLO	SN16 500mm (420 ID)		
	C/W D400 LID, COVER & FRAME	e. In road	
	NCHED MANHOLE WITH ALLOW PRAIN CONNECTION	ANCE FOR	
	SN16 DN500 (420 ID) TO OUTFA T CLAMPS AT EACH JOINT.	LL COMPLETE	
ROAD SIDE			
	IINIMUM 25MPa ONCRETE SURROUND		
20	- REINSTATE ROAD PAVEMEN	NT TO	
	MATCH EXISTING	-	
	— MINIMUM 25MPa CONCRETE SURROUND		
101 101			
FLOW			
		SN16 500mm (420 ID) 16 CULVERT PIPE	
	EUROFLO CONNECT	SN16 400mm (420 ID) ING PIPE	
JPERPIT			
BRYNDERWY BRYNDERWY	II NZ TRANSPORT AGEN N HILLS - S.H.1 R.S 3 N HILL REPAIRS - ENAE	303 R.P 11450.0 - R.F	P 13902.0
	AILS - SHEET 3		
WSP PROJECT NO. (SUB-P		SHEET NO. WA4216	REVISION

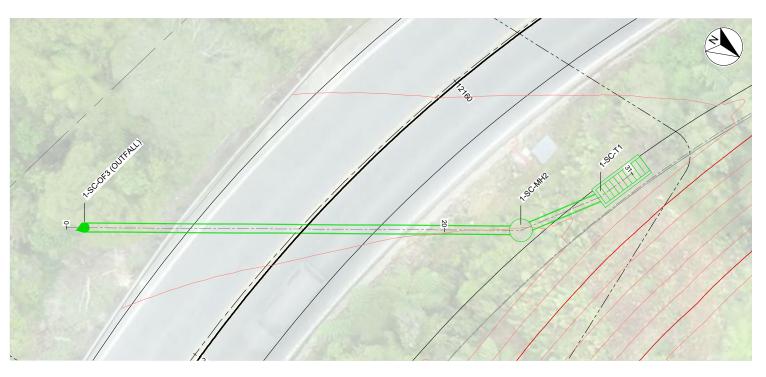
PLAN - SITE C - SW-1 SCALE: 1:100 AT A1, 1:200 AT A3

PIPE STRUCTURES - SITE C - SW-1							
ID	TYPE	DETAILS	CO-ORD (CENTROID				
1-SC-T1	HYNDS WW0450 TRAVS.4 HEADWALL	CL = 233.257 1-SC-P1 INV OUT = 232.553	E: 368914.67 N: 889480.63				
1-SC-MH2	DN1050 INLET MH WITH GRATE	CL = 232.982 1-SC-P1 INV IN = 231.407 1-SC-P2 INV OUT = 231.333	E: 368918.42 N: 889477.99				
1-SC-OF3 (OUTFALL)	OUTFALL	CL = 231.854 1-SC-P2 INV IN = 231.172	E: 368930.51 N: 889458.32

PIPE DATA - SITE C - SW-1								
PIPE ID	TYPE	2D LENGTH	3D LENGTH	GRADE	US IL	DS IL		
1-SC-P1	EUROFLO DN500 (ID420) SN16	4.6	4.7	25.00%	232.55	231.41		
1-SC-P2	EUROFLO DN500 (ID420) SN16	23.1	23.1	0.70%	231.33	231.17

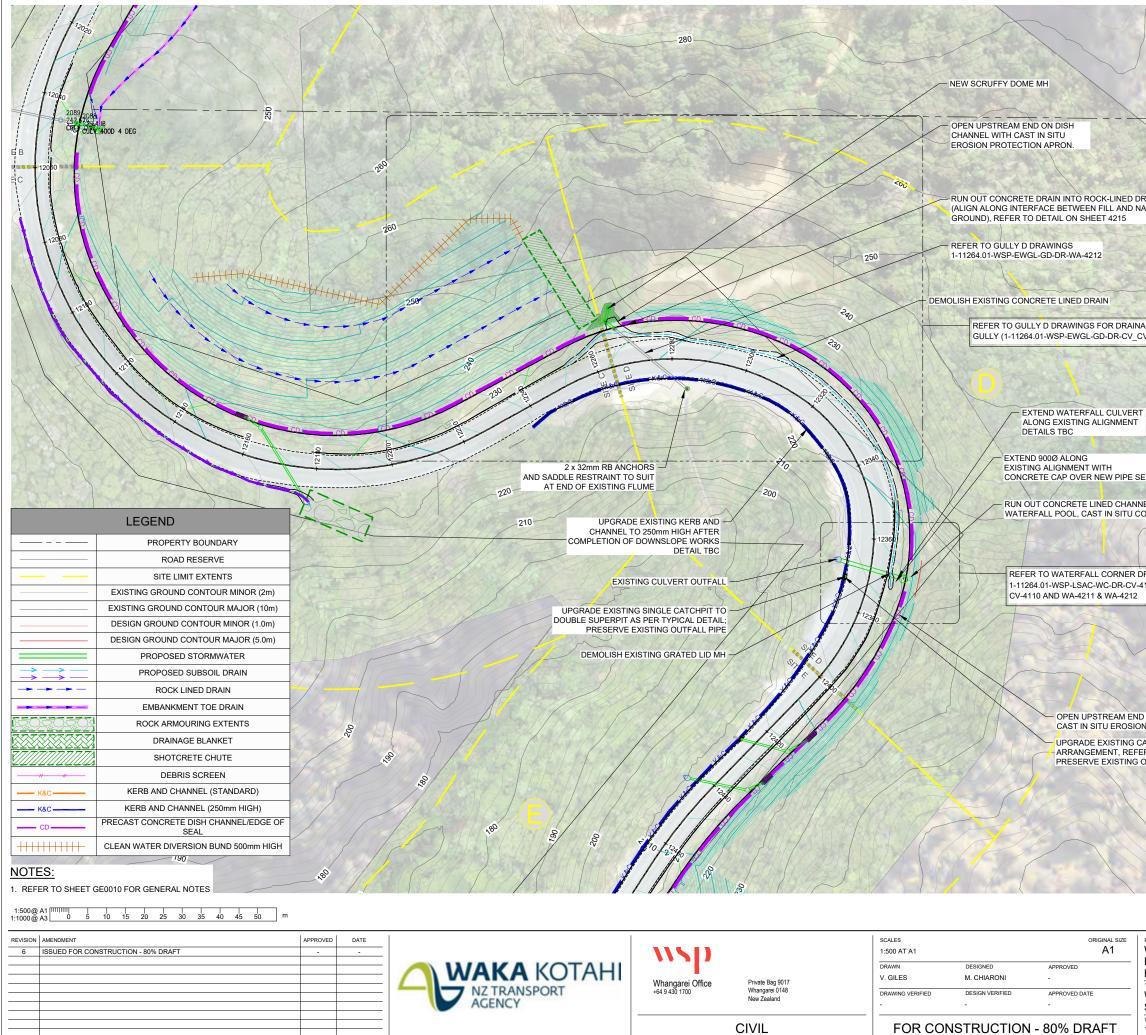
AIN TURAL
GE DETAILS WITHIN (4101 TO CV4108) CTION EL INTO INCRETE RAMP.
RAWING SET 101 TO ON DISH CHANNEL WITH PROTECTION APRON.
ATCHPIT TO DOUBLE SUPERPIT R DETAIL ON SHEET OA-DR-WA4216 DUTFALL
PROJECT WAKA KOTAHI NZ TRANSPORT AGENCY BRYNDERWYN HILLS - S.H.1 R.S 303 R.P 11450.0 - R.P 13902.0 BRYNDERWYN HILL REPAIRS
WATER - DRAINAGE PLANS SITE D - PLAN WSP PROJECT NO. (SUB-PROJECT) 1-11264.01-WSP-SDDC-SD-DR-WA4000 SHEET 04 1

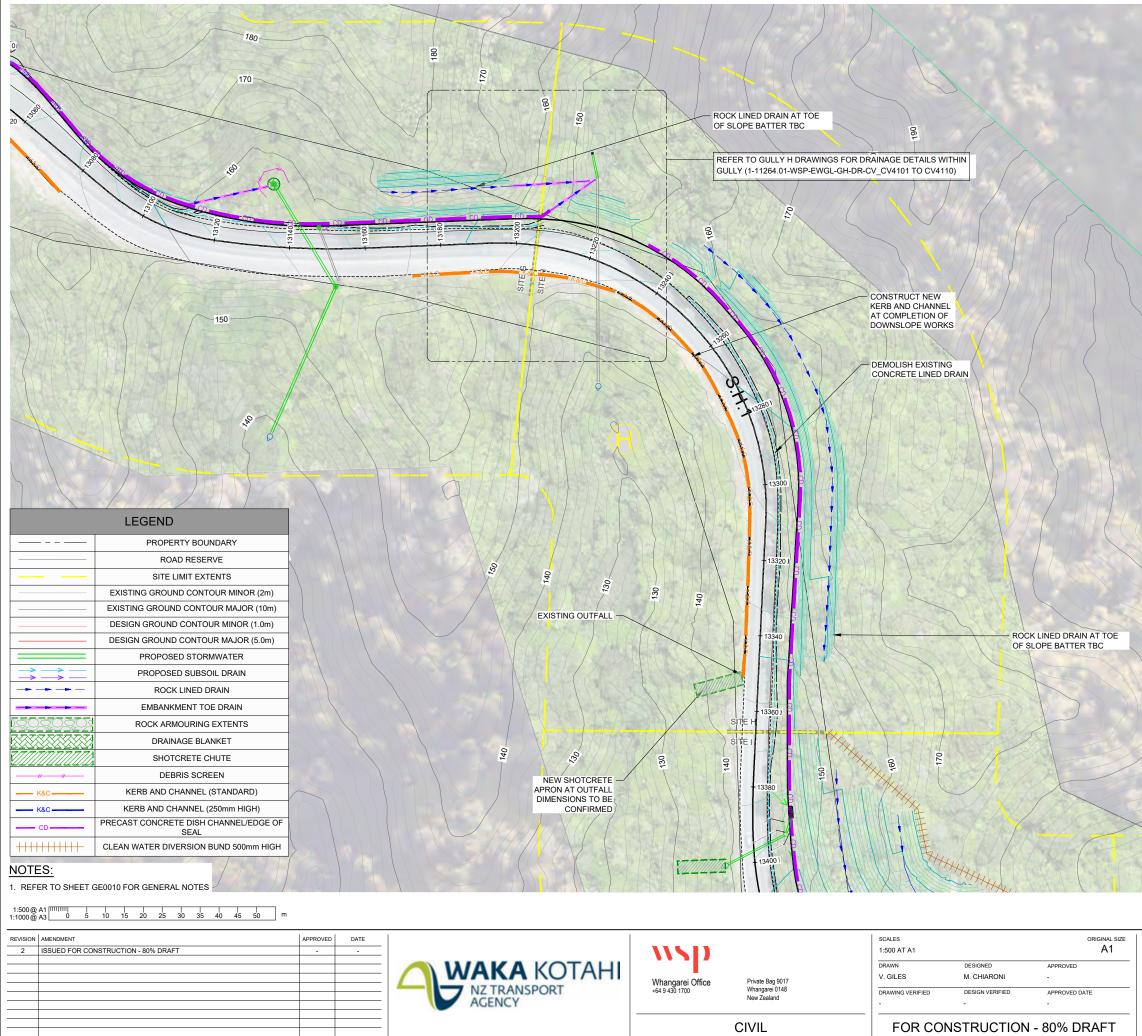
PROJECT WAKA KOTAHI NZ TRANSPORT AGENCY BRYNDERWYN HILLS - S.H.1 R.S 303 R.P 11450.0 - R.P 13902.0 BRYNDERWYN HILL REPAIRS
ITTLE           WATER - DRAINAGE PLANS           SITE H - PLAN           WSP PROJECT NO. (SUB-PROJECT)           SHEET NO.           1-11264.01-WSP-SDDC-SH-DR-WA4000           SHEET 08
